Exploring a Waste Dump Site Failure – Possible Causes and Prevention Measures

D.H. Zou

Dalhousie University, Halifax, Canada

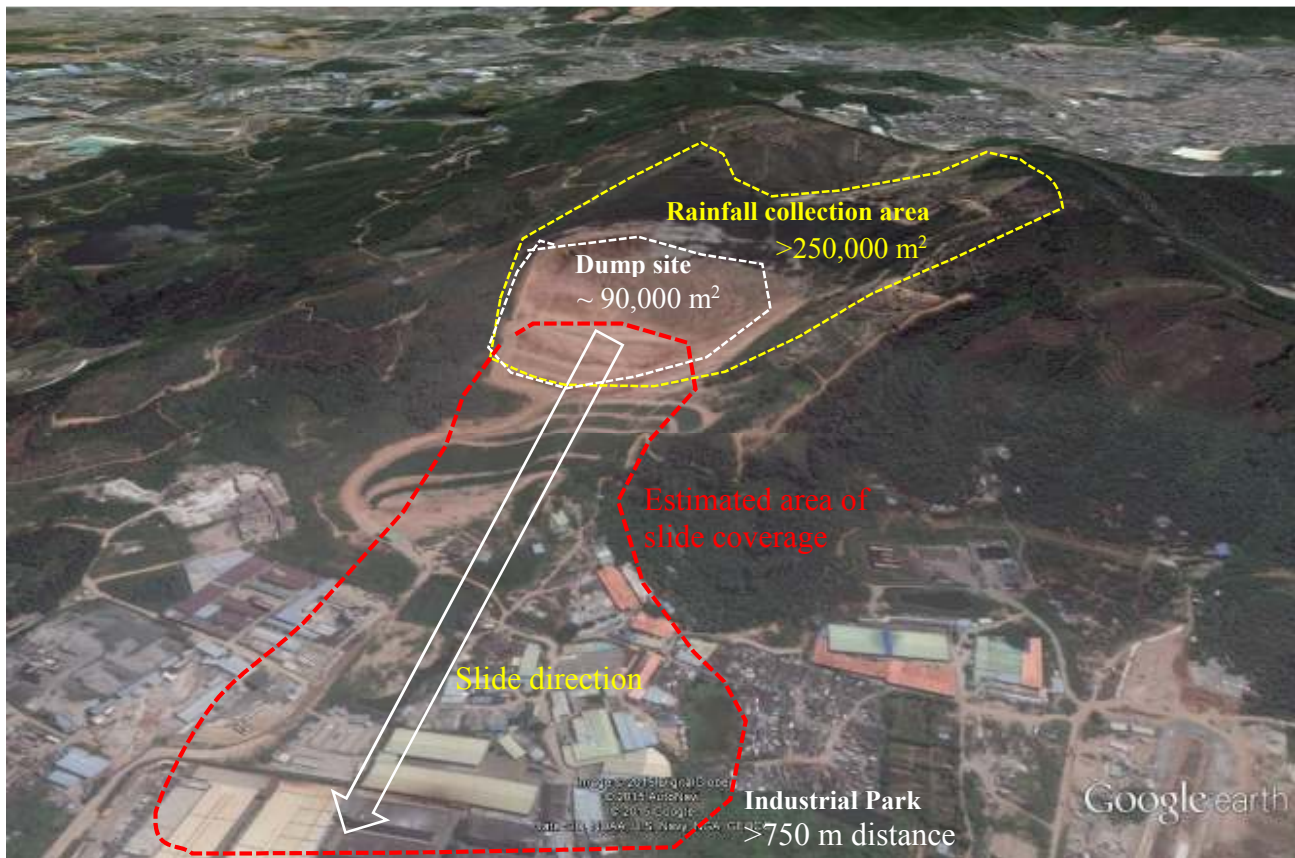
The event of failure occurred quickly and travelled a distance of over 750 m to an industrial park down the hill, as illustrated in [Fig. 1](#). It buried everything on its way and destroyed a few buildings in the industrial park ([Xinhua News](#)

Fig. 1 Bird view of the WDS slide site before the failure (Google earth image facing South, Oct. 2015).

Satellite images were taken using Google earth. Figure 1 is a bird view of the topography of the slide site. The waste dump site is located in a gently hilling area, approximately half way up the hill, with three sides surrounded by hill ridges and one side facing downhill. The industrial park is located near the bottom of the hill, approximately 750 m away and 150 m below the dump ground. The dump site covered an area of approximately 90,000 m², 320 m long and 280 m wide (Fig. 1).

rainfall water collected in an area of 2.7 times of the size of the dump site would have flowed into the waste pile. Without the waste pile, the water would have been accumulated in a pond as shown in Fig. 2. With the waste pile in place, the water would have been absorbed in the pile whether it is visible on the surface or not. Without field measurement, it is difficult to determine the actual water table. It is however reasonable to assume a water condition on the WDS site to correspond to the partially drained condition.

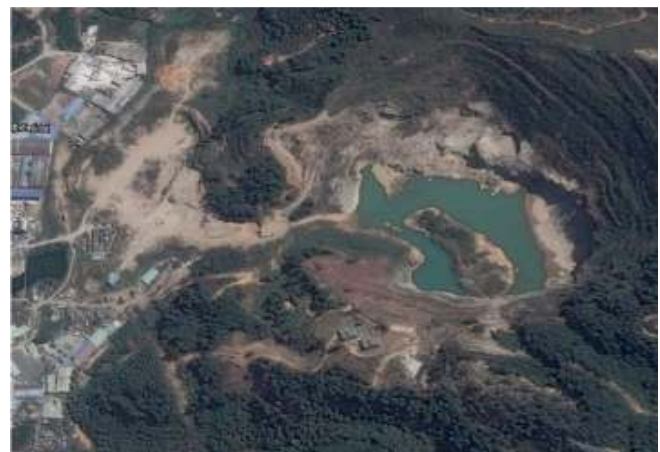
Based on various sources of reports, there was once a quarry on the site. The quarry was closed several years ago after its operation. Later the quarry pit became a pond due to accumulation of rainfall water (Fig. 2). It was reported that dumping of construction wastes on the site from other places started about two years before the slide.

Fig. 2 Abandoned quarry prior to waste dump on the WDS site (Google earth image facing East, Nov. 2013).

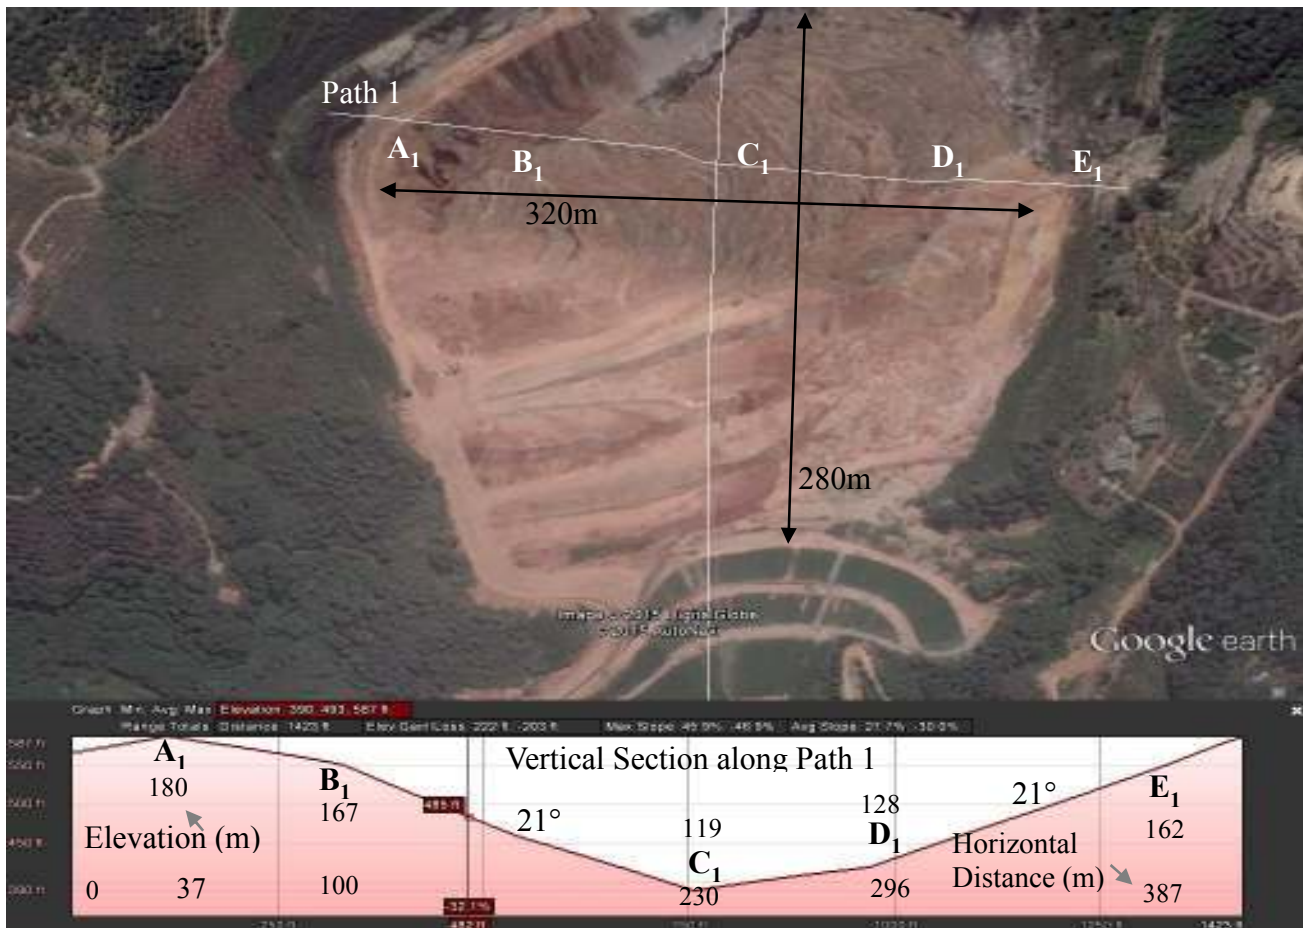
Fig. 3 Section view Path 1 (Google earth image facing South, Oct. 2015).

elevation in Fig. 3, the height of the dump pile is not even along Path 1 cross the pile. The central area near Point C₁ is 40 m lower or more than both sides. This may suggest that dumping was from both sides of the quarry during the last stage. The visible roads on both sides of the quarry would support this suggestion.

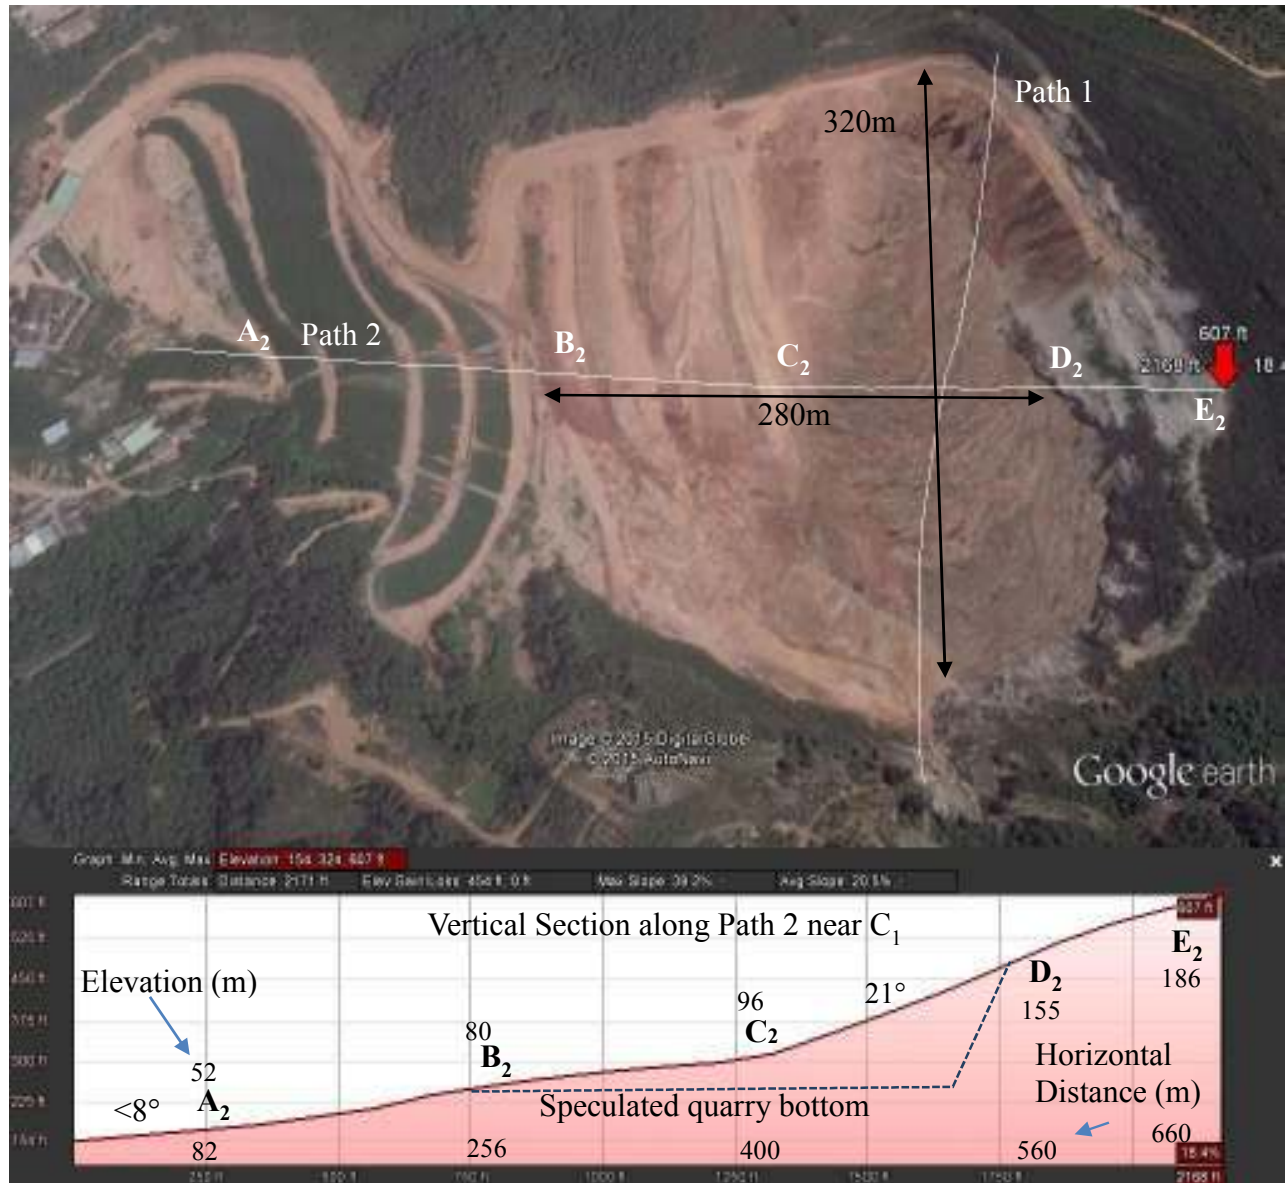
Fig. 4 Section view Path 2 (Google earth image facing East, Oct. 2015). Average slope between C₂ and D₂ on different sections varies between 21° ~ 27°, with max slope of 45° ~ 49°. Elevation at the industrial park is approximately 30 m.

The vertical section on Path 2 is along the slide direction through the central area of the dump site, near Point C₁, the lowest point on path 1 (Fig. 3). The elevation profile of the section is shown in Fig. 4, which revealed two zones: the flatter area (between B₂ and C₂) at the lower portion of the

waste pile near the pit bottom, and the steeper zone (between C₂ and D₂) at the upper portion of the waste pile close to the hill side. The average overall slope angle of the waste pile is <math><12^\circ</math> in the lower portion and approximately 21°, in the upper portion. However, Google earth indicated much steeper slope (40° ~ 49°) in local areas in the C₂ - D₂ zone on Path 2. This may be due to the uneven surface of the waste pile, or the bench slopes created during dumping. Since the WDS slide mobilized the mass of the waste pile, the overall slope stability is of our primary interest and only the overall slope angle is considered in analysis.

Based on the above information, it is possible to reconstruct the original quarry pit profile before any waste dumping on the site. This is shown in Fig. 4 as the dotted lines in the vertical section, with D₂ as the highest point of the pit high-wall and B₂ the out most point at the pit bottom. The pit bottom is not perfectly flat because water accumulated there before (Fig. 2). However for simplicity, a flat pit bottom is assumed for stability analysis. The slope angle of the high-wall in the pit is assumed to be 75° , which is considered reasonable for a rock quarry and is not expected to have any impact the stability of the waste pile in the pit. Our focus of analysis will be on the waste pile stability.

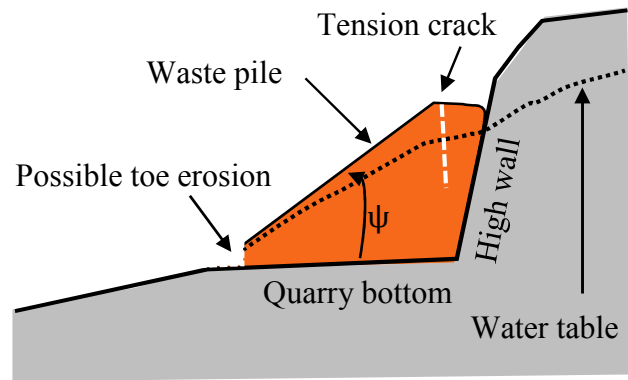
Fig. 5 Typical waste dump profile for numerical modelling

Reports also indicated erosion problem on the dump site. This condition is modelled as “toe cut” with 5 m horizontal depth, as shown in Fig. 5, at the bottom of the waste pile to assess its effect. Tension crack on the slope surface is a common phenomenon and its effect is also modelled.

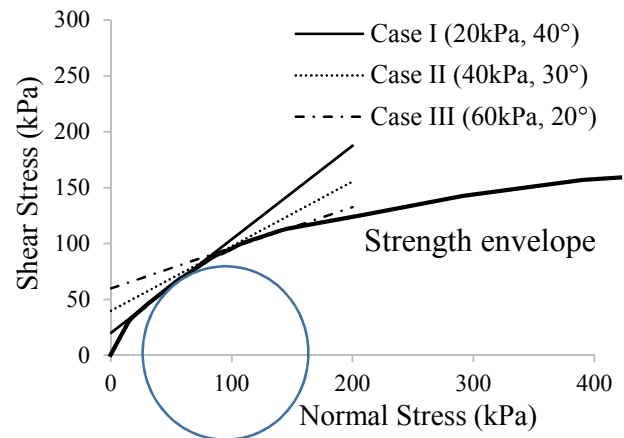
Since no real material sample and actual strength data are available for the WDS pile, the (c , ϕ) values will be estimated based on other sources. Hoek and Bray (1981) gave an estimate of (c , ϕ) for weathered rocks in the following range: $c = 20 \sim 80$ kPa and $\phi = 20^\circ \sim 40^\circ$. They further provided a practical example of a colliery waste dump site, where the estimated properties were $c = 20 \pm 20$ kPa and $\phi = 30^\circ \mp 8^\circ$, correspondingly. The materials in the WDS pile are considered very similar to those in the colliery waste dump. With the above considerations, shear strength properties for the WDS pile in the range of $c = 40 \pm 20$ kPa and $\phi = 30^\circ \mp 10^\circ$ are considered reasonable. Three cases on the strength envelope are considered for stability analysis, as shown in Fig. 6.

Fig. 6 Typical strength envelope from triaxial tests

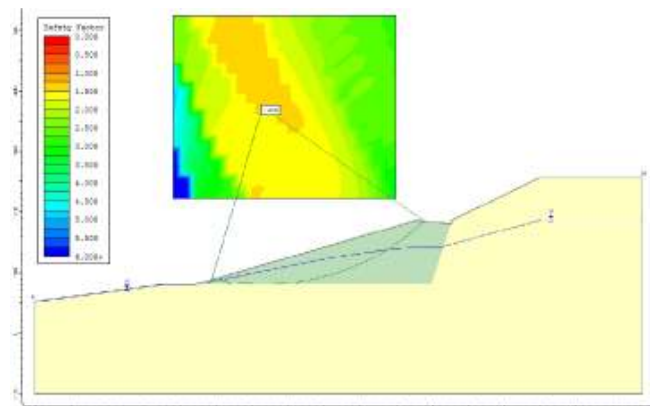
Fig. 7 Typical outcome of rotational failure analysis

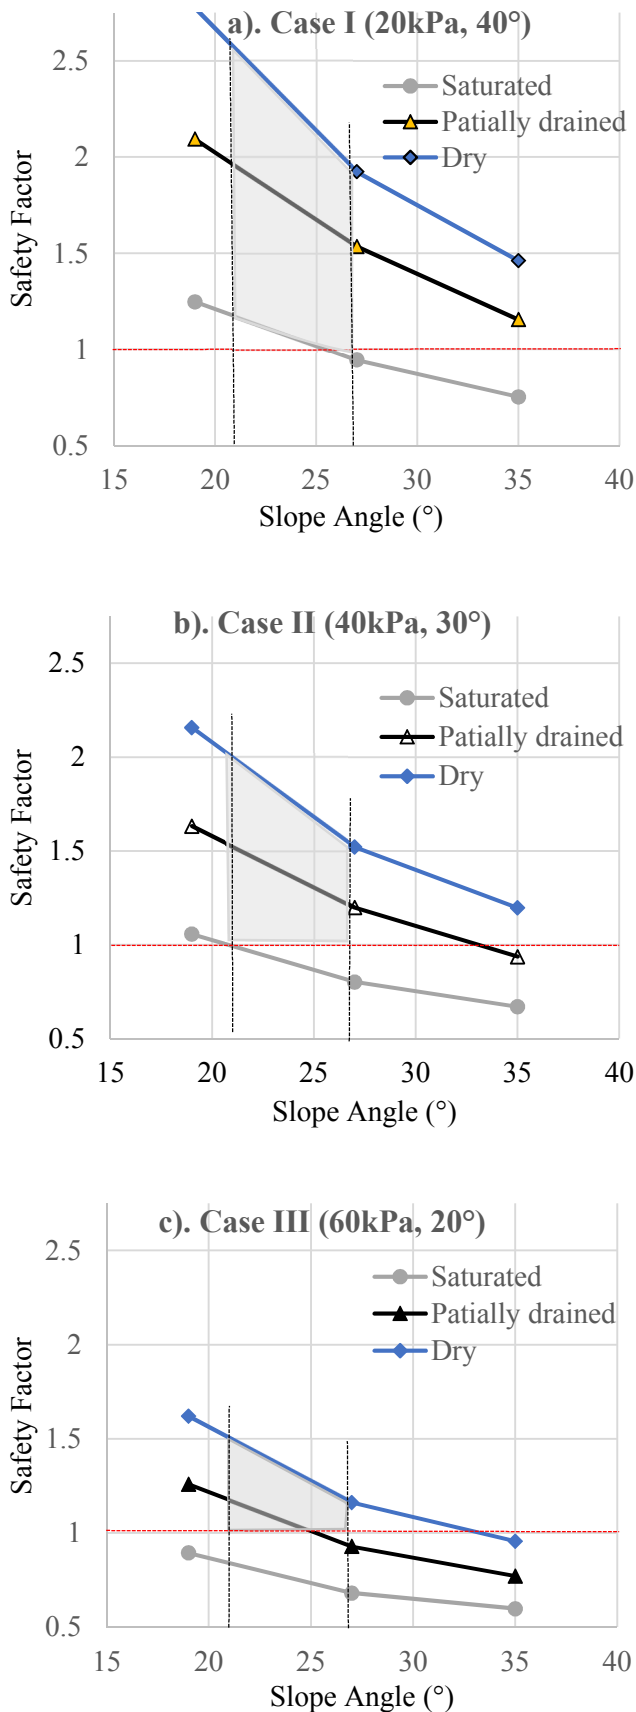
The results of safety factor for the three cases shown in Table 1 are plotted in Fig. 8 against slope angle for three different water conditions. The critical condition of safety factor = 1.0 is marked by red lines.

As shown in Fig. 8, increase of slope angle and water level would reduce the value of safety factor and therefore the stability. Based on the slope profile of the waste pile (with an angle between 21°

Fig. 8 Safety factor varying with slope angle and water conditions

It can be seen from Fig. 8 that in both Cases I and II, the safety factor is above 1.25 for the partially drained condition at slope angle $\leq 30^\circ$, indicating a stable pile. In Case III, the pile lost its stability at slope angle of approximately 26° and higher.

- The water table or water pressure in the waste pile has built up to some level. Generally, the higher the water table, the less stable for the pile. In severe conditions as would be expected during a heavy rainfall storm, which may cause liquefaction, the stability of a waste pile will be significantly reduced. It is important to point out that when a waste pile is saturated, as in a storm, slide failure become inevitable as indicated in Fig. 8 b and c).

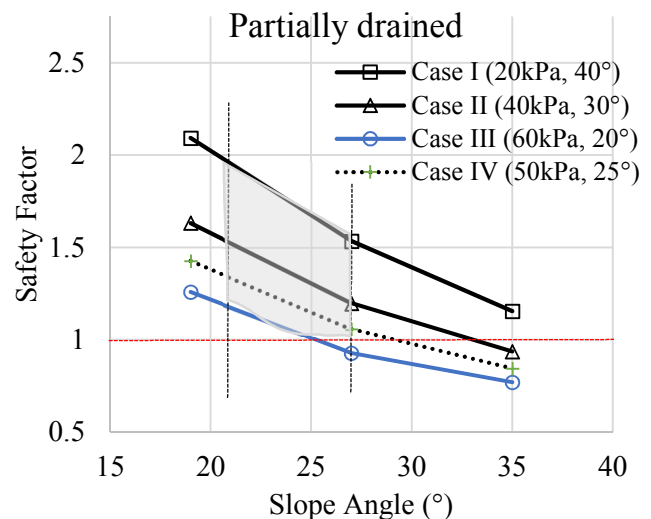
The results for the partially drained condition corresponding the strength parameters of Cases I to III are replotted in Fig. 9. It shows that the shear strength parameters for the waste pile most likely lie between Cases II and III, with estimated $c = 40\sim 60$ kPa and $\phi = 30^\circ\sim 20^\circ$, Case IV being a typical representation.

Fig. 9 Case IV as a representation of the WDS site
