## Geophysical Investigation and Management Plan of a Shallow Landslide along the NH-44 in Atharamura Hill, Tripura, India

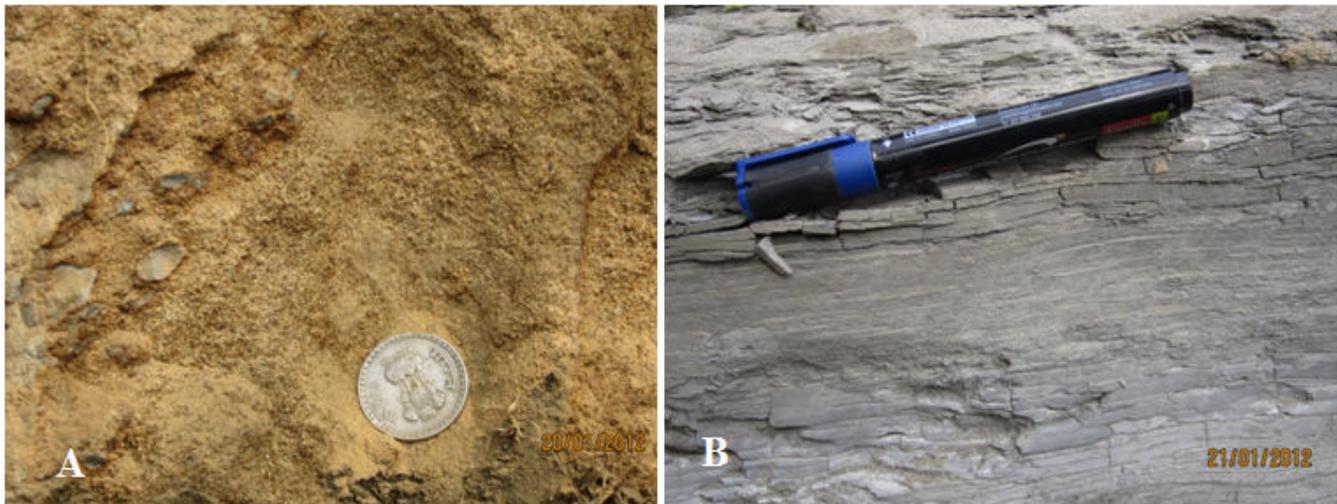
materials with occasional intercalation of moderate to poorly sorted silt or clay layers. The whole slope is composed of highly weathered and fragile shale and mudstone. They are relatively weak in resistance and favour the development of landslides. In some parts of the slope, coarse grained sand with mud balls (Plate 1A) was also found. The whole landslide scar is mainly composed of huge thickness of laminated siltstone, shale with narrow bands of sandstone; occasionally lenticular structure of medium to coarse sandstone with mudstone (Plate 1B). The present study area is characterized by the presence of large number of strike-slip fault. Most of the fault lines are in SW – NE direction. The altitude of the slide varies from 166 m - 191 m asl with a convex slope ranging from 15° to 75°. Dip of the rock strata ranges between 40° to 45° in SSW direction. The alignment of the bedding indicates two major directions from which deposition started, i.e., northwest to southeast, and north to southeast trends. The present landslide is located within 150 m buffer zone of fault line (Figure 2B).

**Plate 1.** (A) Coarse grained sands with occasional mud balls, (B) Laminated siltstone with occasional very thin laminated sands

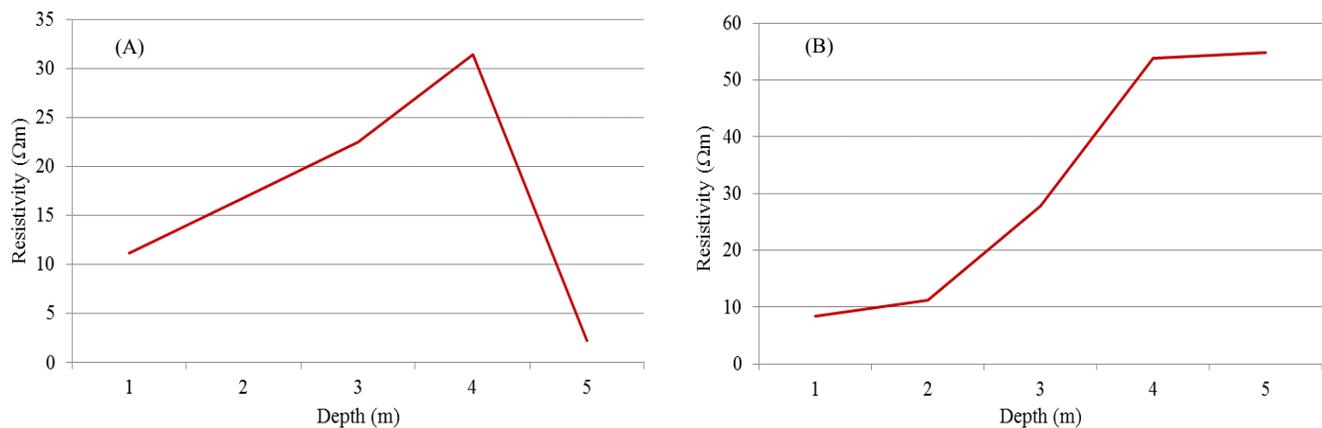
minimum resistivity of 2.2  $\Omega\text{m}$  that is recorded at the 5 m depth (Figure 3A). At 4 m depth, the resistivity is 31.4  $\Omega\text{m}$ . At the top (1 m depth) the resistivity was recorded 11.2  $\Omega\text{m}$  and gradual increase has been recorded up to 4 m depth, but at 5 m depth sharp decrease is recorded. The maximum resistivity is recorded at 4 m depth. Thus, within a 1 m depth (4 - 5 m) the maximum variation in resistivity was recorded. This kind of sharp negative change in electrical resistivity proves the existence of water bearing strata or very wet soil in these areas (Mukherjee et al 2011). These variations of the resistivity values at different depth suggest that the area belongs to very high geological complexity.

In the second VES point the top soil has a comparatively lower resistivity than in the first VES point. In this point, the minimum (8.48  $\Omega\text{m}$ ) resistivity was recorded at the top at 1 m depth. The resistivity of the rocks gradually increases with the gradual increase of depth. The maximum resistivity (54.8) was recorded at 5 m depth (Figure 3B). The pseudo profile of VES points 1 and 2 is shown in Figure 4.

Figure 3. Geo-electrical resistivity of VES point 1 (A) and VES point 2 (B). Source: Field data

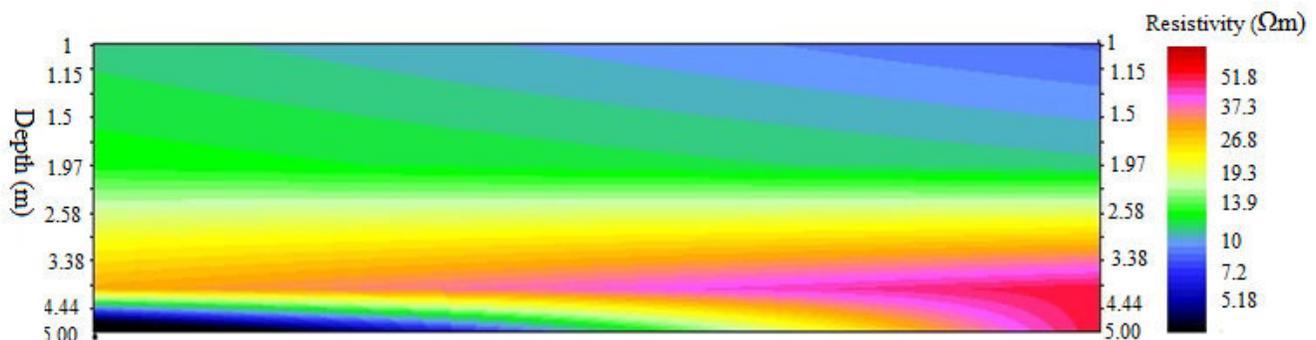
Figure 4. Pseudo profile of geo- electrical resistivity survey of point 1 and 2. Source: Field data

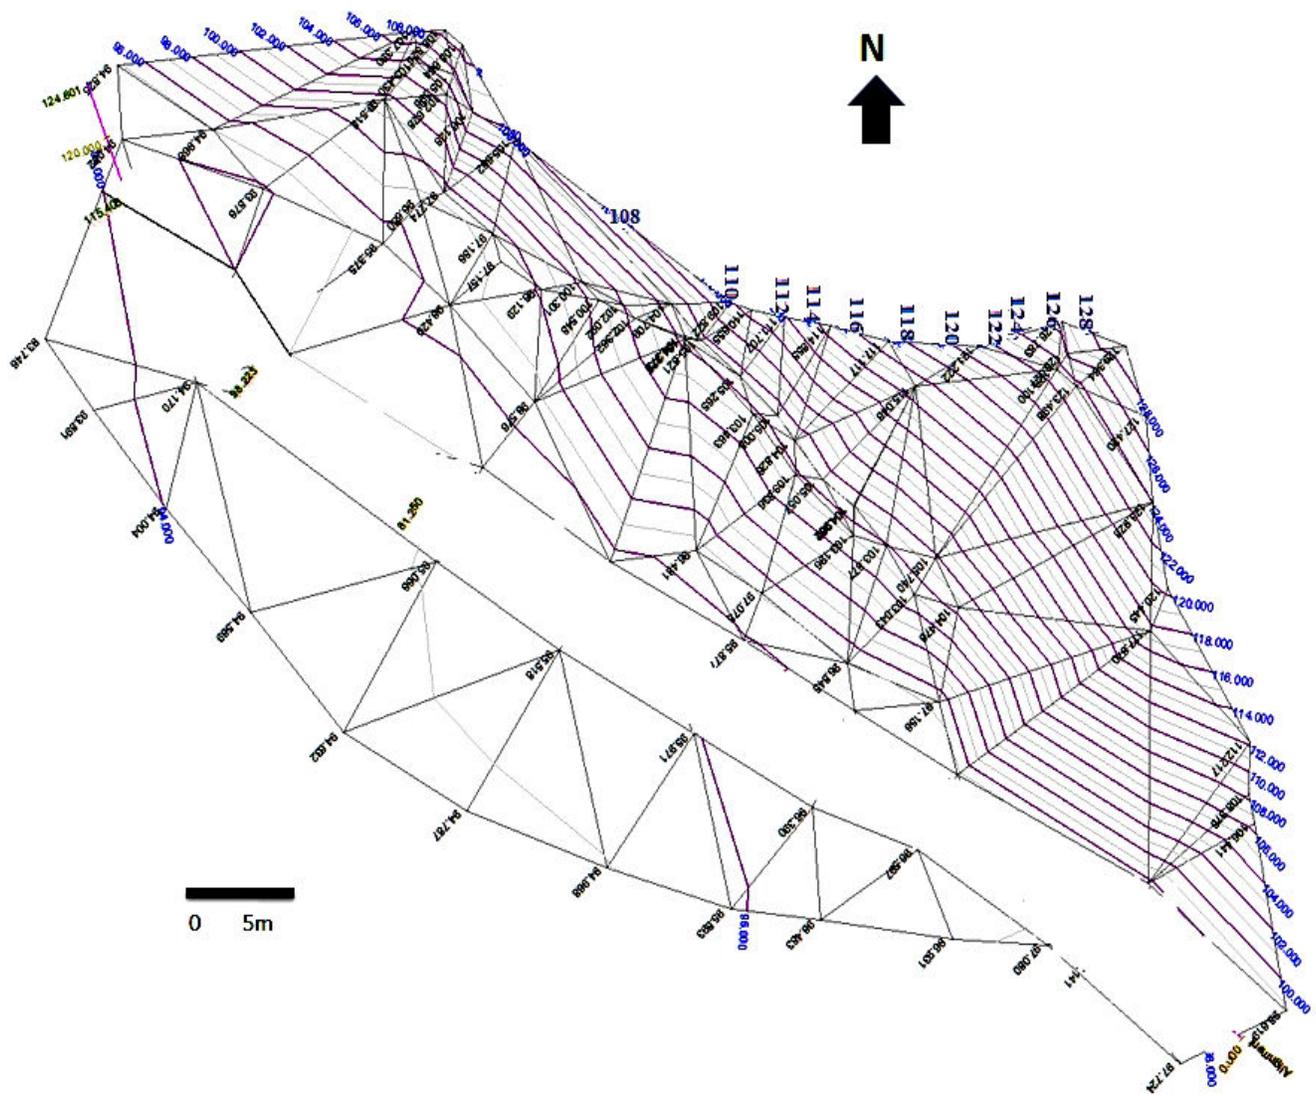
The whole landslide failure surface is very complex in nature. Middle portion of the slide experiences translational displacement due to continuous seepage and flow of water and the southern part shows block movement due to presence of fractures. In order to understand the geomorphological characteristics of the slide, contour lines at 2 m interval (Figure 5). The terrain condition was studied through terrain modeling (Figure 5) of the whole scar, which basically represents 3D representation of topographic surface. The numbers of facets are more in left side of the scar which represents relatively rough condition of the scar. The slope of the scar varies from  $15^{\circ}$  to  $75^{\circ}$ . From the Digital Terrain Model it is found that the height of the scar ranges from 95 m to 129 m asl. The shape of the whole scar is semi-circular. Field investigations reveal that the landslide covered 1,500.7  $\text{m}^2$ . Horizontal length of the surveyed scar was 69 m.

Figure 5. Digital Terrain Model with contour lines of the landslide. Source: Field survey by Total Station

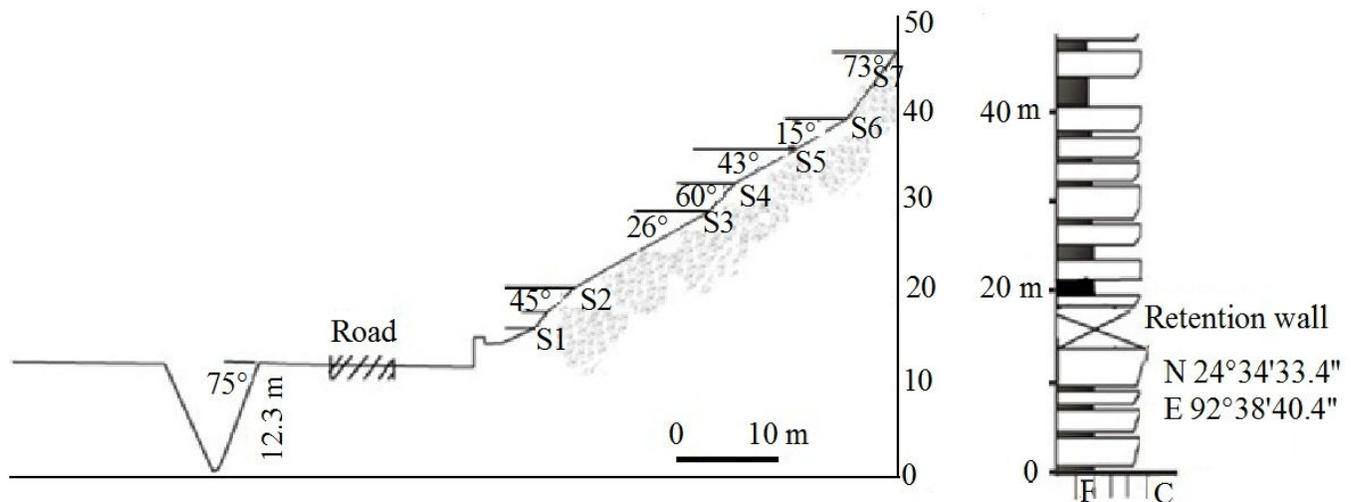
Figure 8. Ground condition of landslide slope. Source: Field data

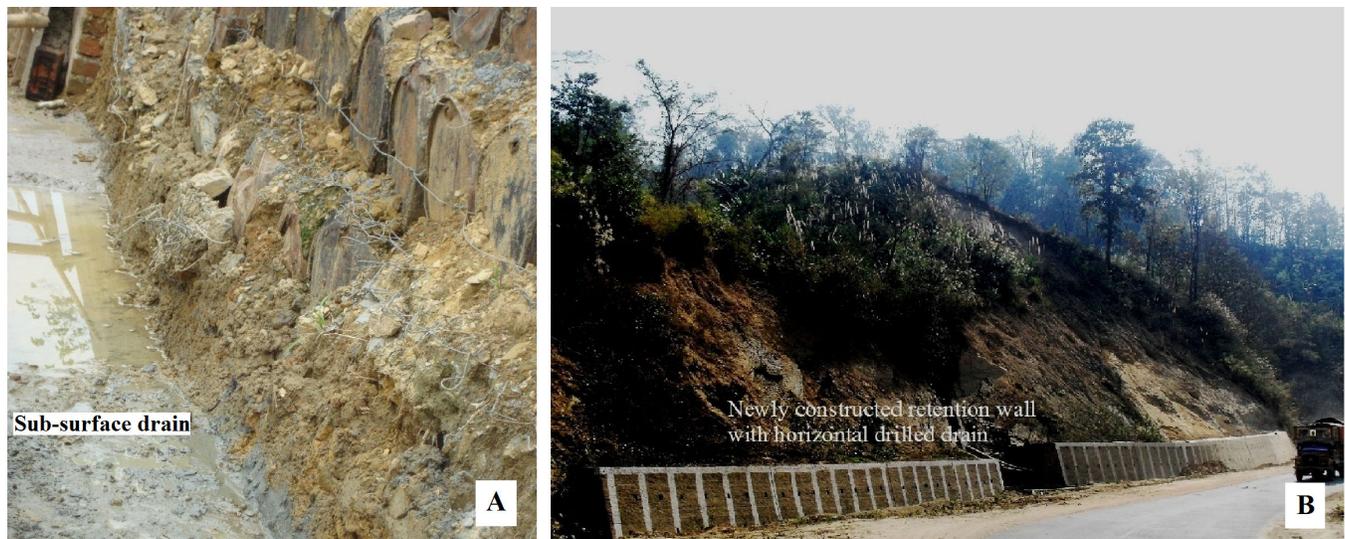
Plate 2 (A). Construction of sub-surface drain (left side); Plate 2 (B). Construction of retention wall with horizontal drilled drains (right side). Source: field survey

pressure. Landslides are closely related to short-term rainfall and surface drainage may be an effective measure. In the present study (Plate 2A and B), the whole slope is made up of unconsolidated material, on which surface drains could not be constructed. Thus, instead of only surface drains, subsurface drains and horizontal drilled drains for slope management are also recommended (Figure 9). The subsurface drainage collects the seepage water from surface runoff and reduces the pore water pressure. As the present study area receives high amount of rainfall, it is recommended that the length of the horizontal drilled drain should be equal to the length of the landslide scar.

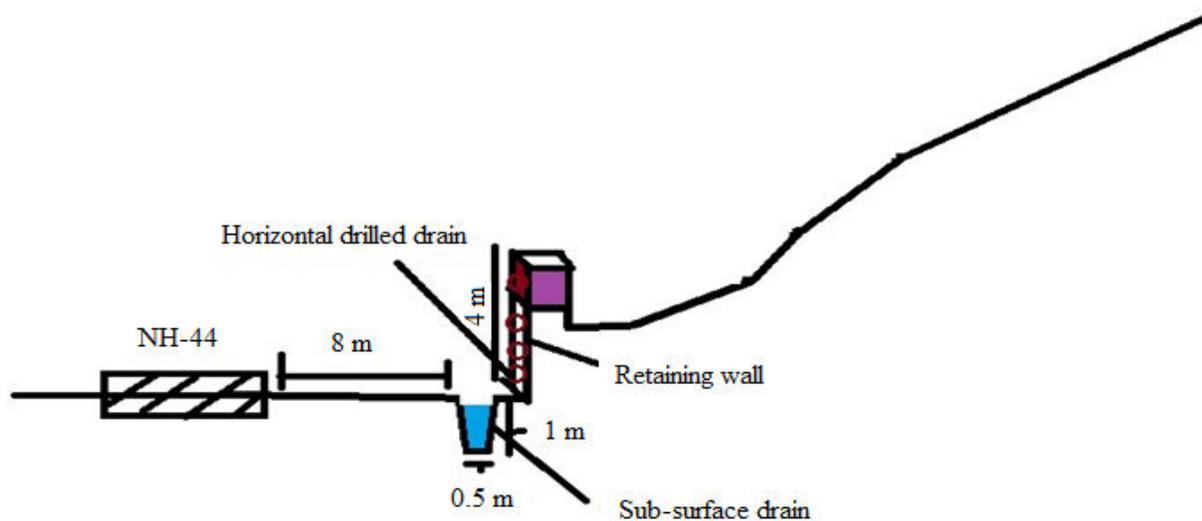
Figure 9. Proposed drains for the landslide

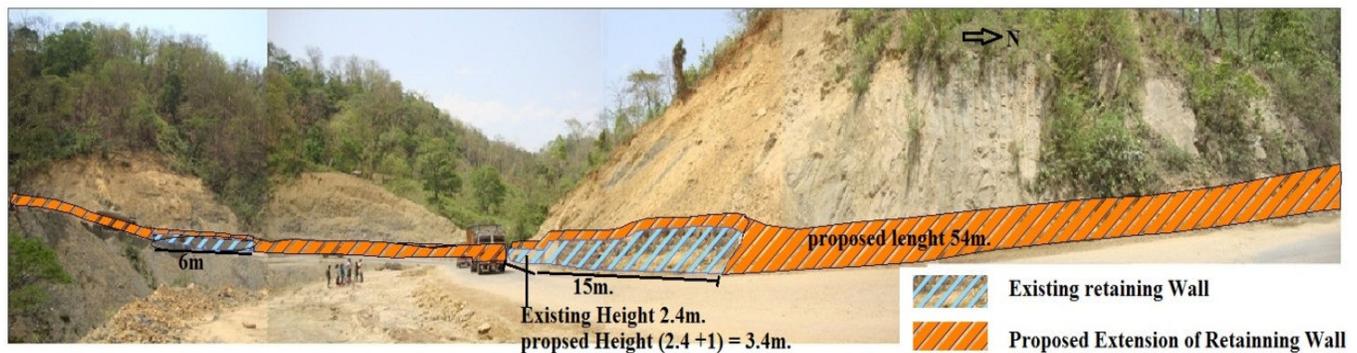
Figure 10. Proposed extension of retaining wall for the landslide

Retaining wall can be constructed to act as an effective barrier to arrest debris or small rock fragments and to prevent displacement at the foot of the landslide. In case of the present landslide, the retaining wall should be extended across the foot of the landslide scar. From the field investigation, it was found that a small section (21 m) of retaining wall had been constructed. Moreover, both ends of the retaining wall are open. Thus, it is recommended that the retaining wall should be extended across the landslide scar (i.e. as far as both ends of the scar). At right side

it should be extended 54 m more and at middle part by 15 m and at left side by 12 m. The field survey also revealed that the height (3 m) of the retaining wall is not adequate to arrest the annual accumulation of debris. Therefore, it is suggested that the height of the retention wall should be extended at least one meter more (Figure 10). The existing retaining wall has been constructed by providing only a single row of horizontal drill drains which may be choked by debris during rainfall. Thus three or four rows of horizontal drill drains are recommended in order to safely drain infiltrated water from the scar.
