CURATORIAL REPORT NUMBER 106

The Robertson Building: An Archaeological and Architectural Survey

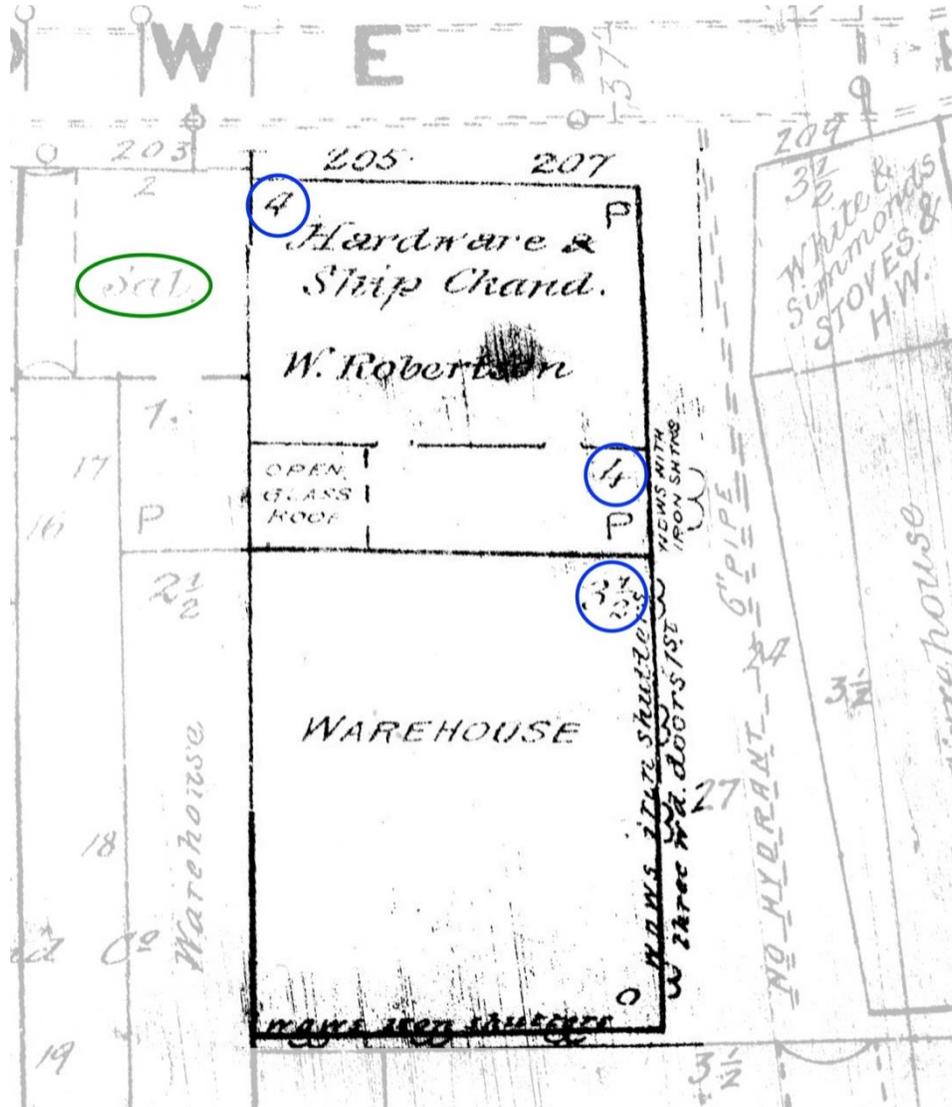
Figure 3-2 – The Robertson Building in 1889.¹⁹ Note the number of floors to each structure (blue), and the neighbouring saloon (green). The infill portion also features a glass roof at its southern end. North is to the right.

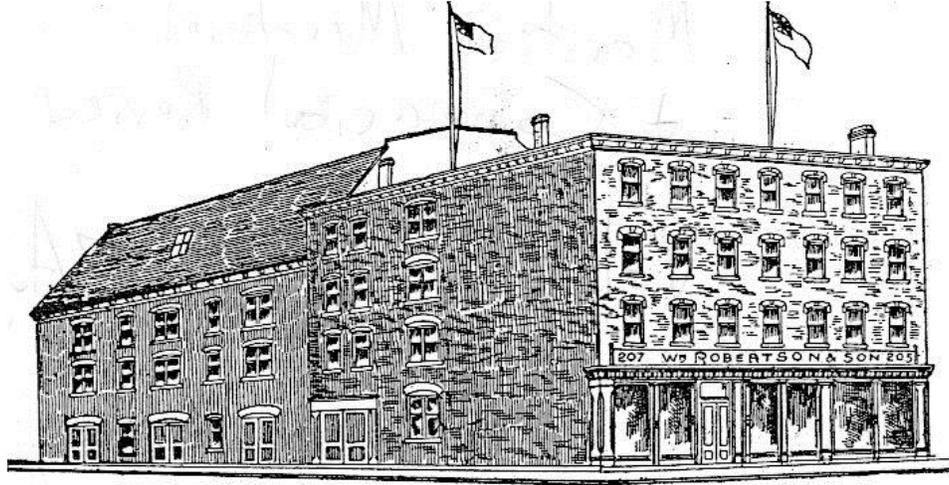
Figure 3-6 – An illustration from August of 1899 shows “Wm. Robertson’s building as it will appear when remodeled.”³²

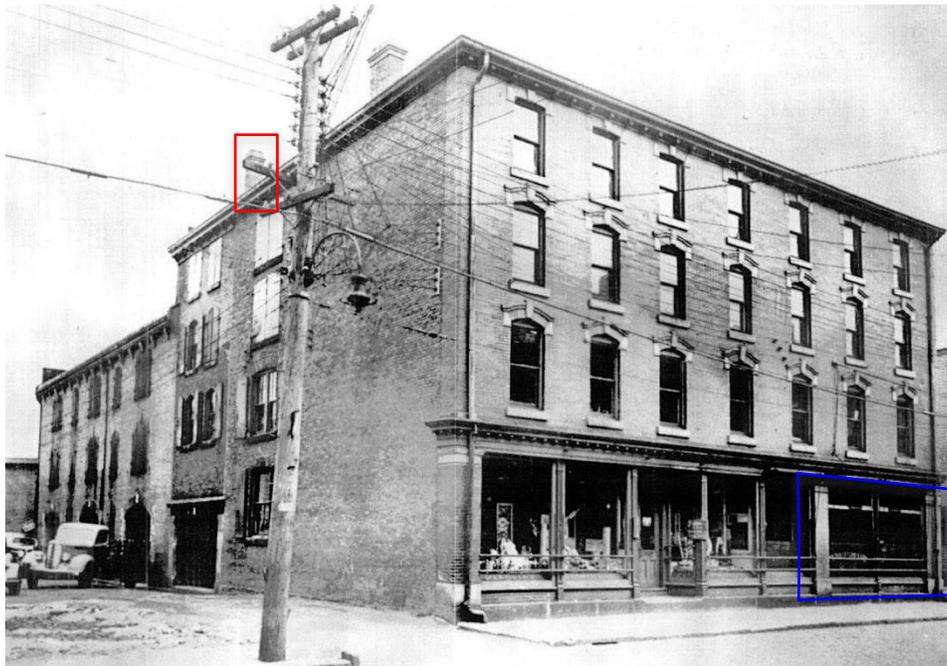
Figure 3-9 – *The Robertson Building in 1935.*⁴¹ Note that the three southern windows all appear to be taken up by offices rather than display space (blue). Note also a secondary chimney on the north wall (red).

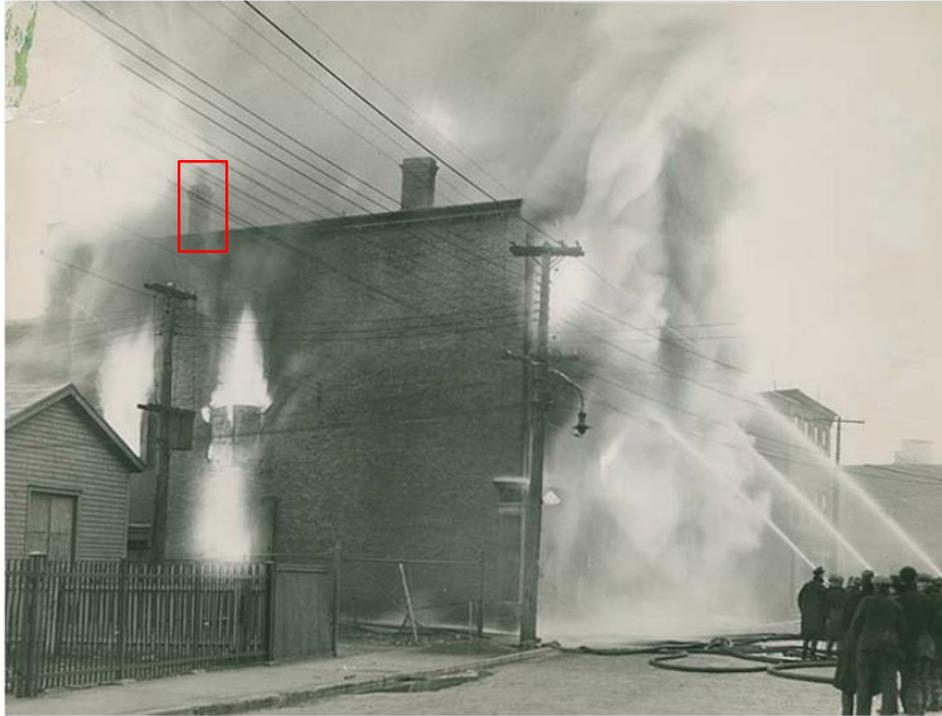
Figure 3-10 – *The 1943 fire roars through the ship chandlery and hardware store.⁴³ Note the presence of fire shutters on the north wall, where fire erupts from the ground and second floor windows but not the third or fourth floor. The front façade is affected on all floors. The secondary chimney in the north wall is still present at this time (red).*

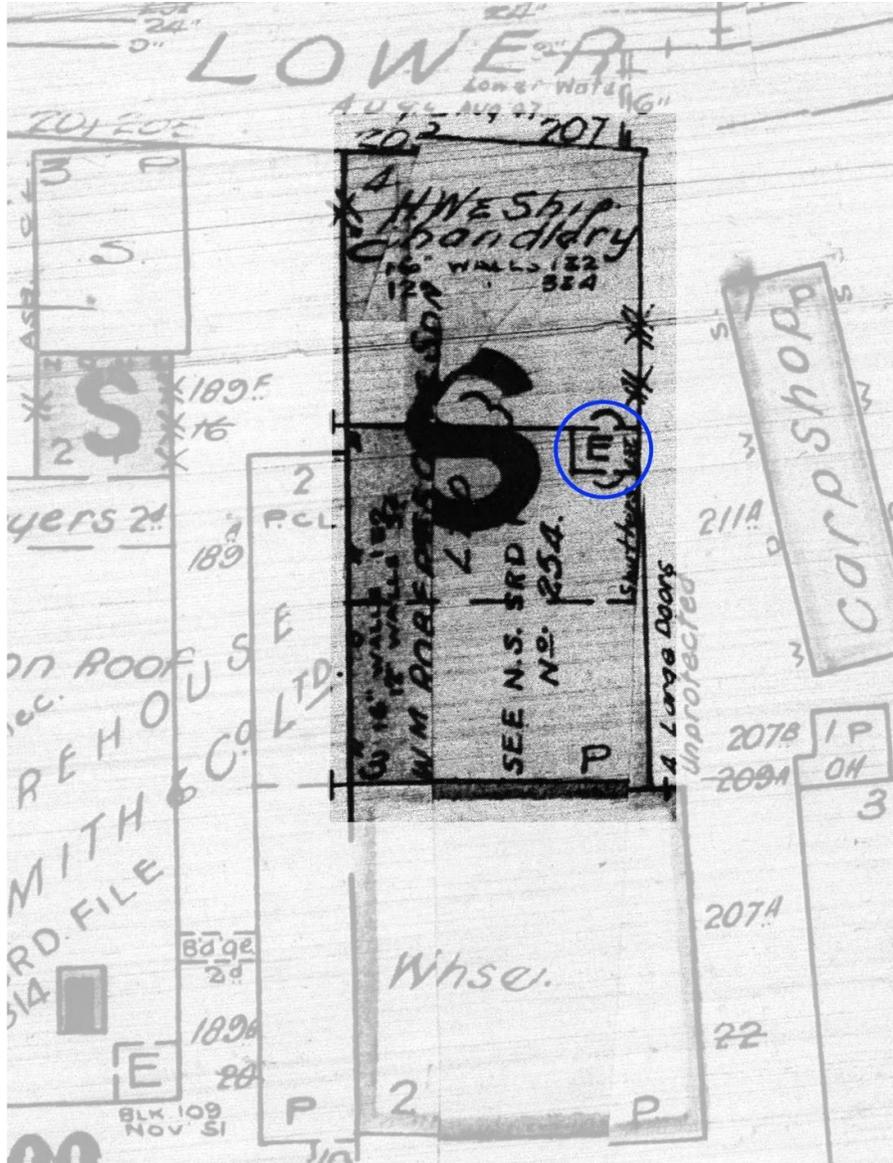
Figure 3-11 – *The Robertson Building in 1951, showing the new freight elevator (blue).*⁴⁶ Note that no hoist is indicated at the rear of the store as in previous plans.

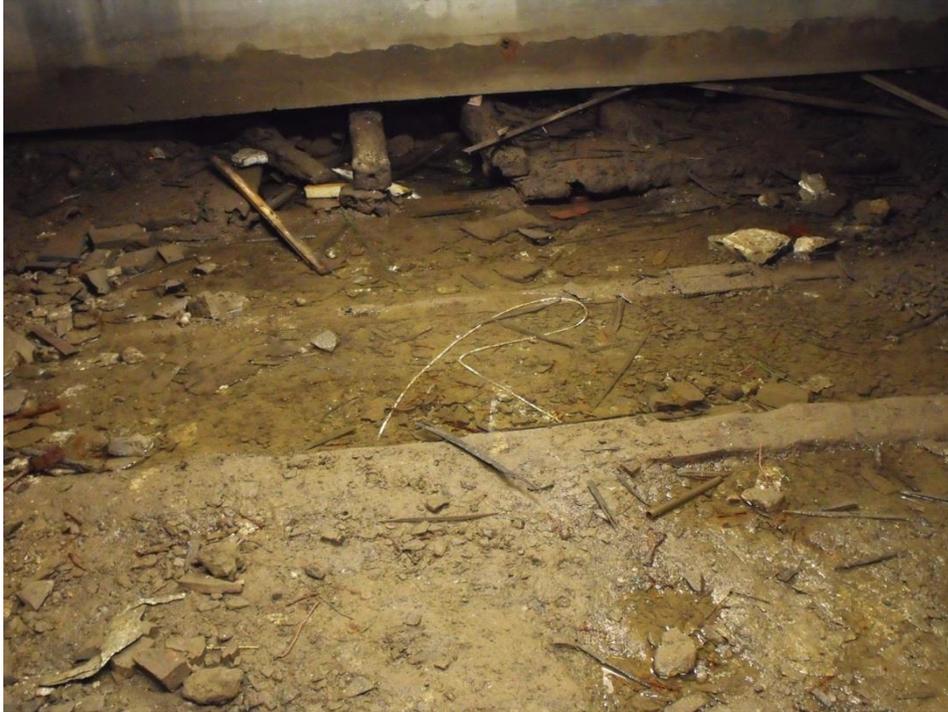
Plate 1 – Tidewater seeping into the basement, approximately 20 minutes before a moderate high tide.

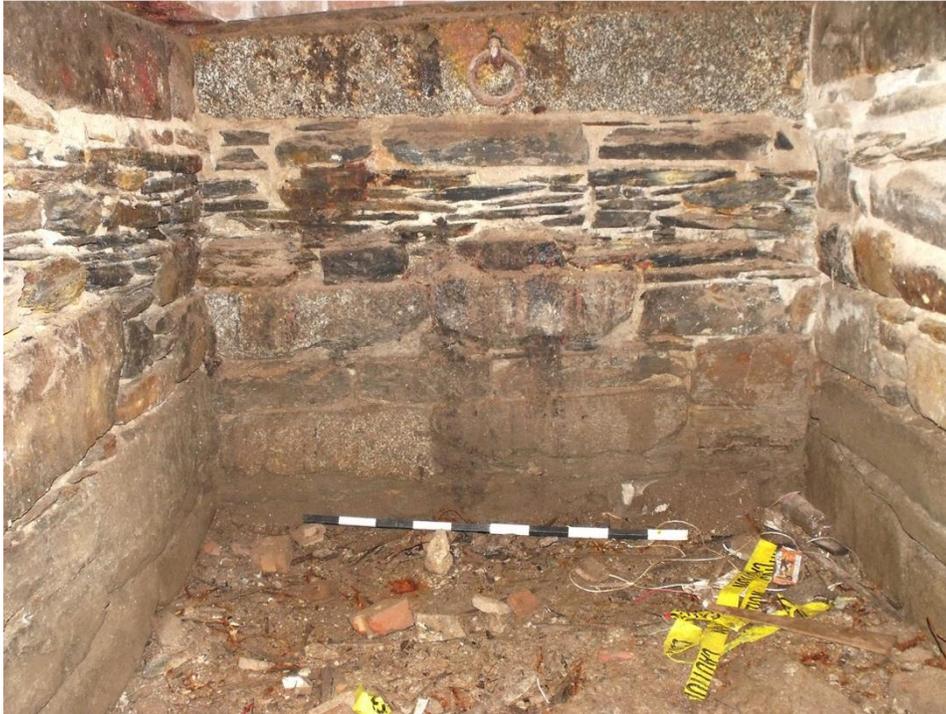
Plate 6 – *The central recess in the eastern wall provides access to a hatch above, Looking east.*

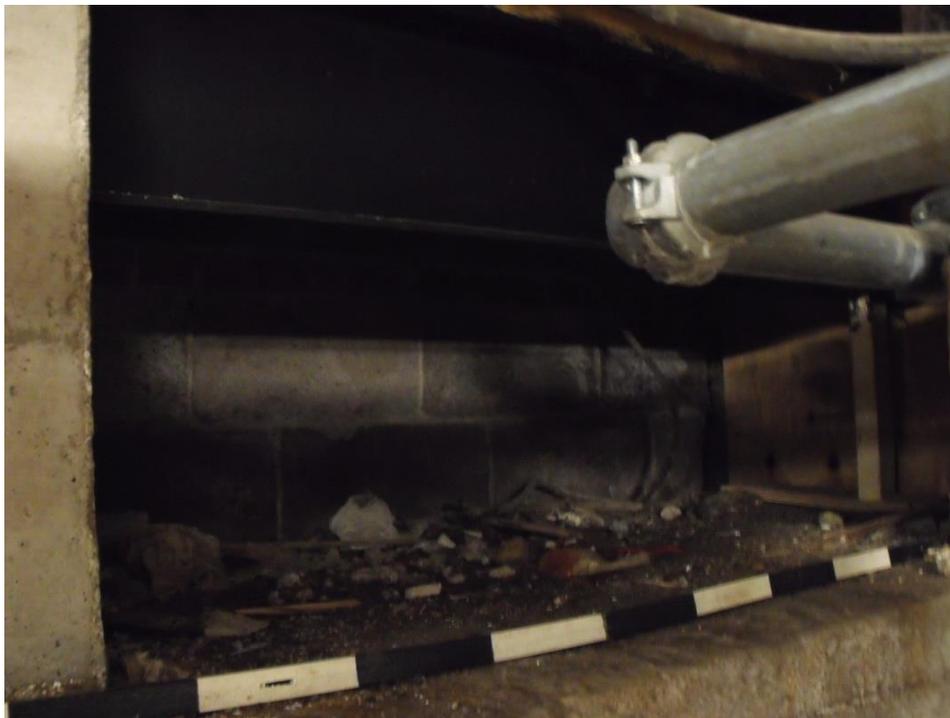
Plate 8 – *The southern recess in the east wall, showing modern cinderblock at the back.*

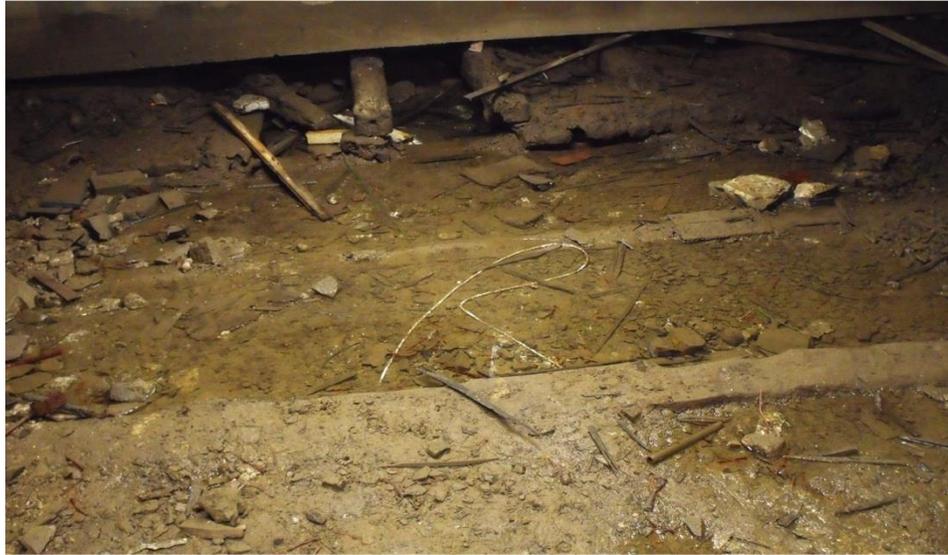
Plate 9 – *Half-buried joists in the mud and dirt floor of the basement. Note the remains of planks over them at the top of the frame, below the concrete beam. Looking south.*

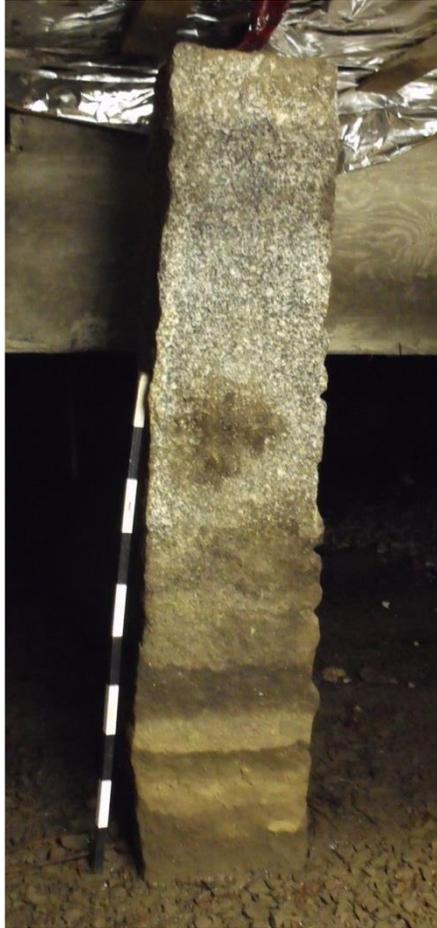
Plate 10: A free-standing granite lintel abandoned in the basement. Looking north.

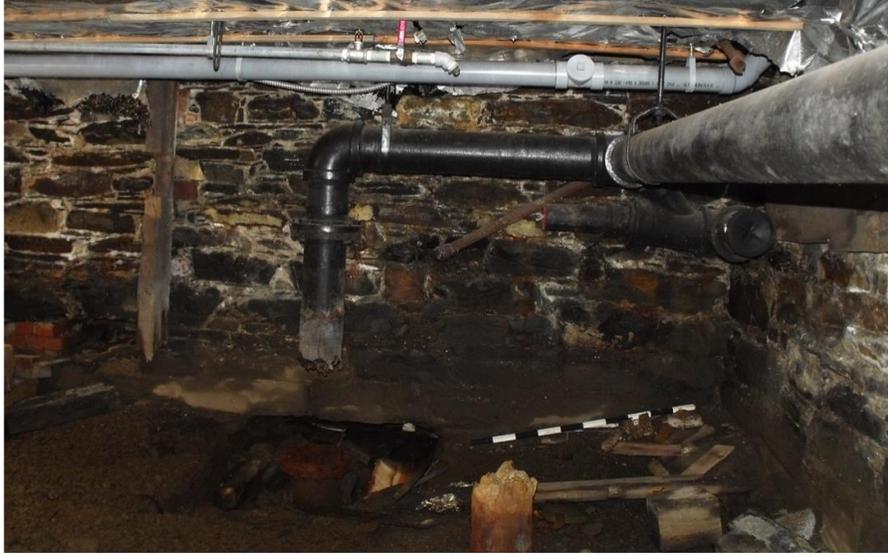
Plate 13 – *The storm drain at the northern wall, looking west.*

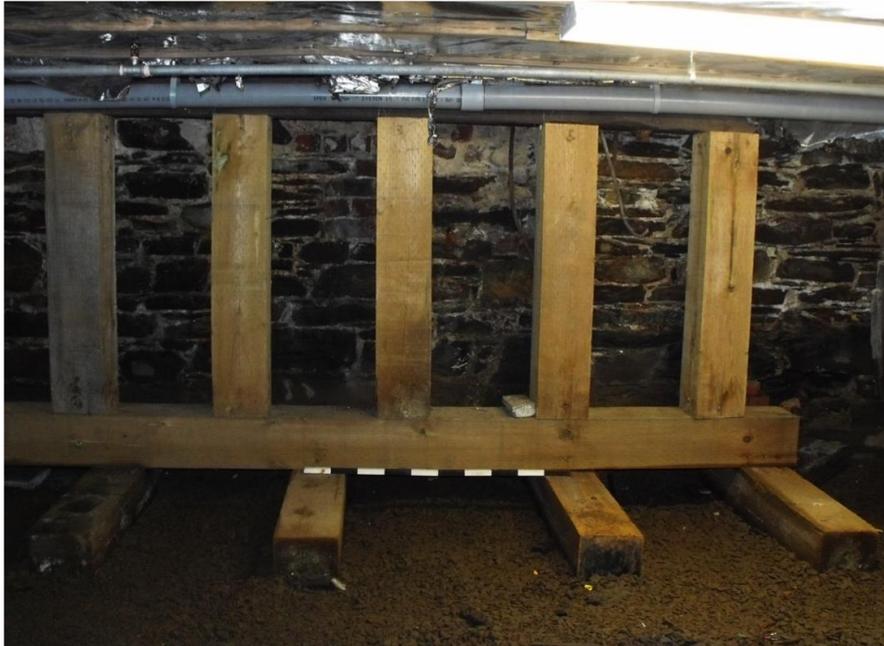
Plate 14 – *Late twentieth century wooden supports below the main shop entrance on the west wall.*

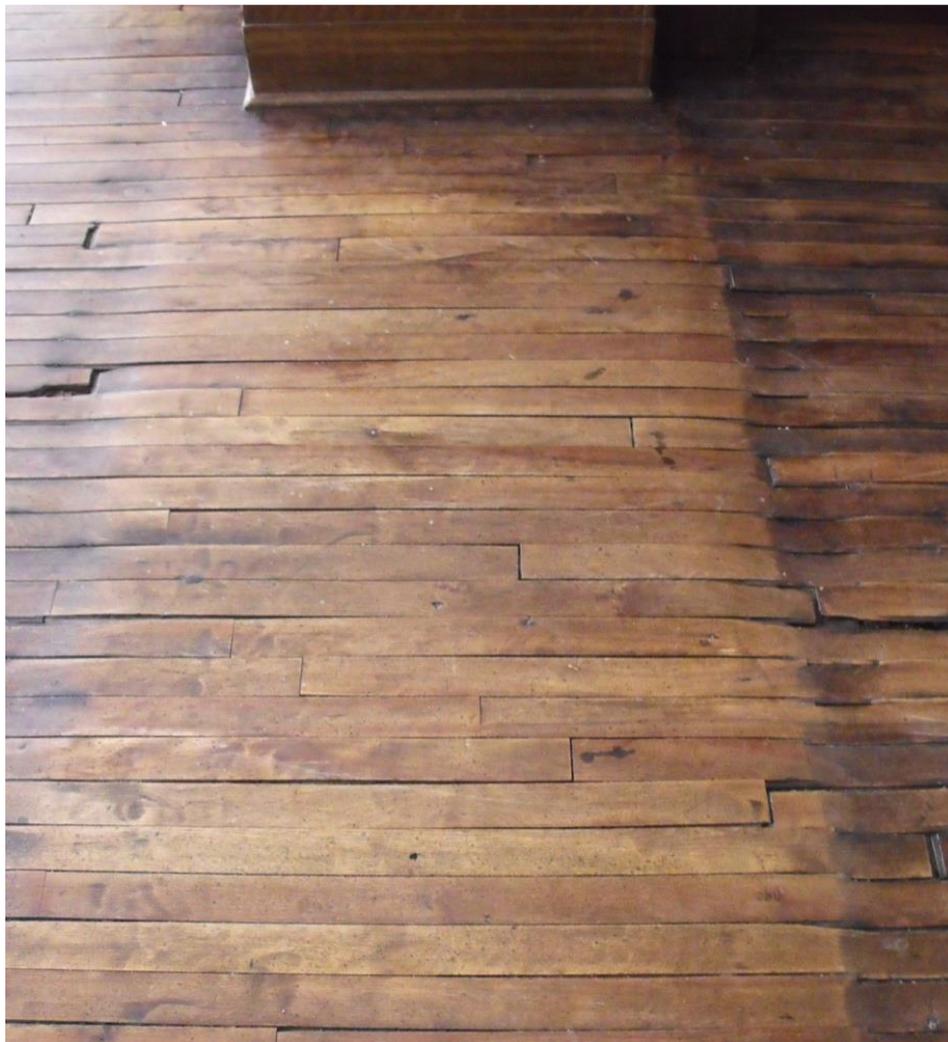
Plate 17 – *Worn floorboards show the original length of the shop's counter.*

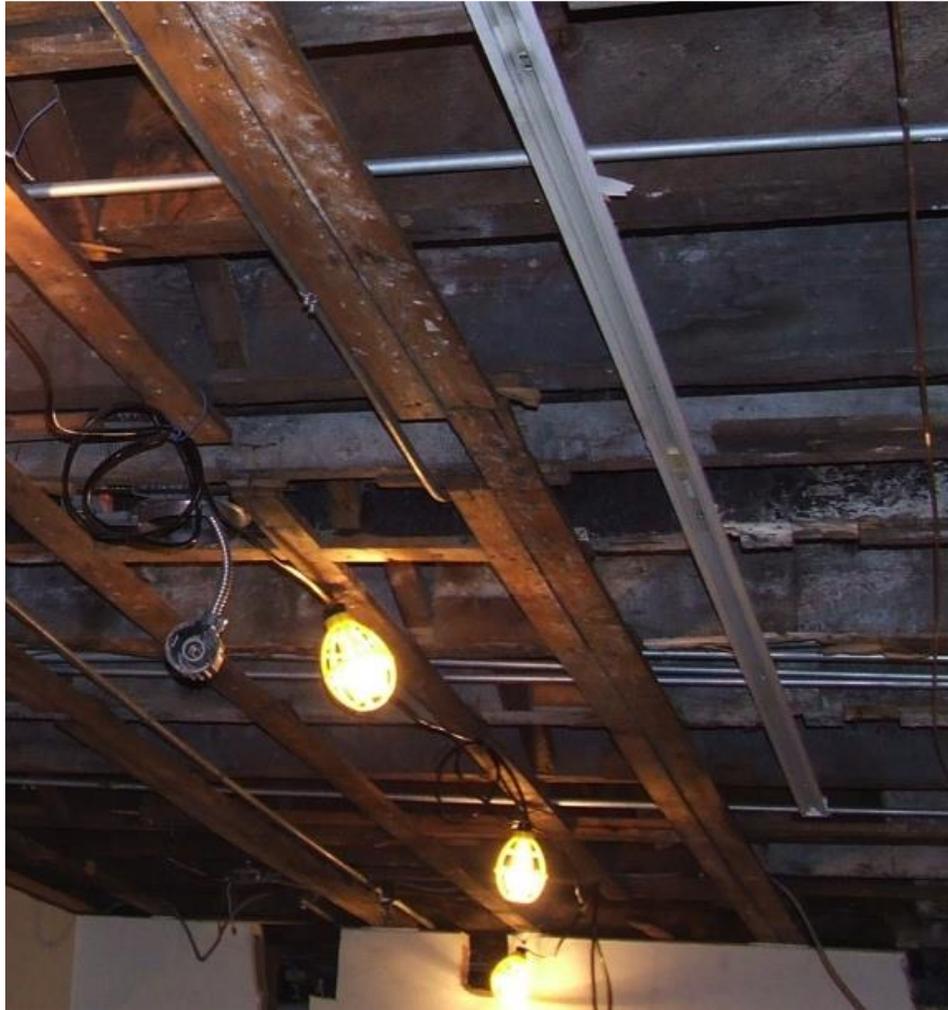
Plate 18 – Charred timbers above the visible storage area behind the Robertson Store reconstruction. Image courtesy Dan Conlin, Maritime Museum of the Atlantic.

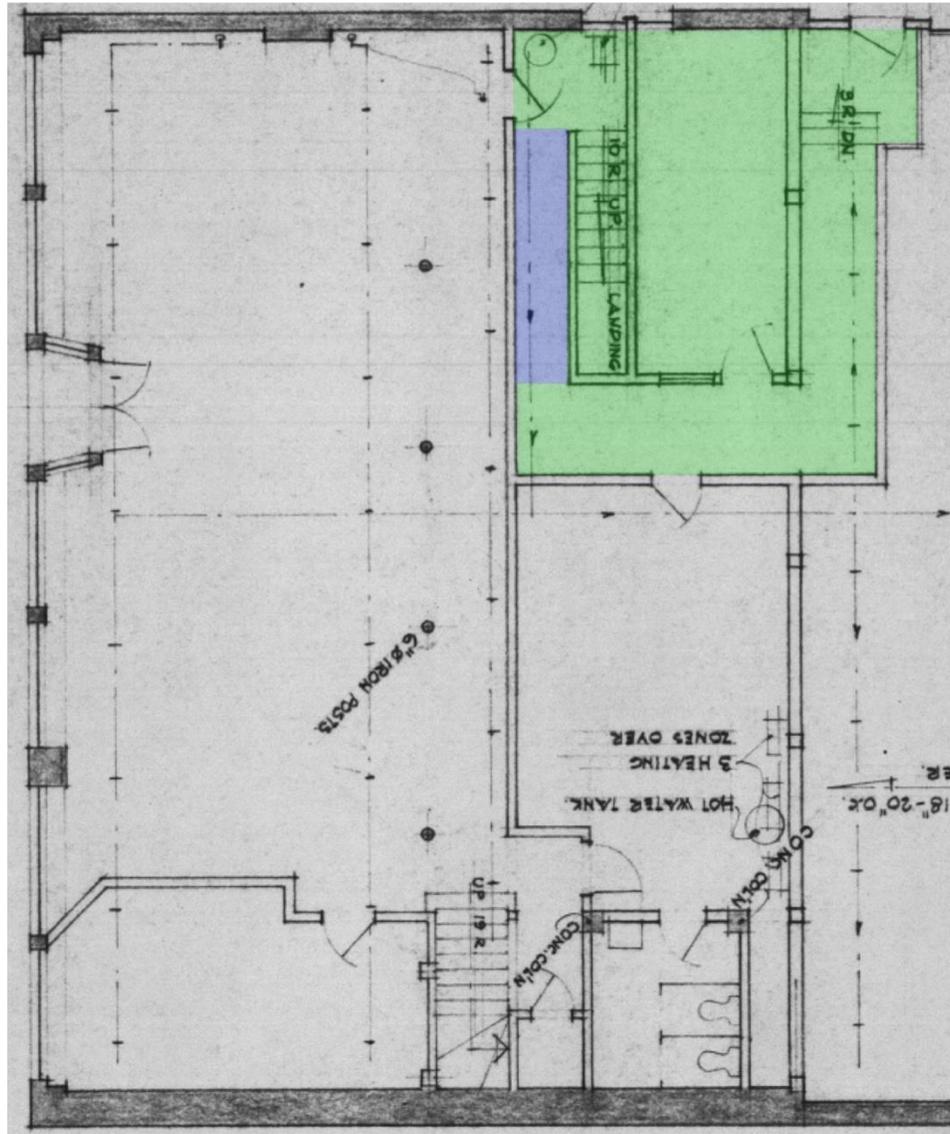
Figure 4-3 – Detail of a 1977 architectural plan, showing the remnant corridor (blue) as part of the larger packing area (green).⁶⁸

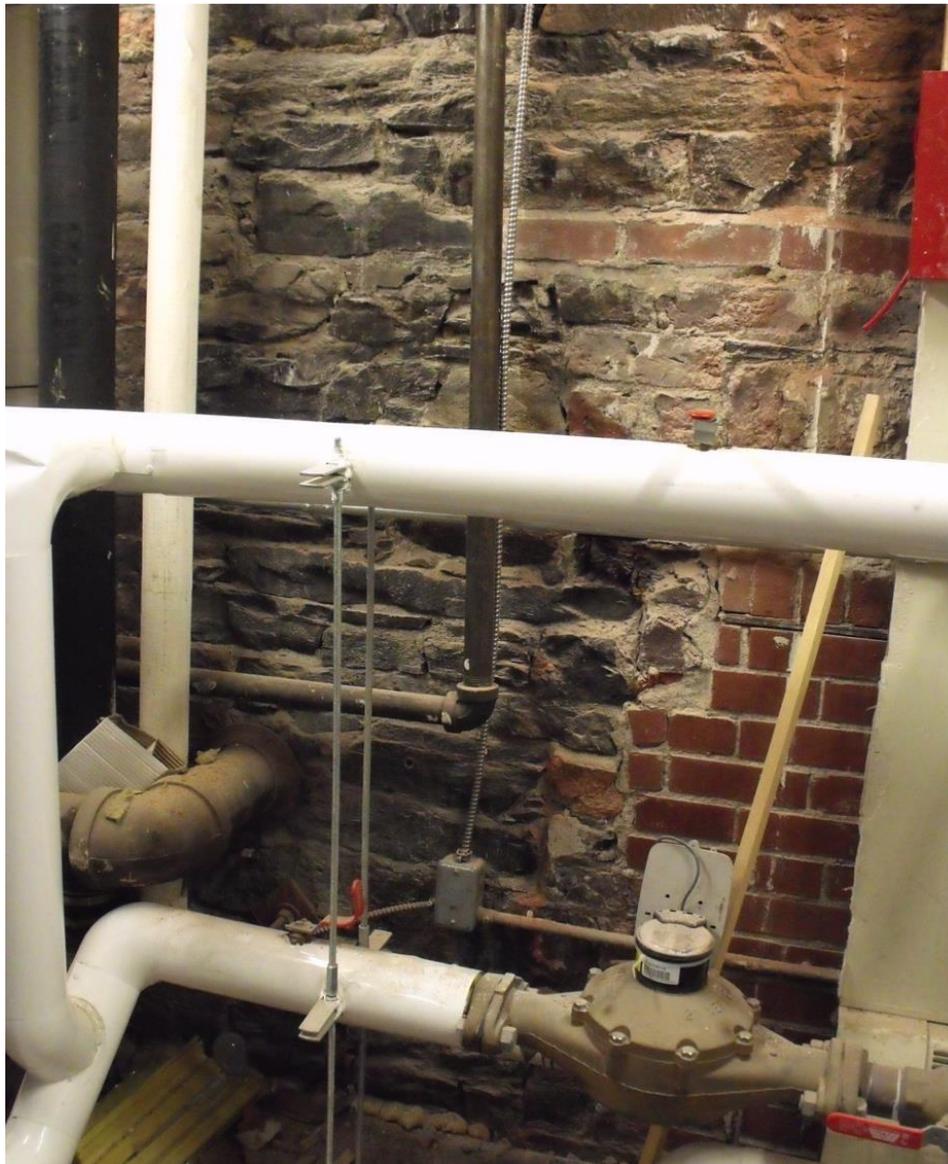
Plate 19 – *The south wall of the electrical room, showing twentieth century brick repair partially behind a drywall sheet.*

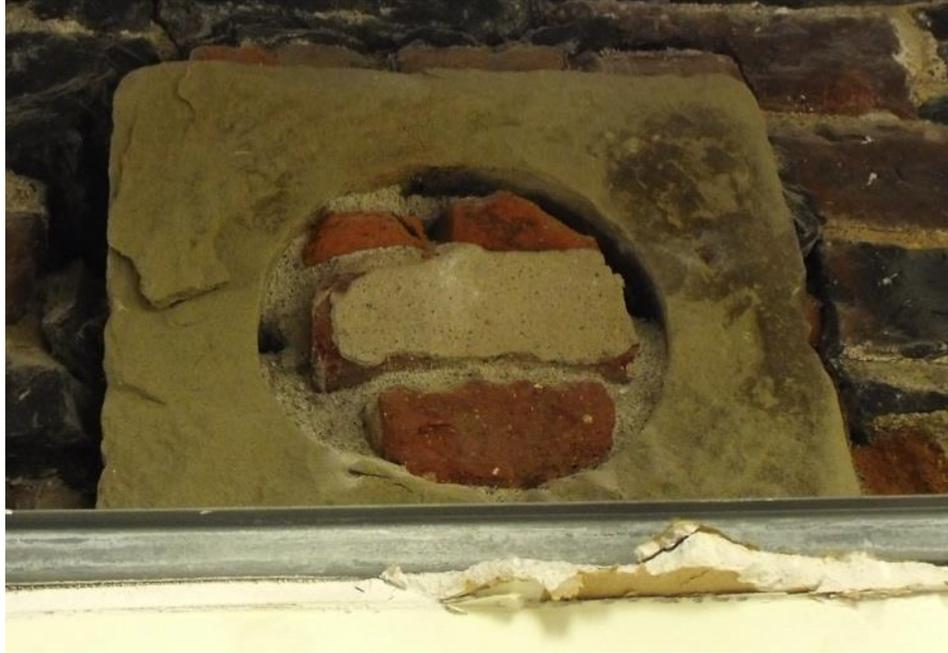
Plate 20 – A blocked sandstone thimble above the drywall sheet in the electrical room.

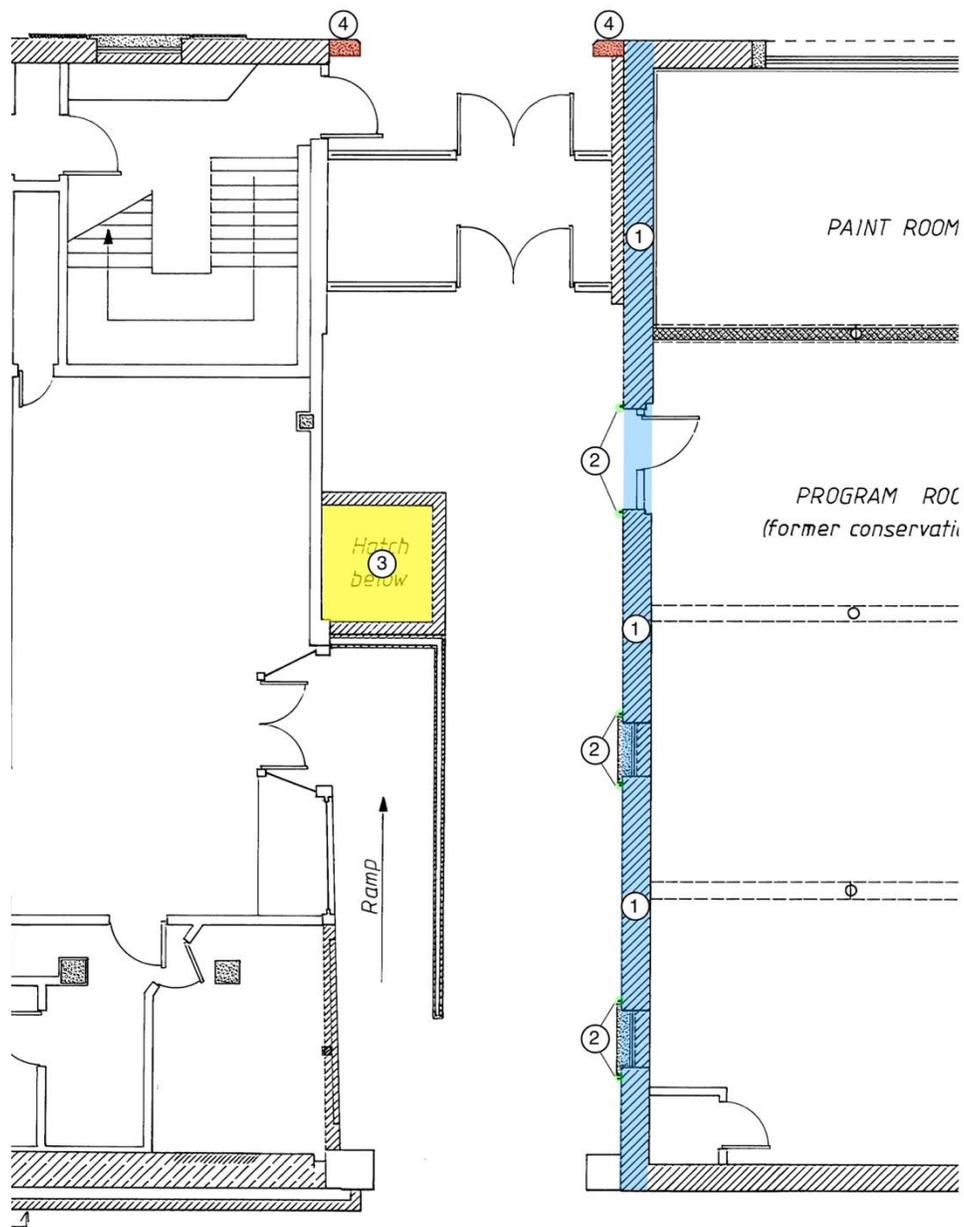
Figure 4-4 – An annotated copy of the ground floor plan, infill portion. North is to the top.

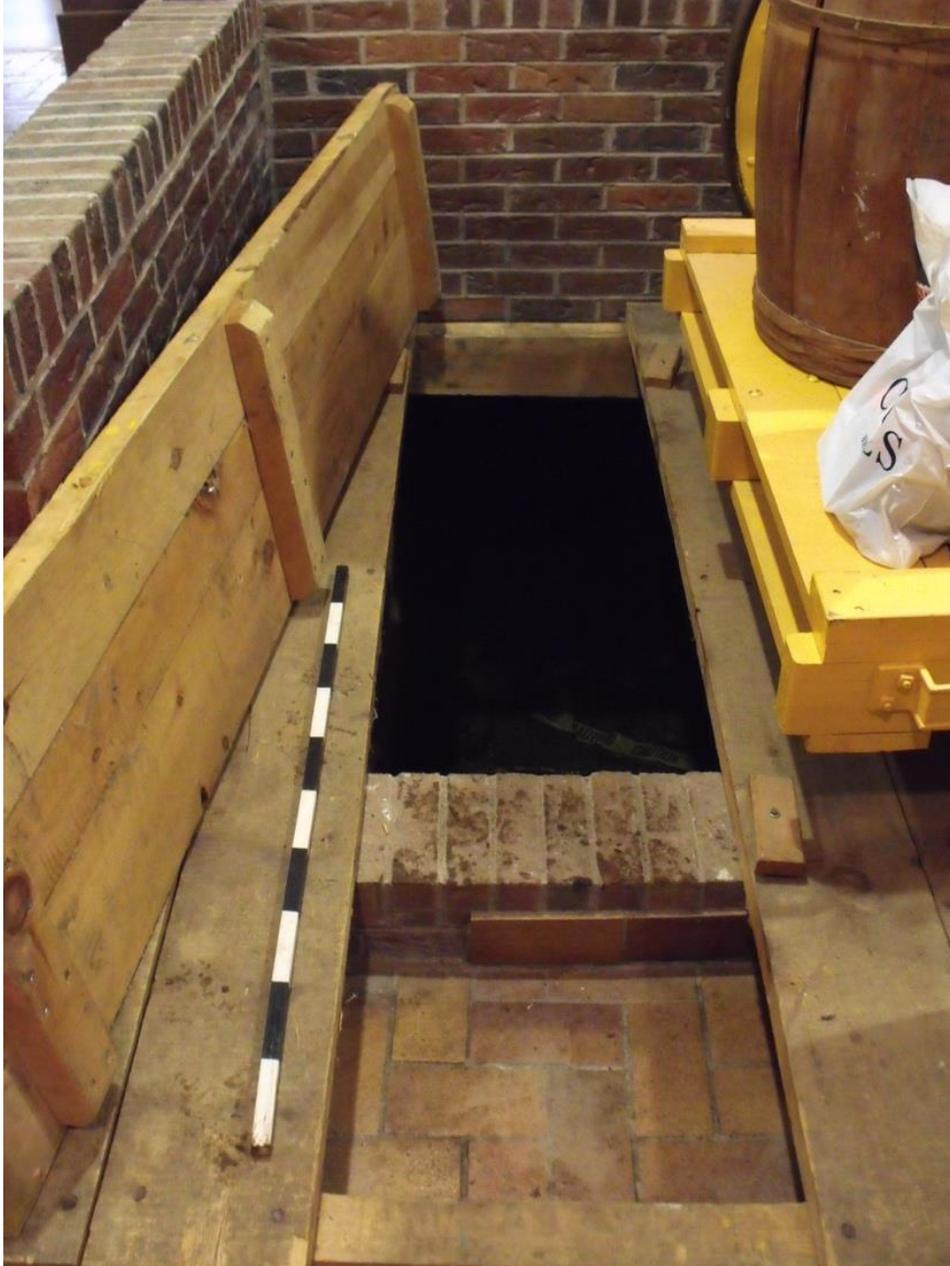
Plate 25 – *The opened hatch leading to the basement.*

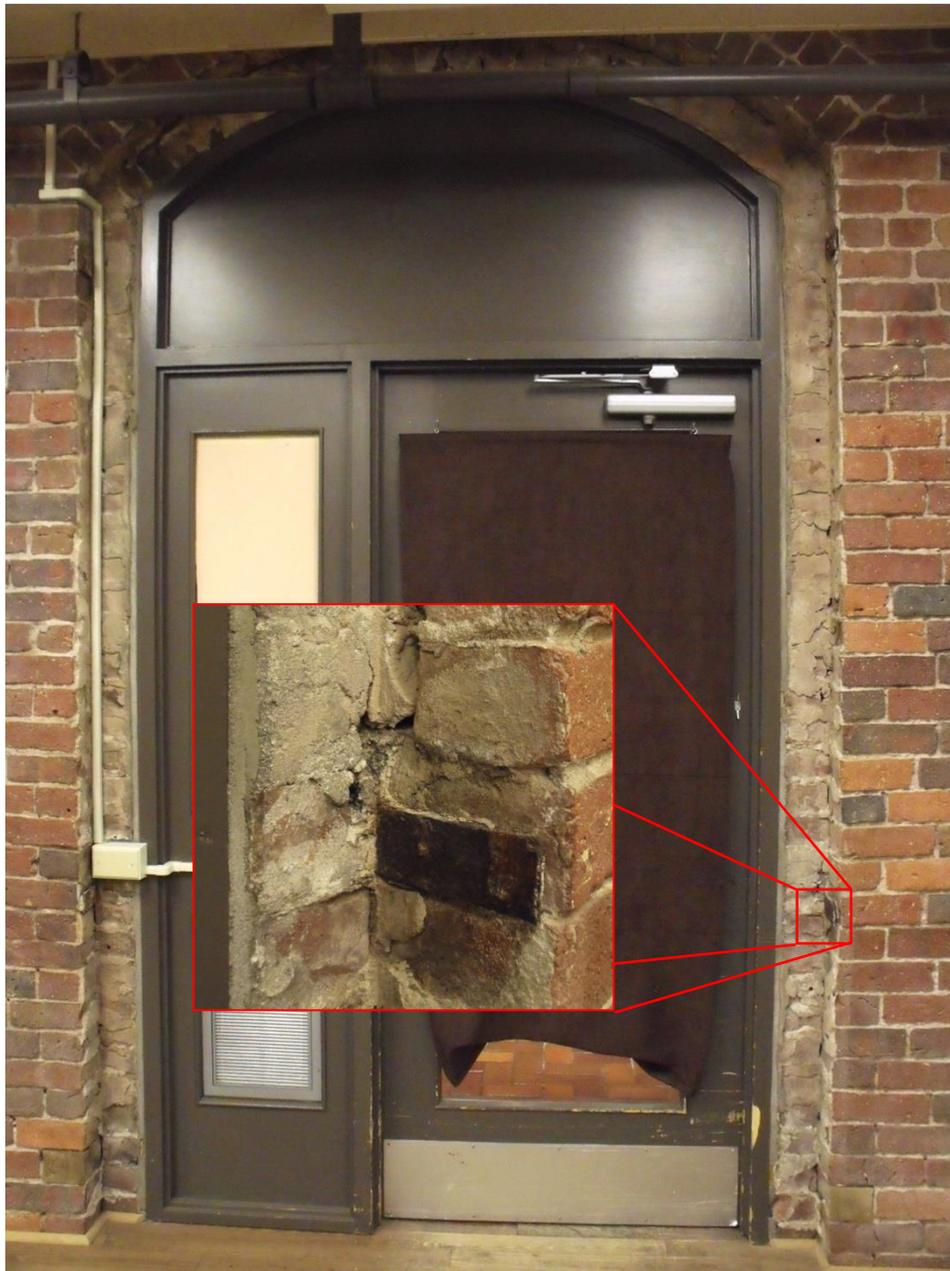
Plate 27 – *The arched doorway at the northwest corner of the program room, showing mortared recesses and iron straps (inset) suggesting an inner set of doors was once present. Looking west.*

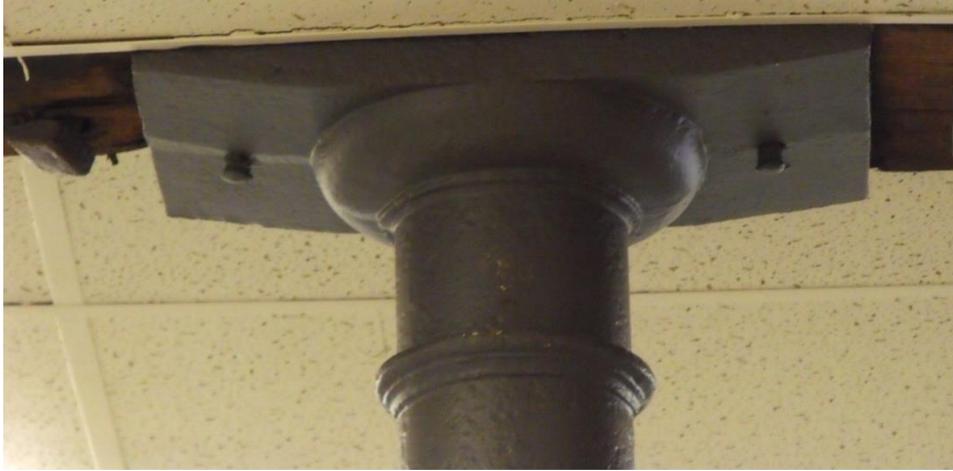
Plate 28 – *The cast iron top of one of the posts in the program room.*

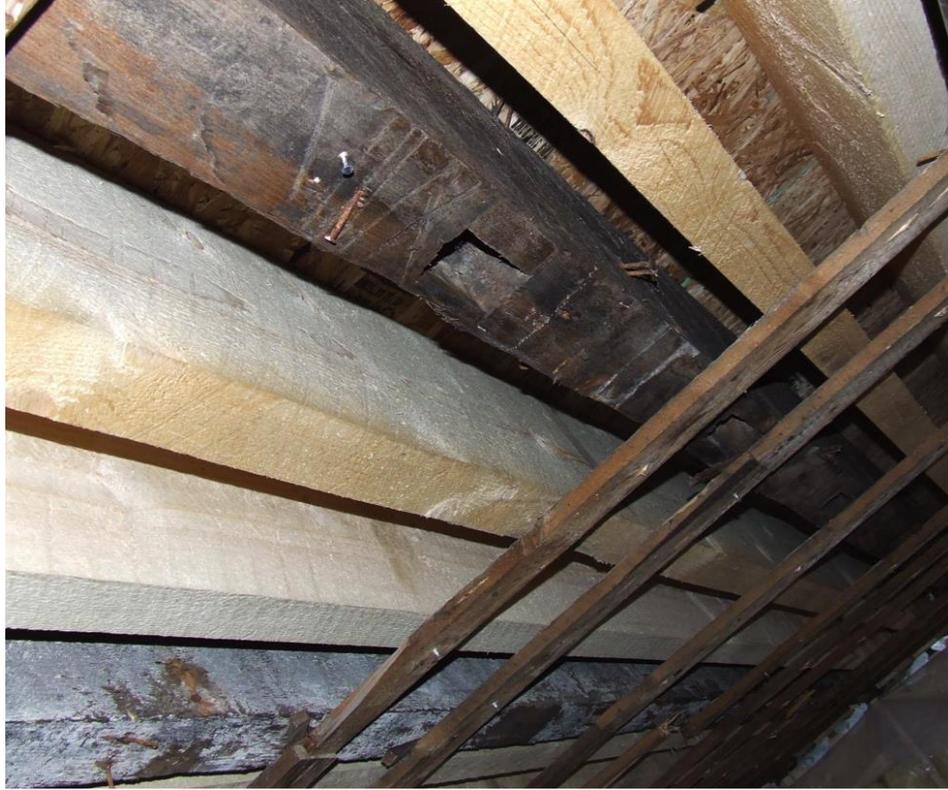
Plate 31 – *A reused joist in the ceiling of the second floor meeting room. Note also the new reinforcement beams and the heavy charring on the old beam at the bottom of the photo. Image courtesy Dan Conlin, Maritime Museum of the Atlantic.*

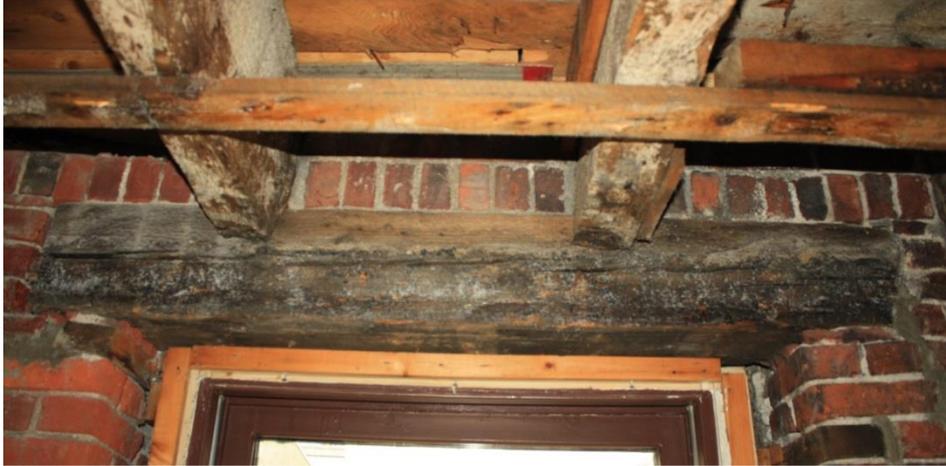
Plate 32 – A heavily charred lintel above a west-facing window in the second floor meeting room. Image courtesy Dan Conlin, Maritime Museum of the Atlantic.

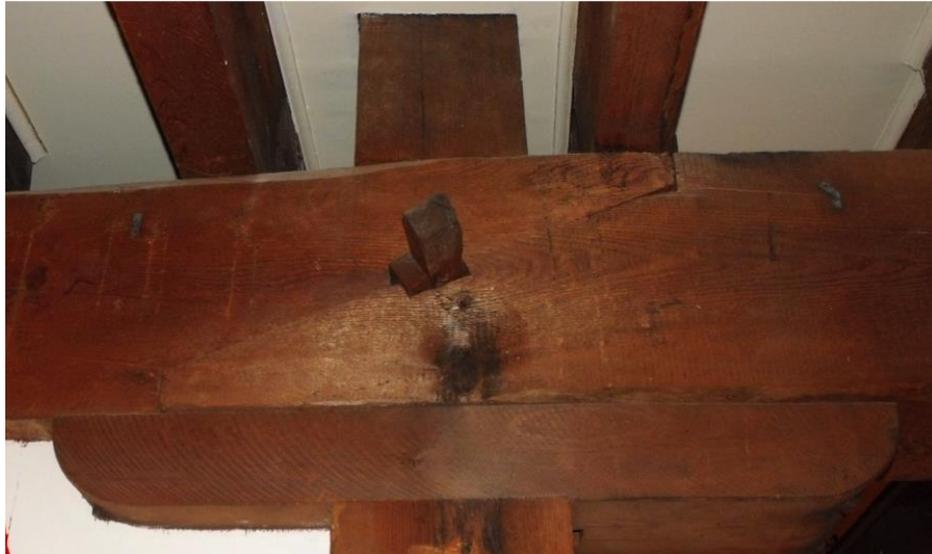
Plate 35 – One of the hooked scarf (or notched splay) joints in the middle running beam. Note the dramatic reduction in post size from the second to the third floors (the base of the third floor post is visible resting on top of the joint).

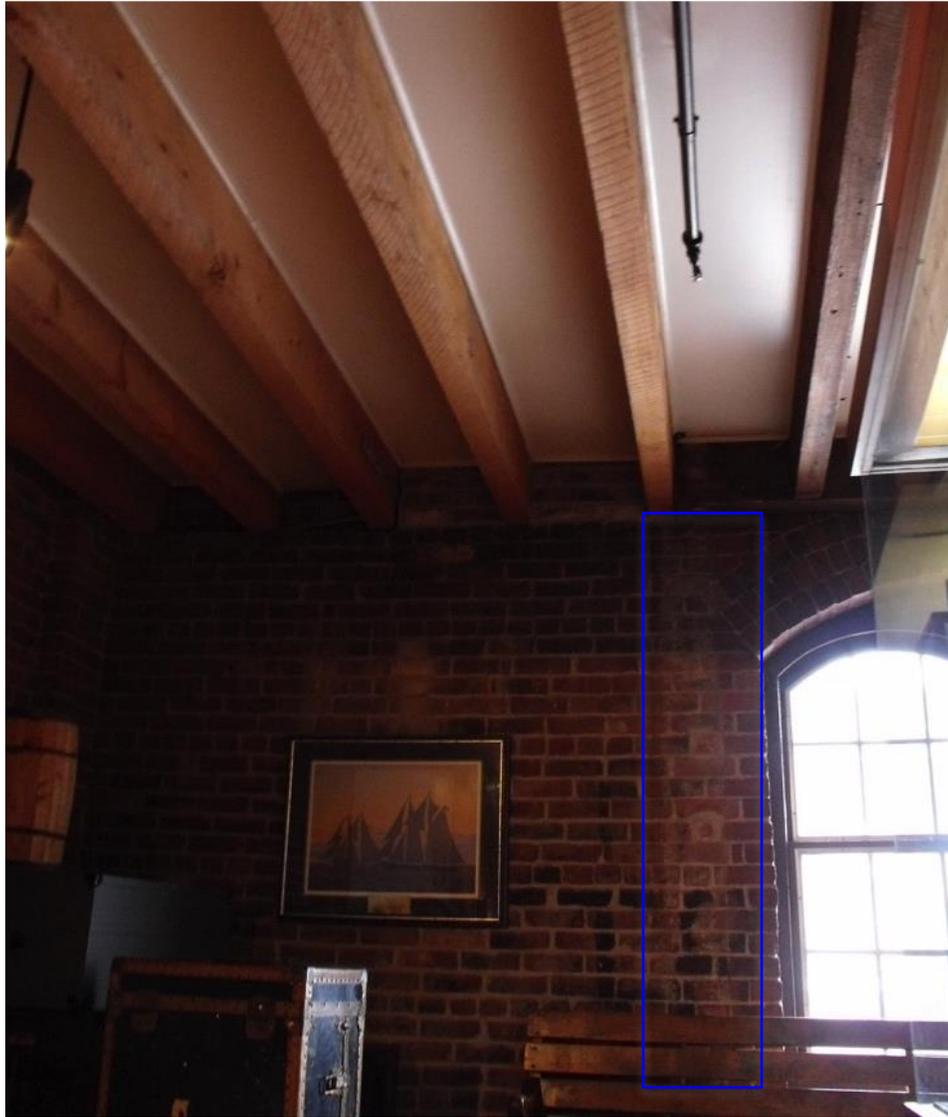
Plate 36 – *Slight staining beside the window (blue) and new floor joists above clearly show where the freight elevator was located until the late 1970s. Northwest corner, looking north.*

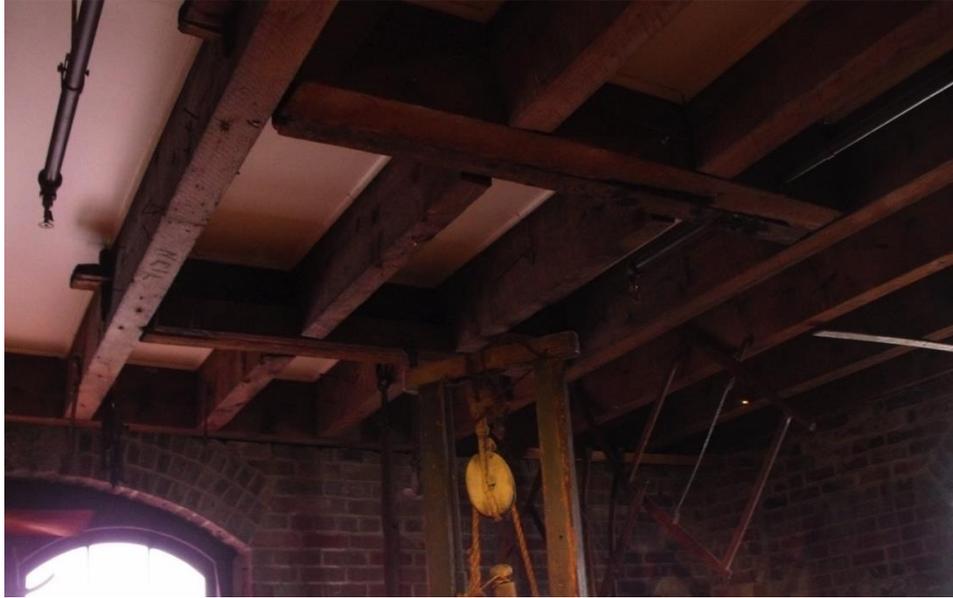
Plate 37 – *A blocked hatch in the northeast corner, inside an enclosed glass display area.*

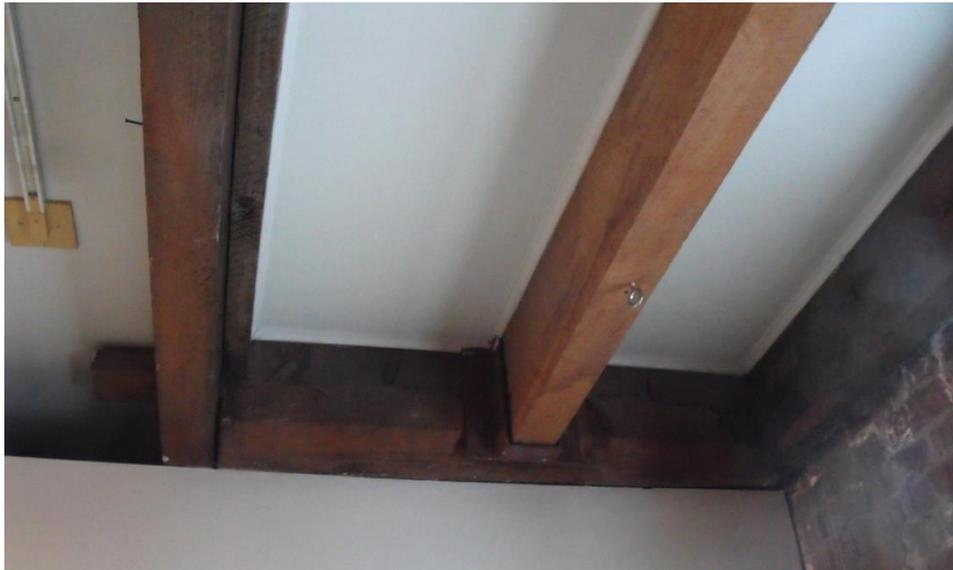
Plate 38 – *An extra crosspiece and a new joist near the southeast corner suggests the former presence of a staircase. Looking north.*

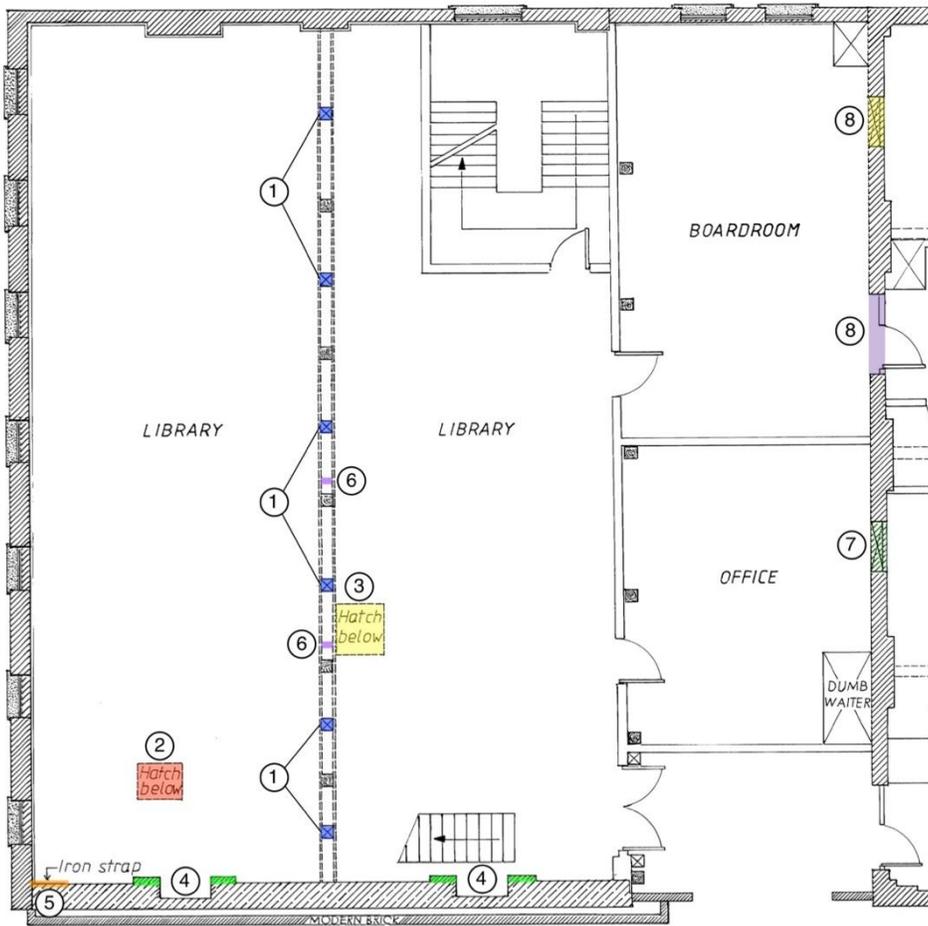
Figure 4-8 – An annotated copy of the third floor plan, front portion. North is to the top.

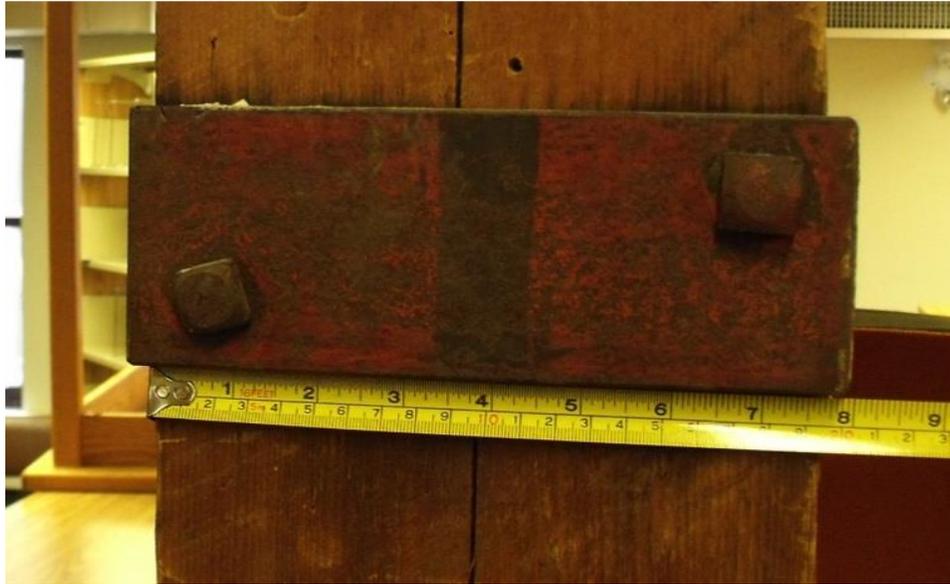
Plate 44 – One of the iron straps on the second original post from the south wall, looking west.
