CURATORIAL REPORT NUMBER 106

The Robertson Building: An Archaeological and Architectural Survey

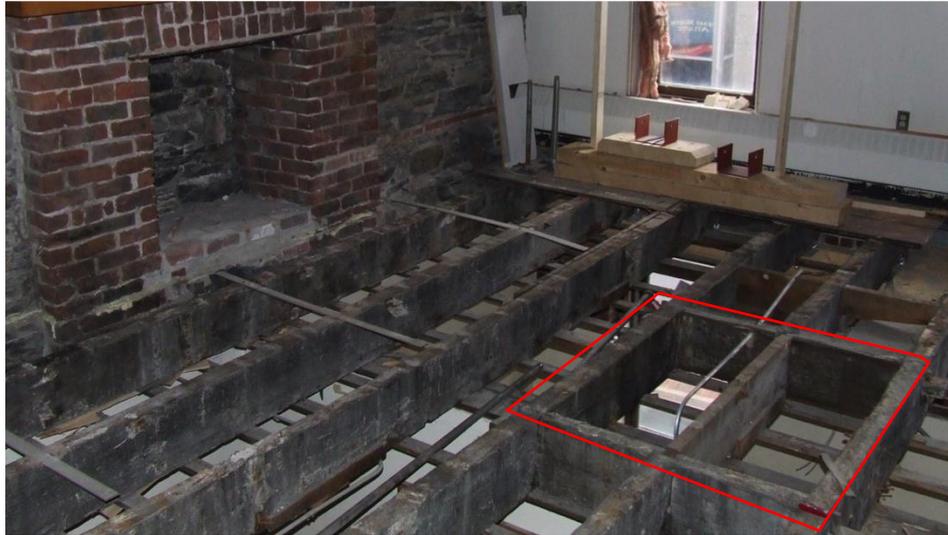
Plate 46 – The blocked hatch (red) noted near the western fireplace in the south wall. Image courtesy Dan Conlin, Maritime Museum of the Atlantic.

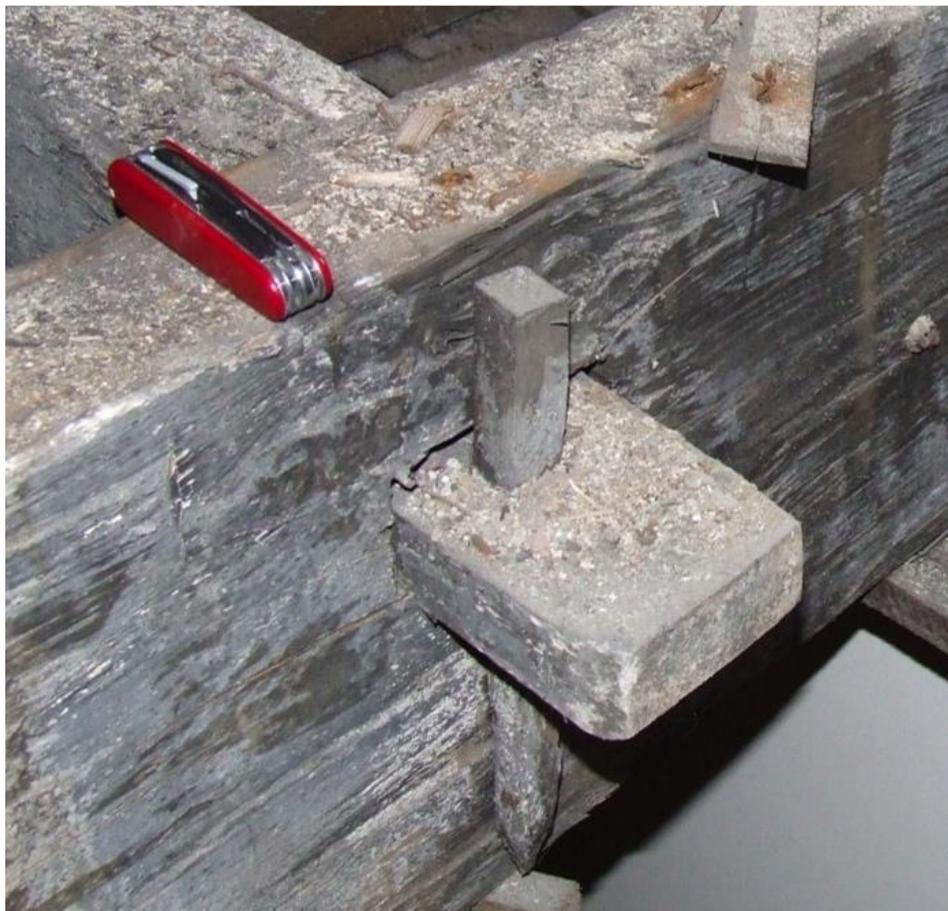
Plate 47 – Detail of one of the mortis and tenon joints used to support the hatch crosspieces. Image courtesy Dan Conlin, Maritime Museum of the Atlantic.

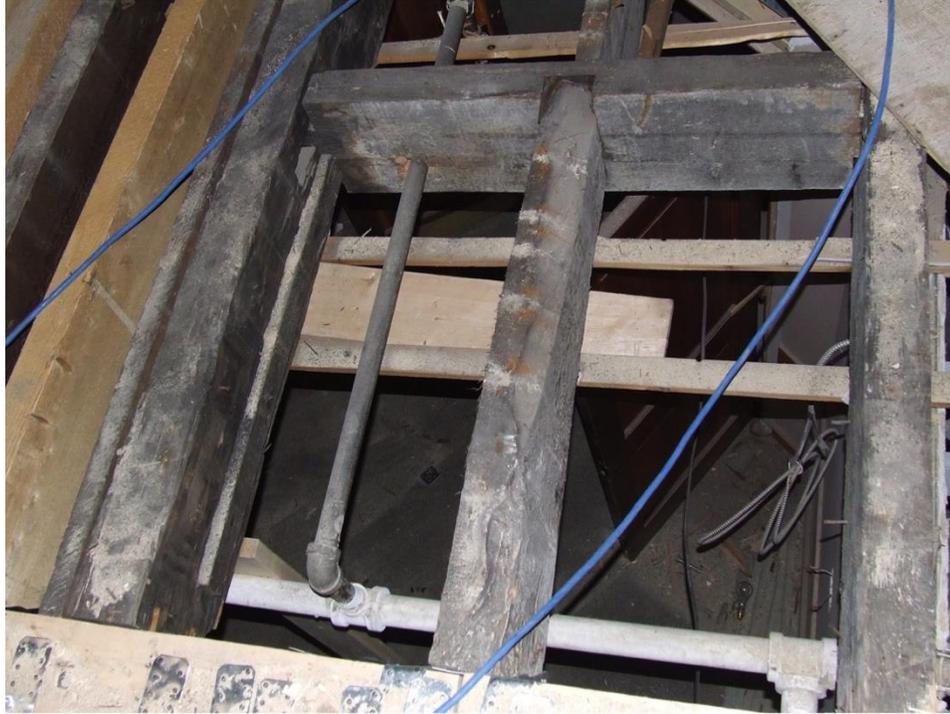
Plate 48 – A second possible blocked hatch, again carefully jointed, adjacent to the central running beam (bottom of frame). South is to the top. Image courtesy Dan Conlin, Maritime Museum of the Atlantic.

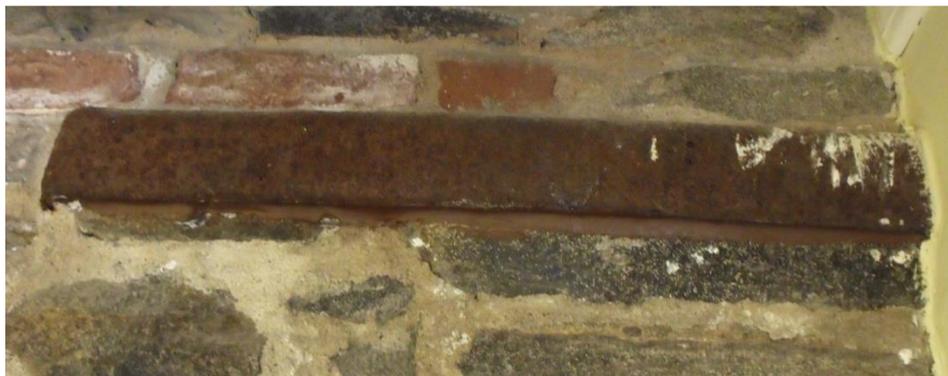
Plate 50 – *A 32" iron strap extending along the south wall from the southwest corner, likely helping to secure the brick façade to the main building.*

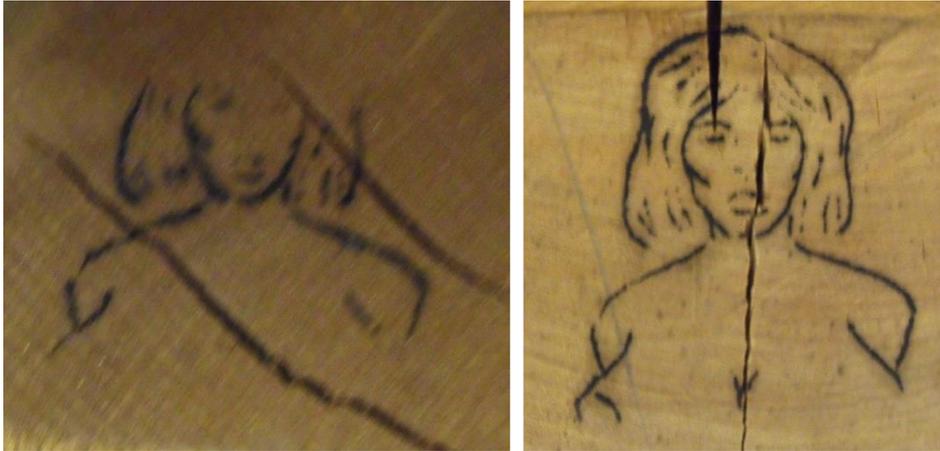
Plate 51 – Two nearly identical pieces of graffiti from the north ends of two post caps along the central running beam.

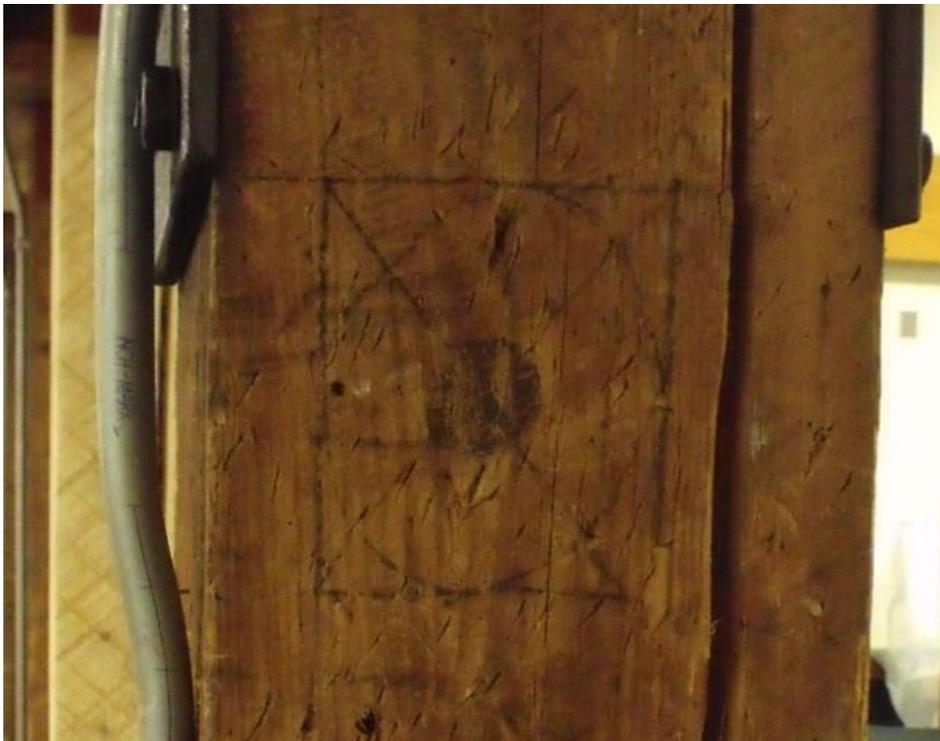
Plate 52 – A geometric design on the south side of one of the posts supporting the central running beam. Looking north.

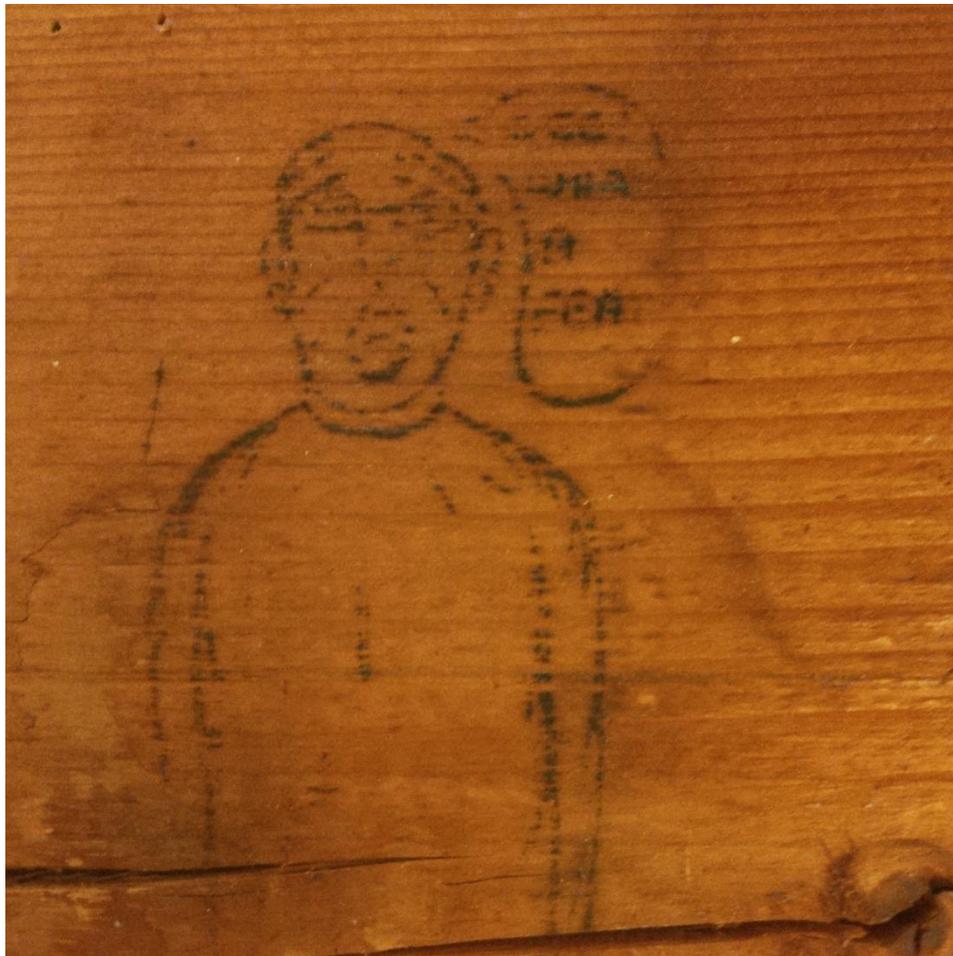
Plate 53 – *A small drawing of a man with a speech balloon, saying "See! What a feat".*

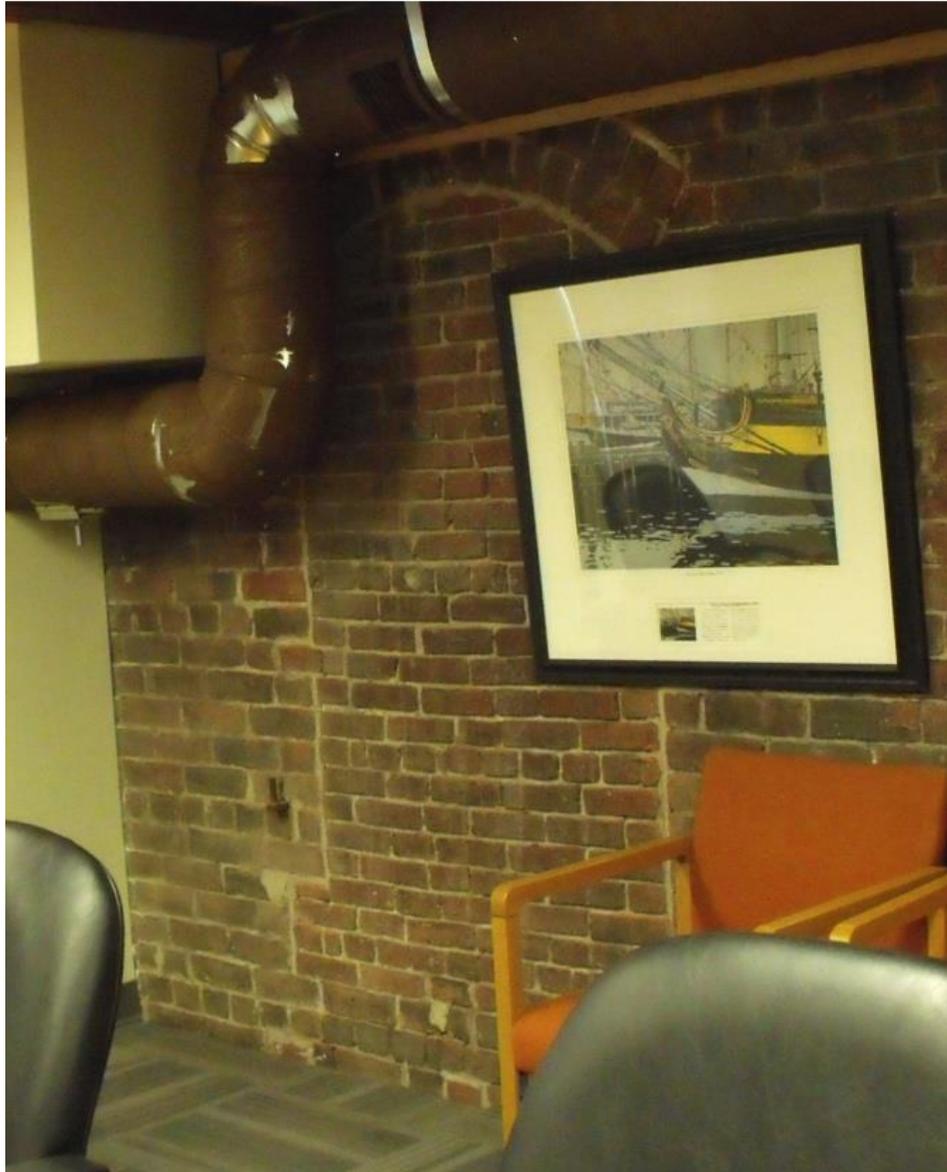
Plate 57 – *A blocked window in the boardroom retains much of its original outline. Looking northeast.*

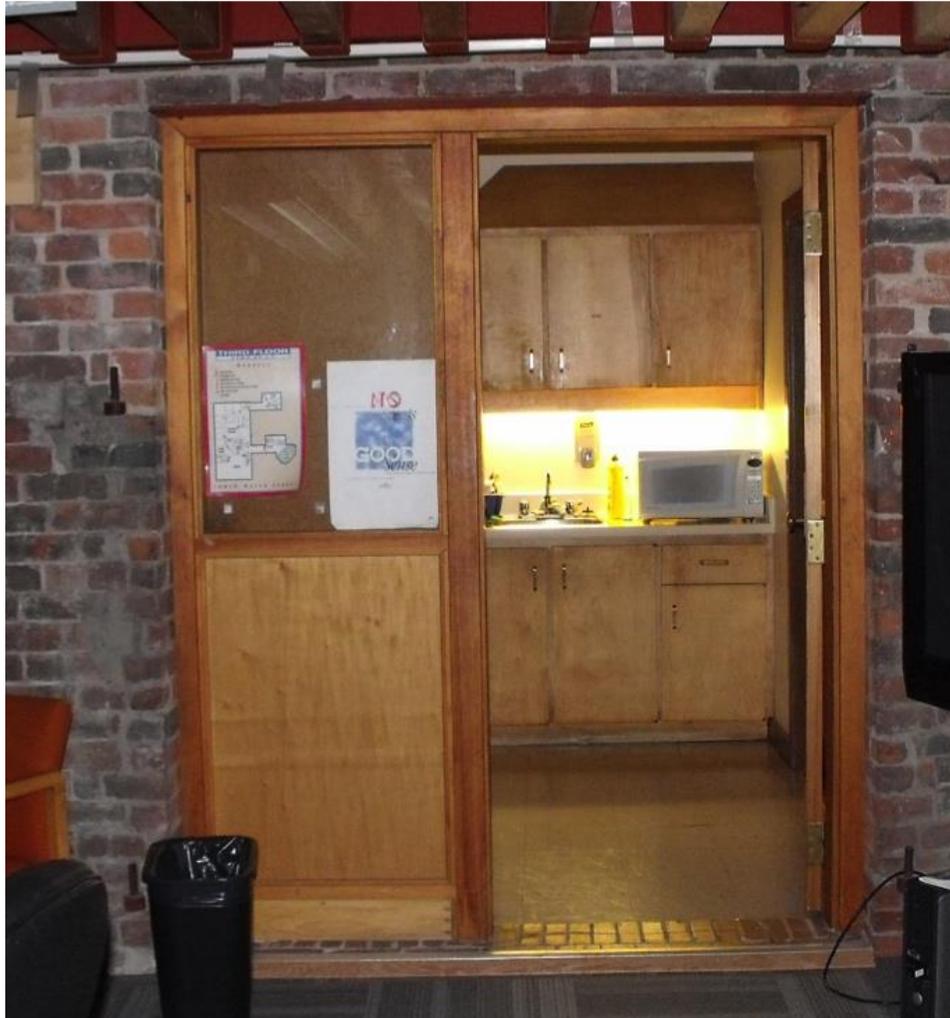
Plate 58 – *A door between the infill portion and the brick warehouse, with brackets meant for a set of iron doors.*

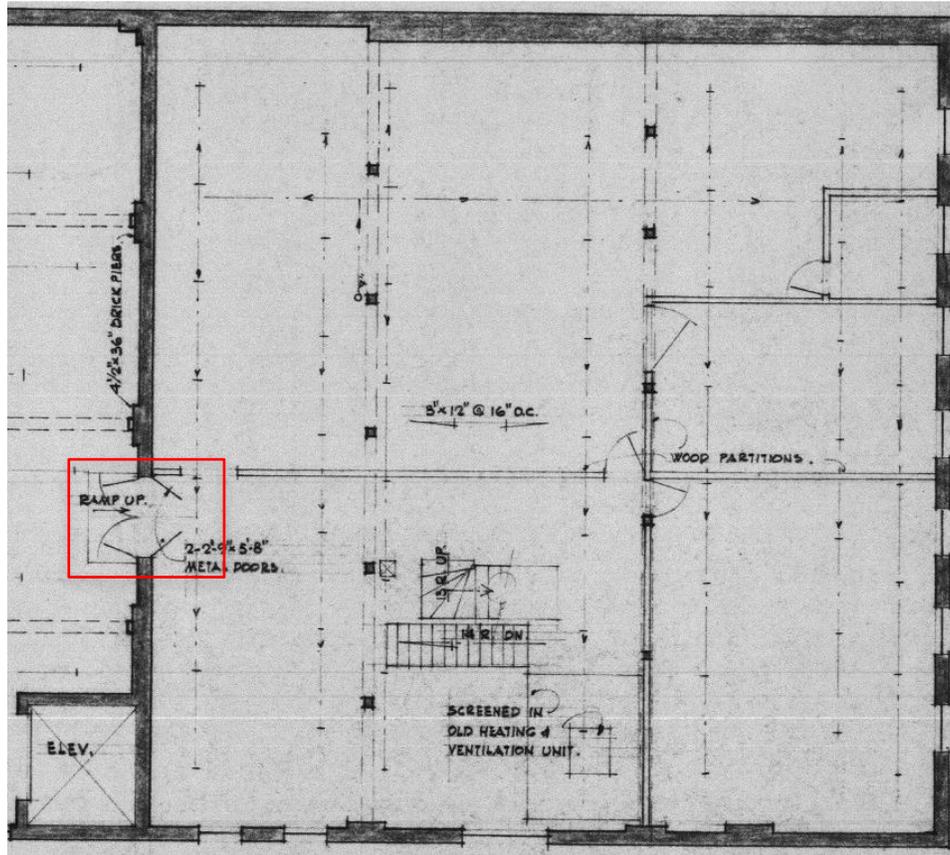
Figure 4-9 – Detail of a 1977 plan, showing the existing doorway between the front and rear portions of the building.^{75 76} Note that north is to the bottom.

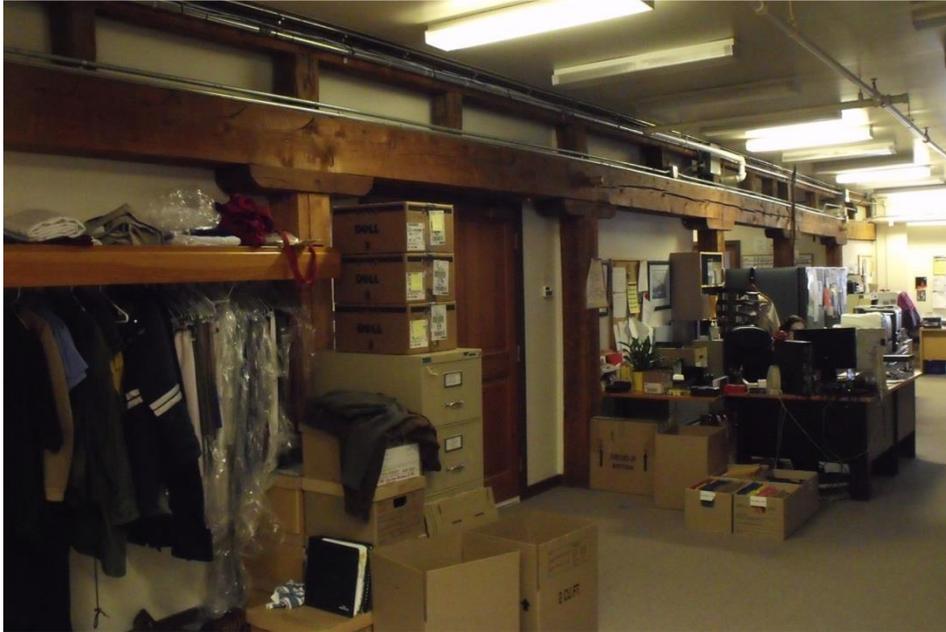
Plate 59 – *The southern running beam, showing a secondary set of short posts and a smaller beam on top. Shorter posts are found over the other two running beams, creating a downward slope to the north. Looking northeast.*

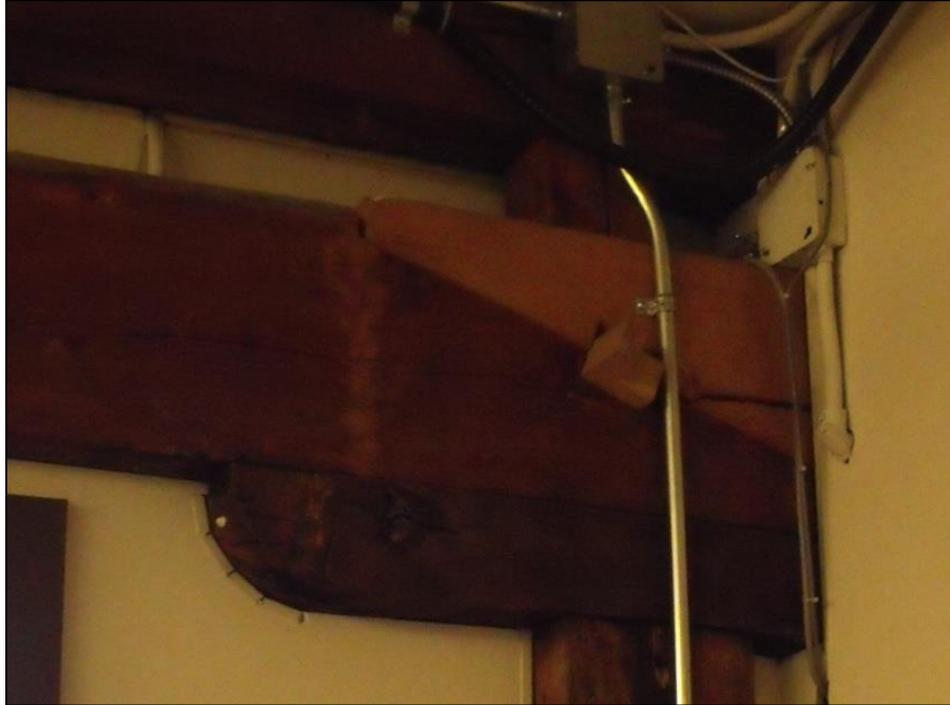
Plate 60 – The exposed eastern scarf joint in the northeast corner, showing a replaced (lighter) section of the beam.

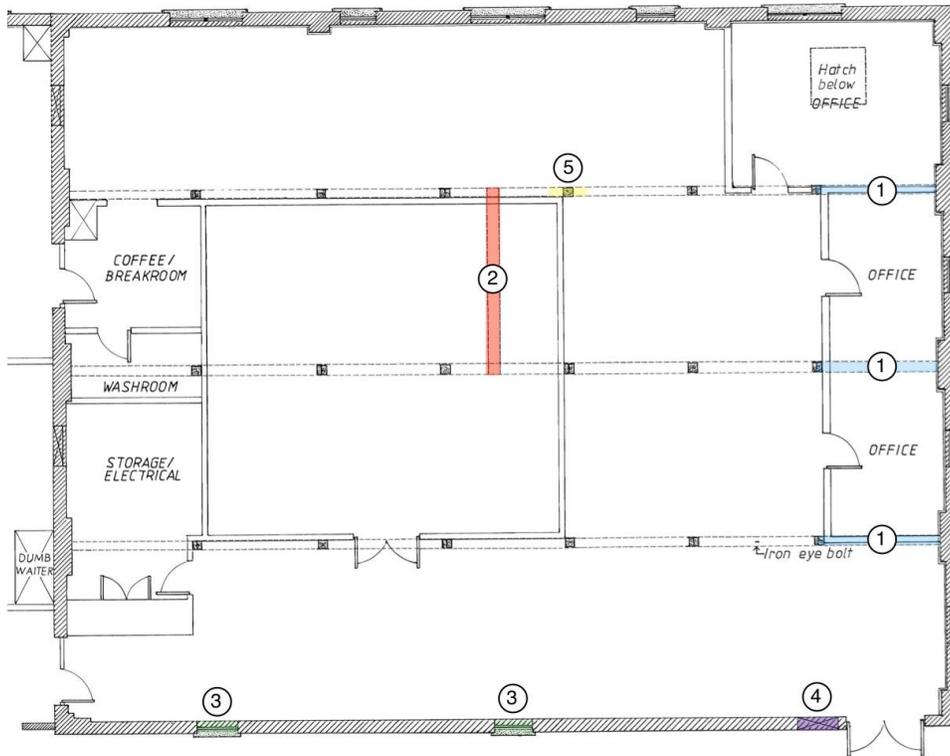
Figure 4-1 – An annotated copy of the third floor plan, rear portion. North is to the top.

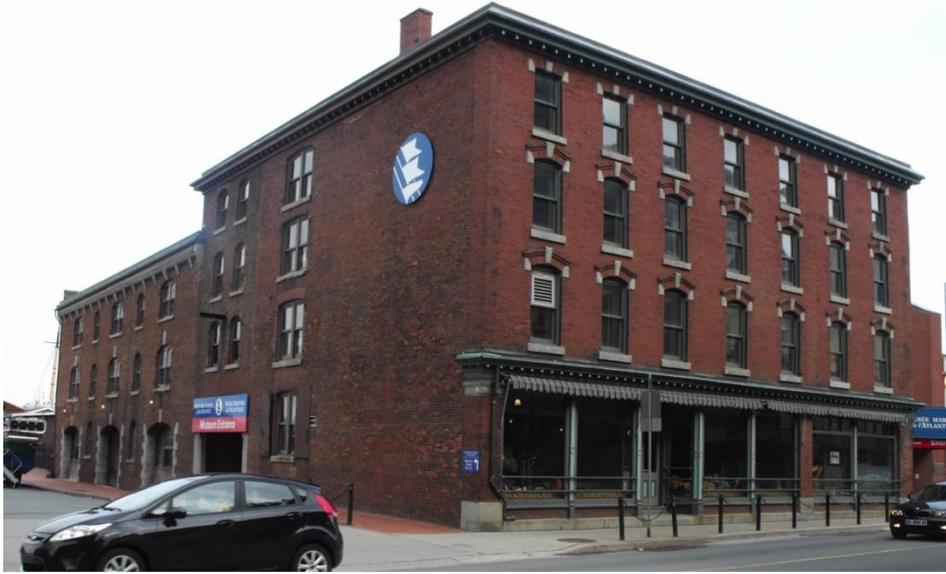
Plate 65 – *The Robertson Building viewed from the northwest corner of Lower Water and Prince Streets.*

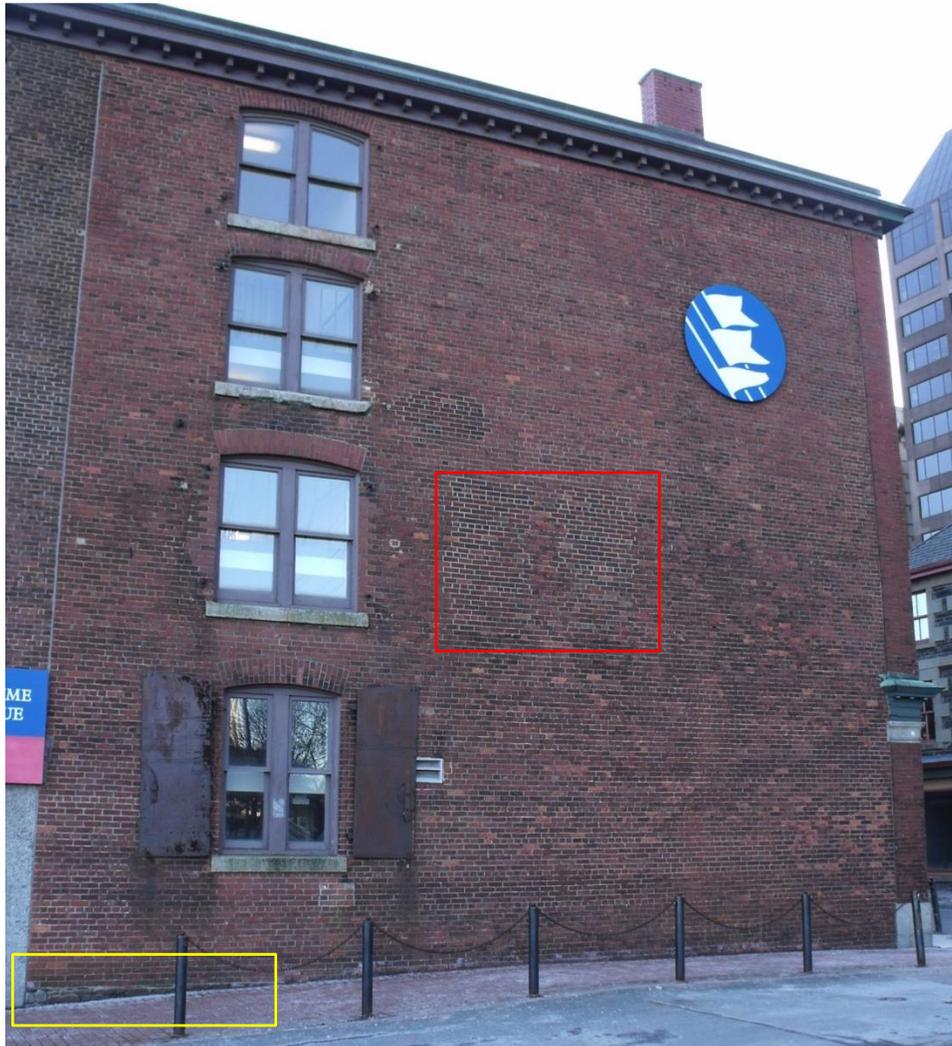
Plate 66 – *The northern side of the Robertson Store portion of the building. Note the new mortar at the site of two blocked windows (red) and the hint of the ironstone foundation (yellow).*

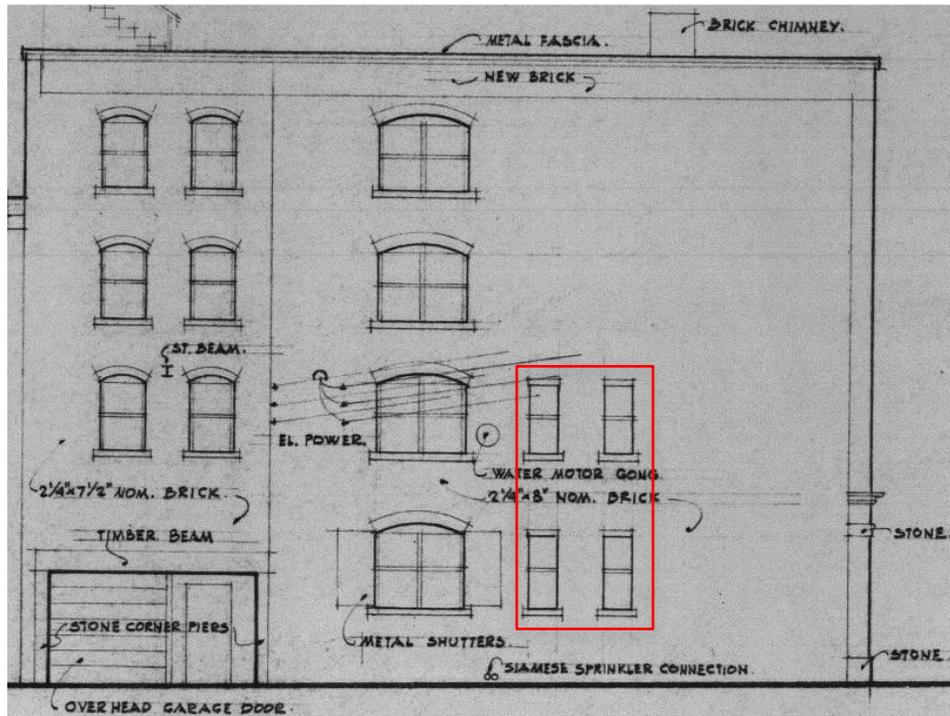
Figure 4-12 – Detail of a 1977 architectural plan, showing four windows now blocked (red).⁸¹

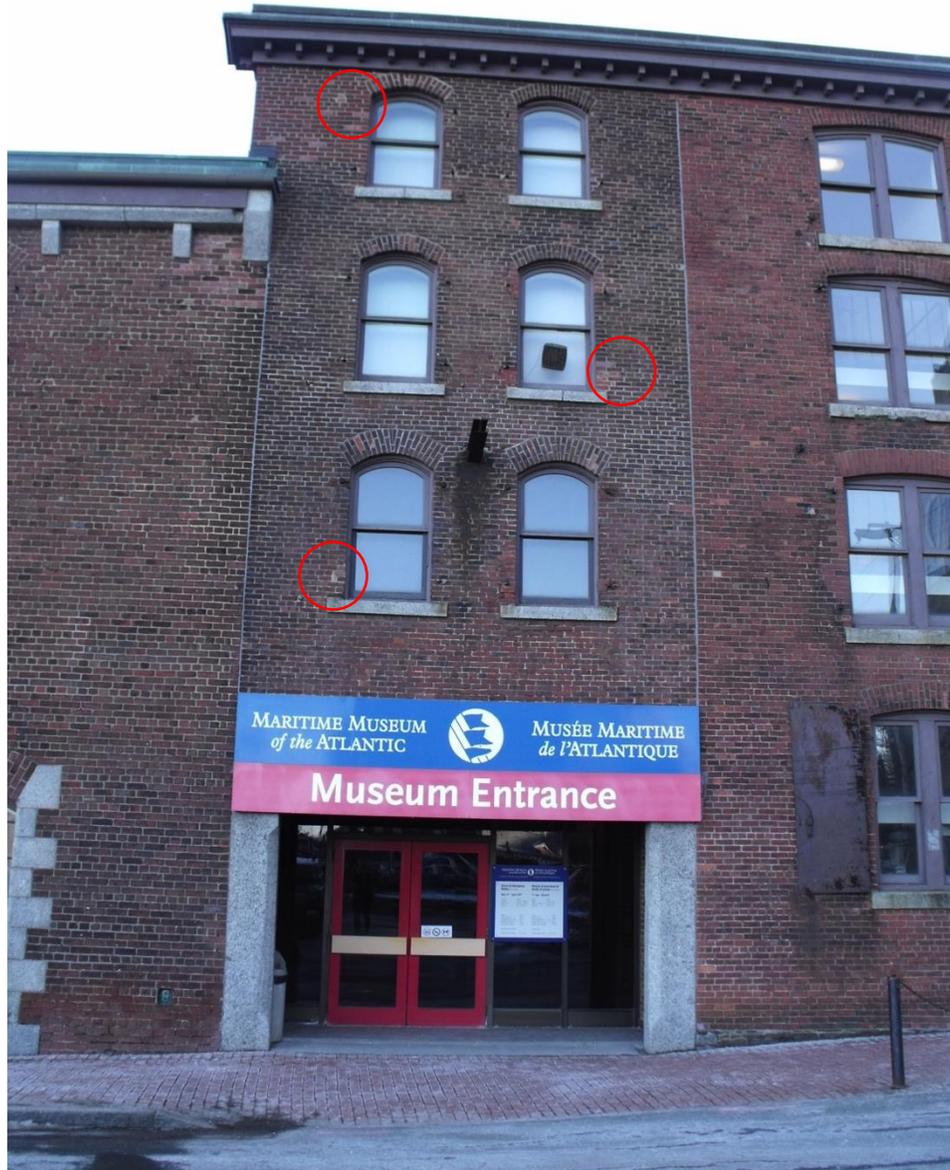
Plate 67 – *The infilled section on the building’s north face. Note missing brackets for iron shutters at repair points (red).*

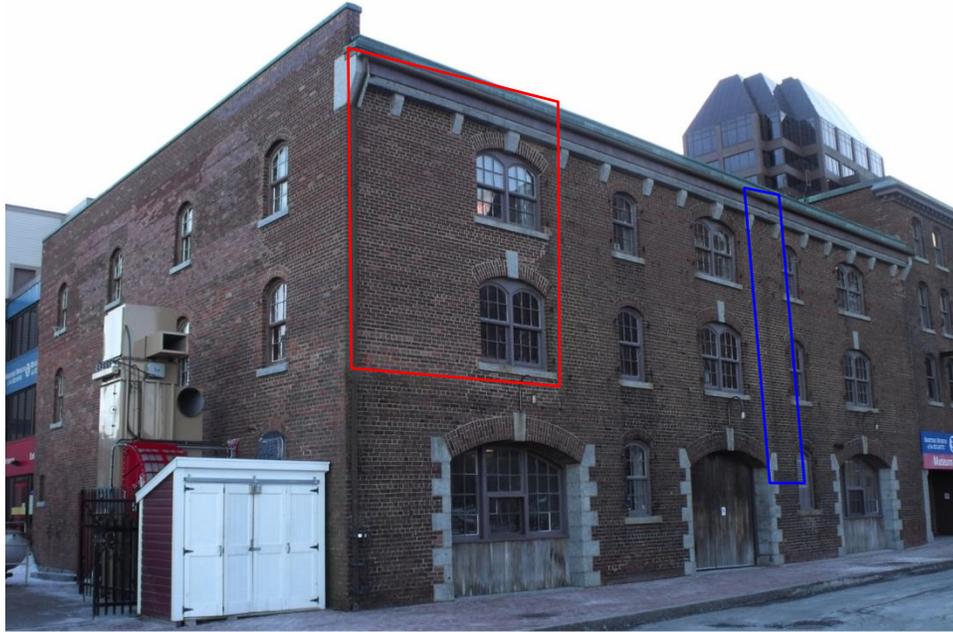
Plate 68 – *The north (right) and east (left) faces of the brick warehouse. The shadow or “ghost mark” or an old downspout can be seen (blue), as can one of the areas repaired in the late 1970s (red).*

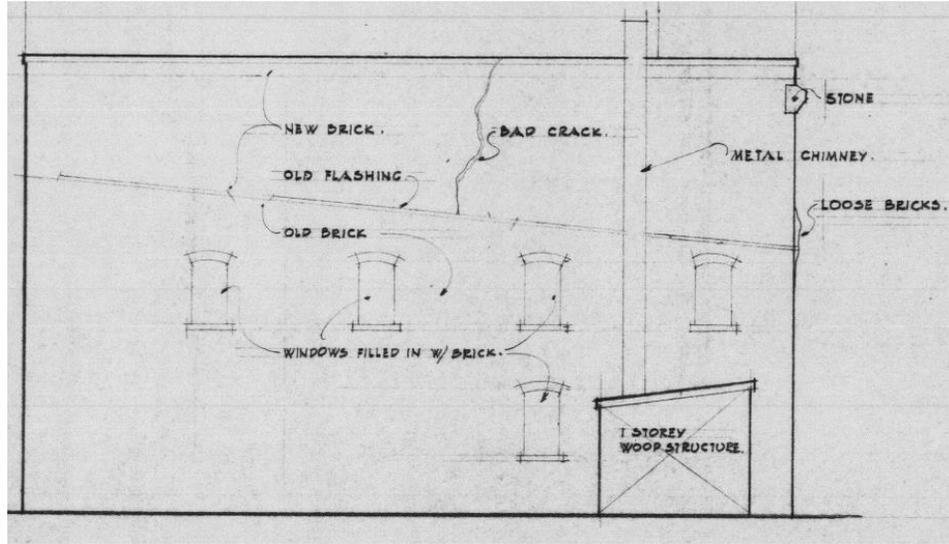
Figure 4-13 – Detail of a 1977 illustration showing the rear or east façade of the building, with all windows apparently blocked.⁸³

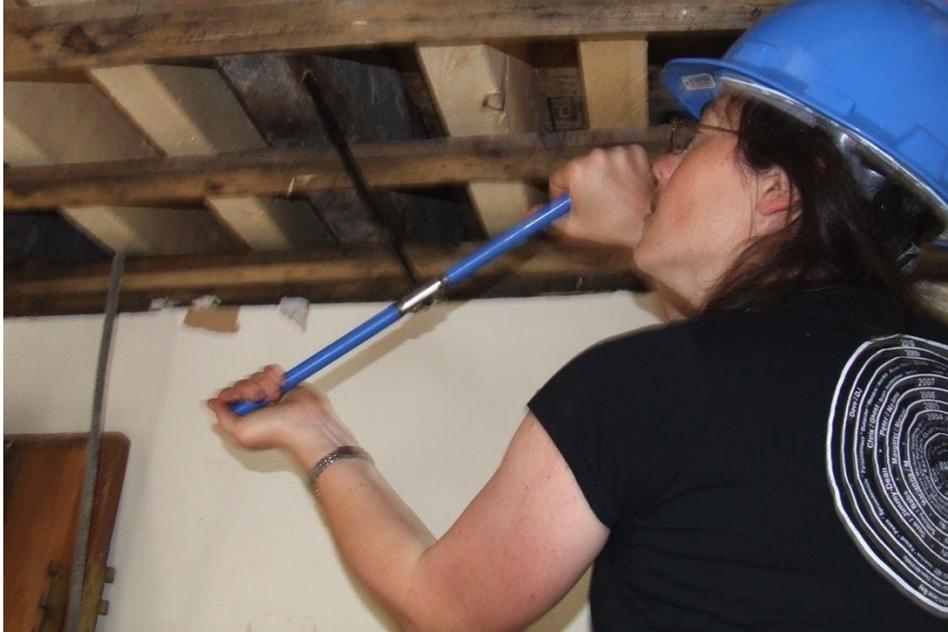
Plate 723 – MAD Lab technician Amanda Young takes a core sample in the phone room. Image courtesy Dan Conlin, Maritime Museum of the Atlantic.

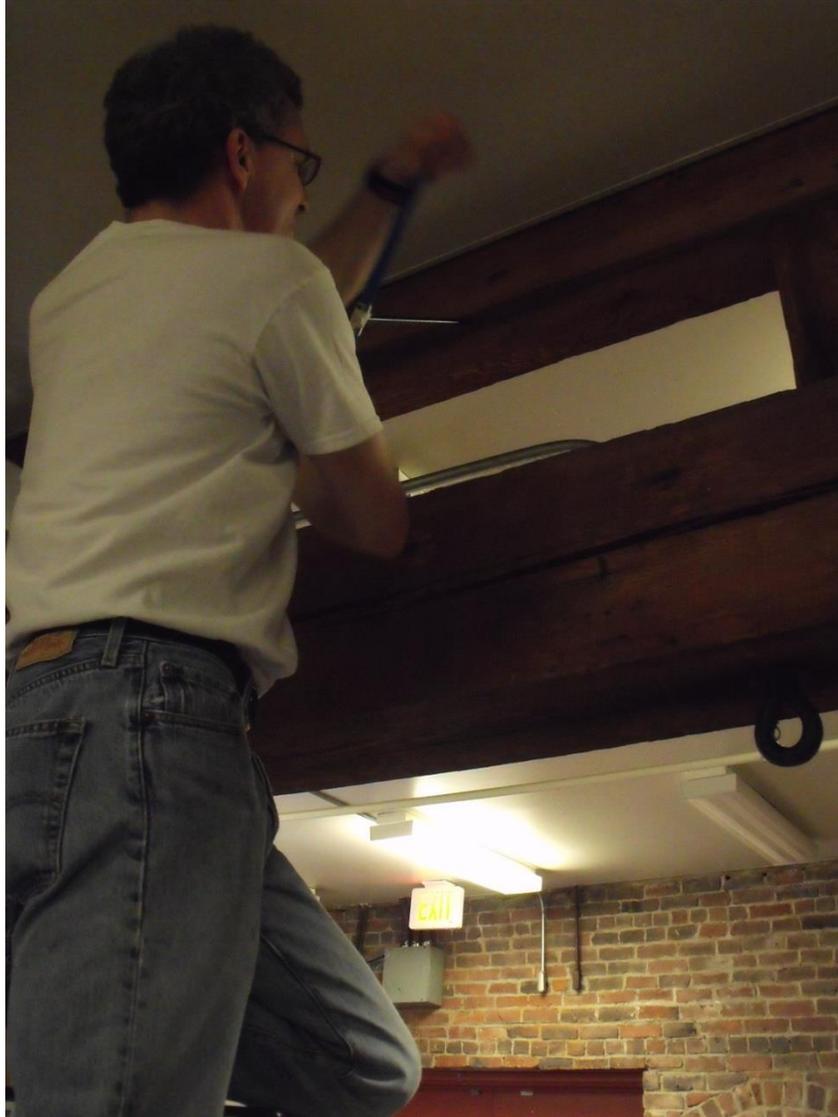
Plate 74 – Colin Laroque takes a sample from the smaller running beam supporting the roof's slope on the third floor.
