Curatorial Report Number 60

# The Simeon Perkins House: an Architectural Interpretation 1767-1987

By Allen Penney  
February 1987

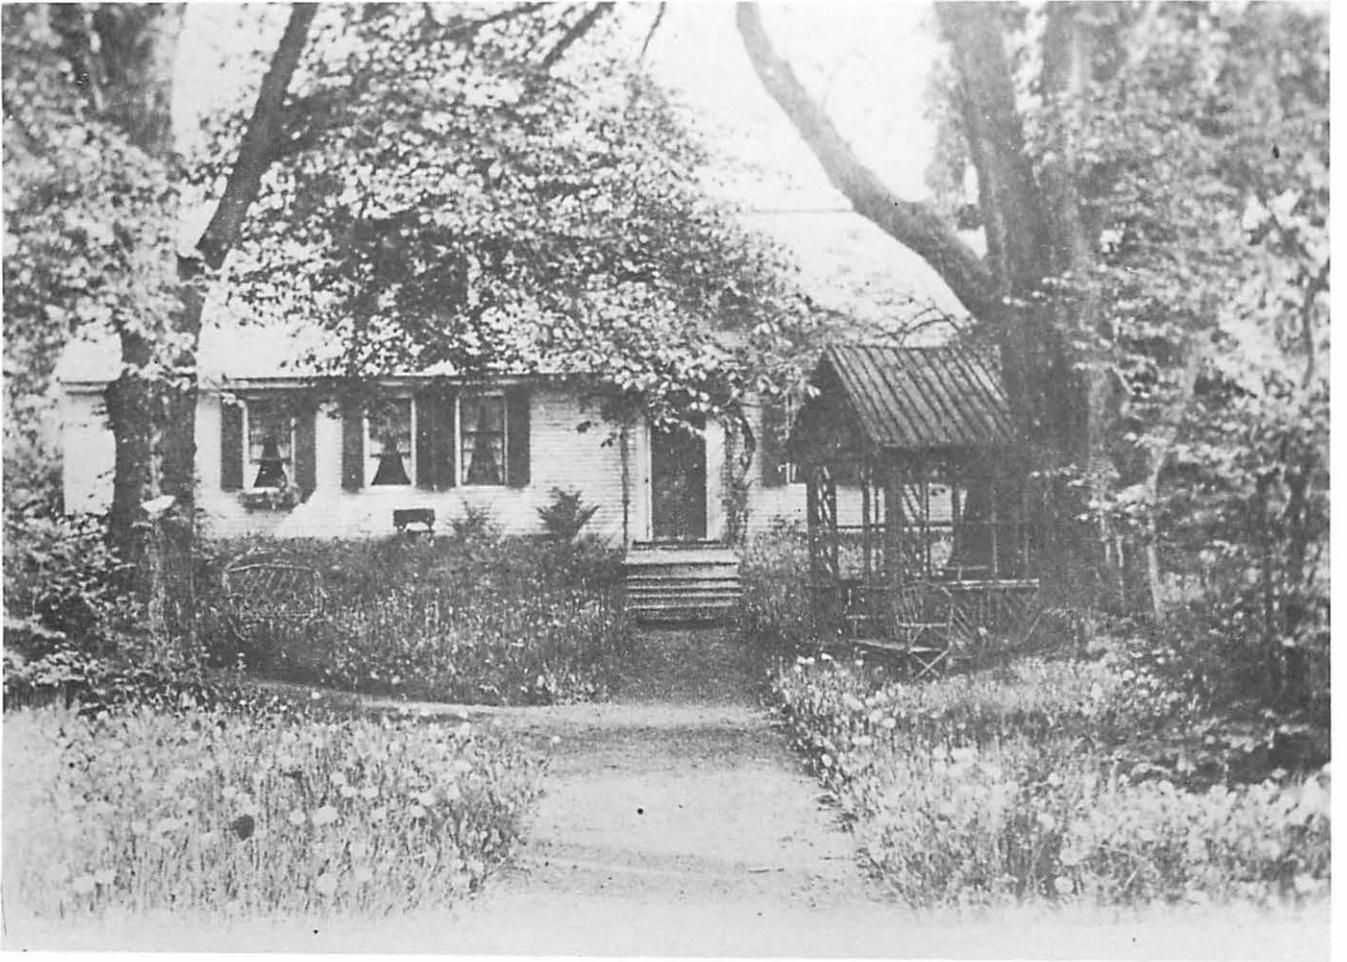
The North Front before 1935, possibly as early as 1900

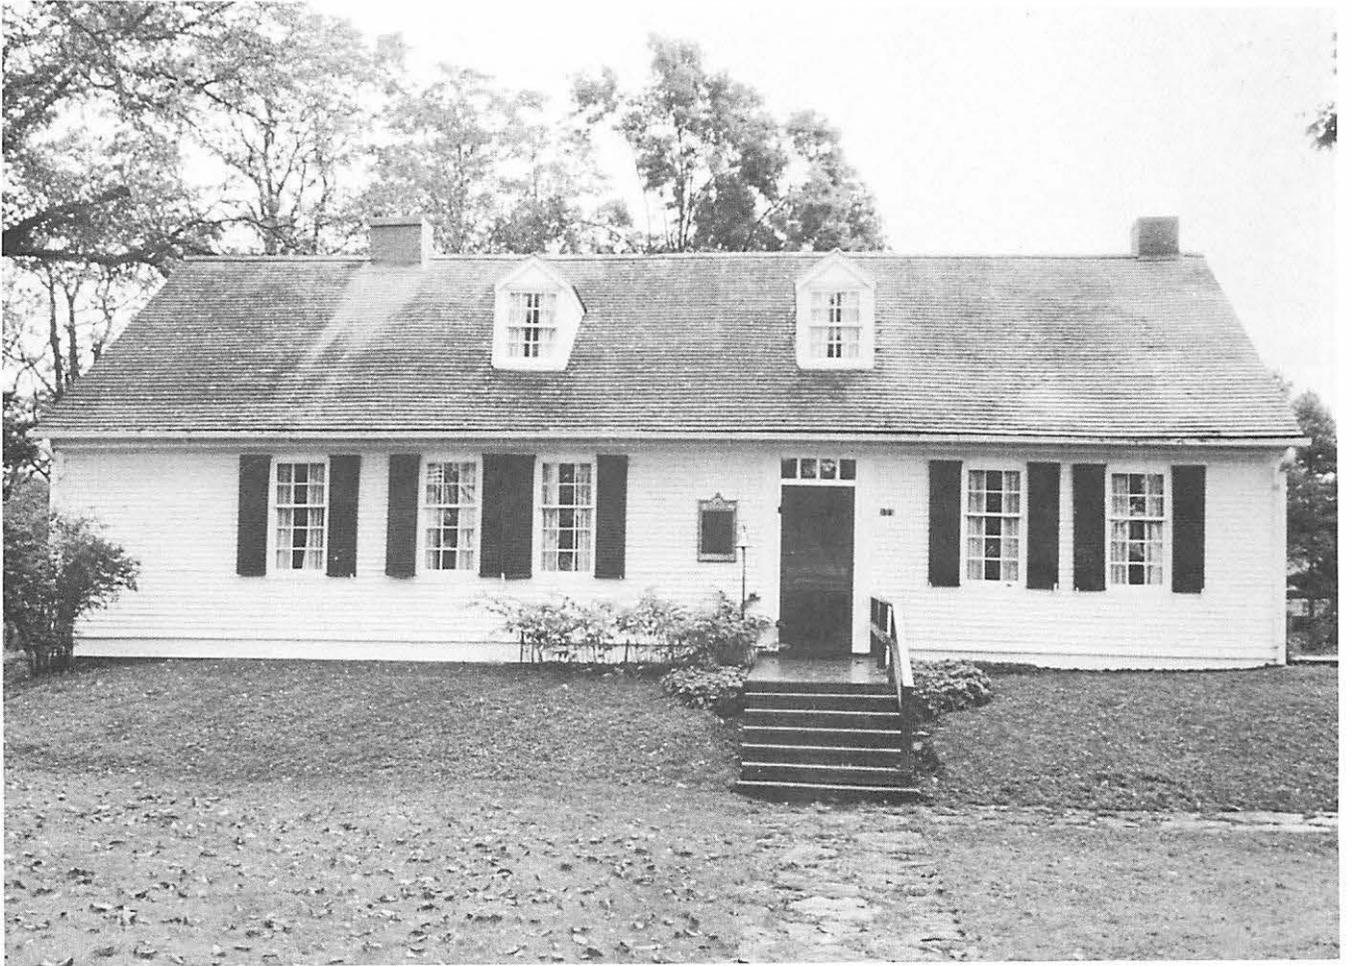
The North Front in 1978. The lack of symmetry is caused by the addition to the left hand end in 1781 and the later dormers.

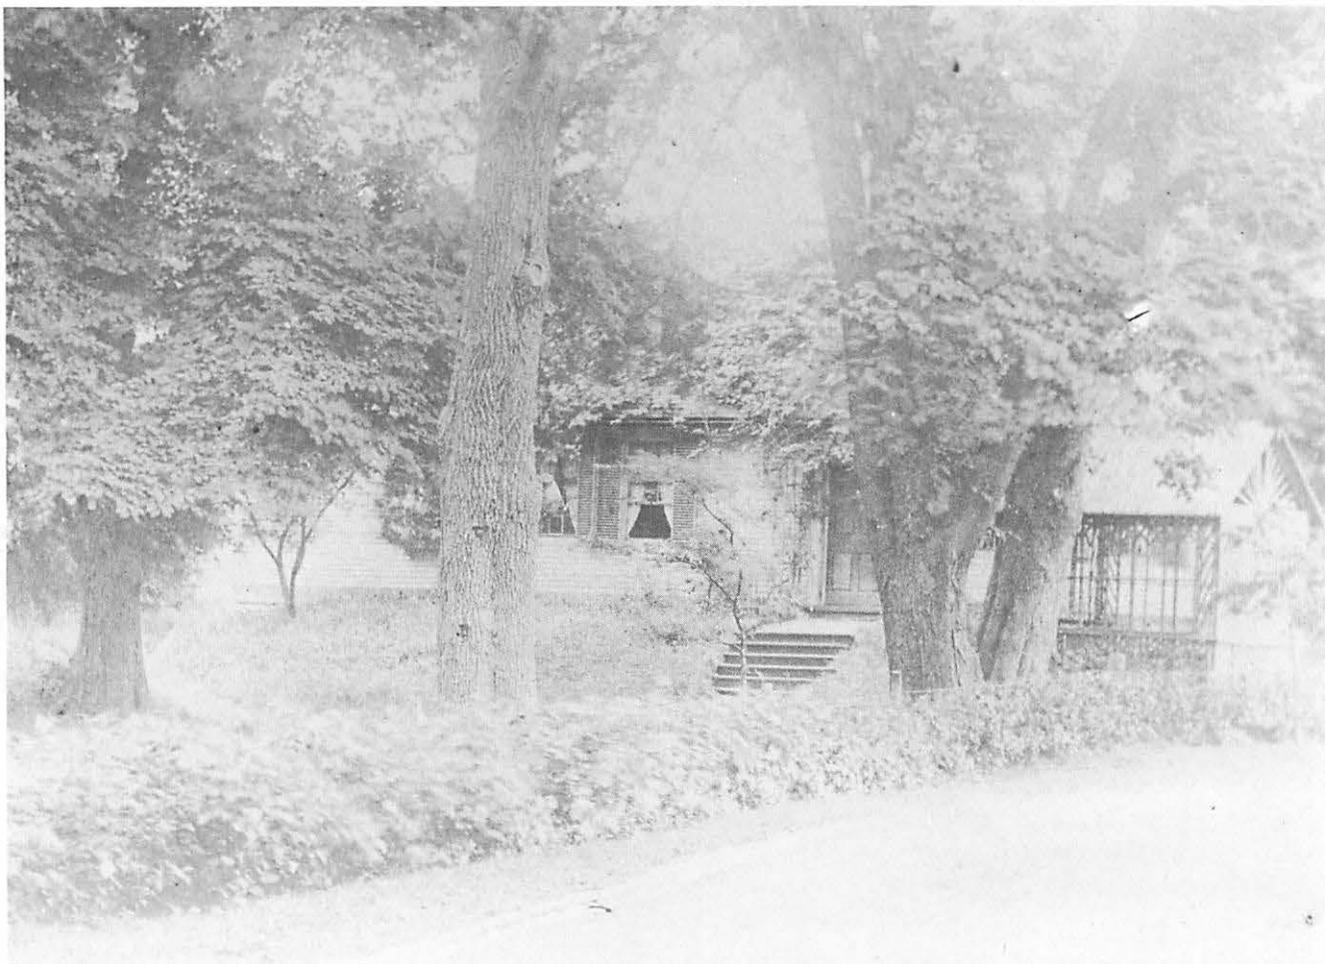
An early photograph shows the house with creeper on the roof.

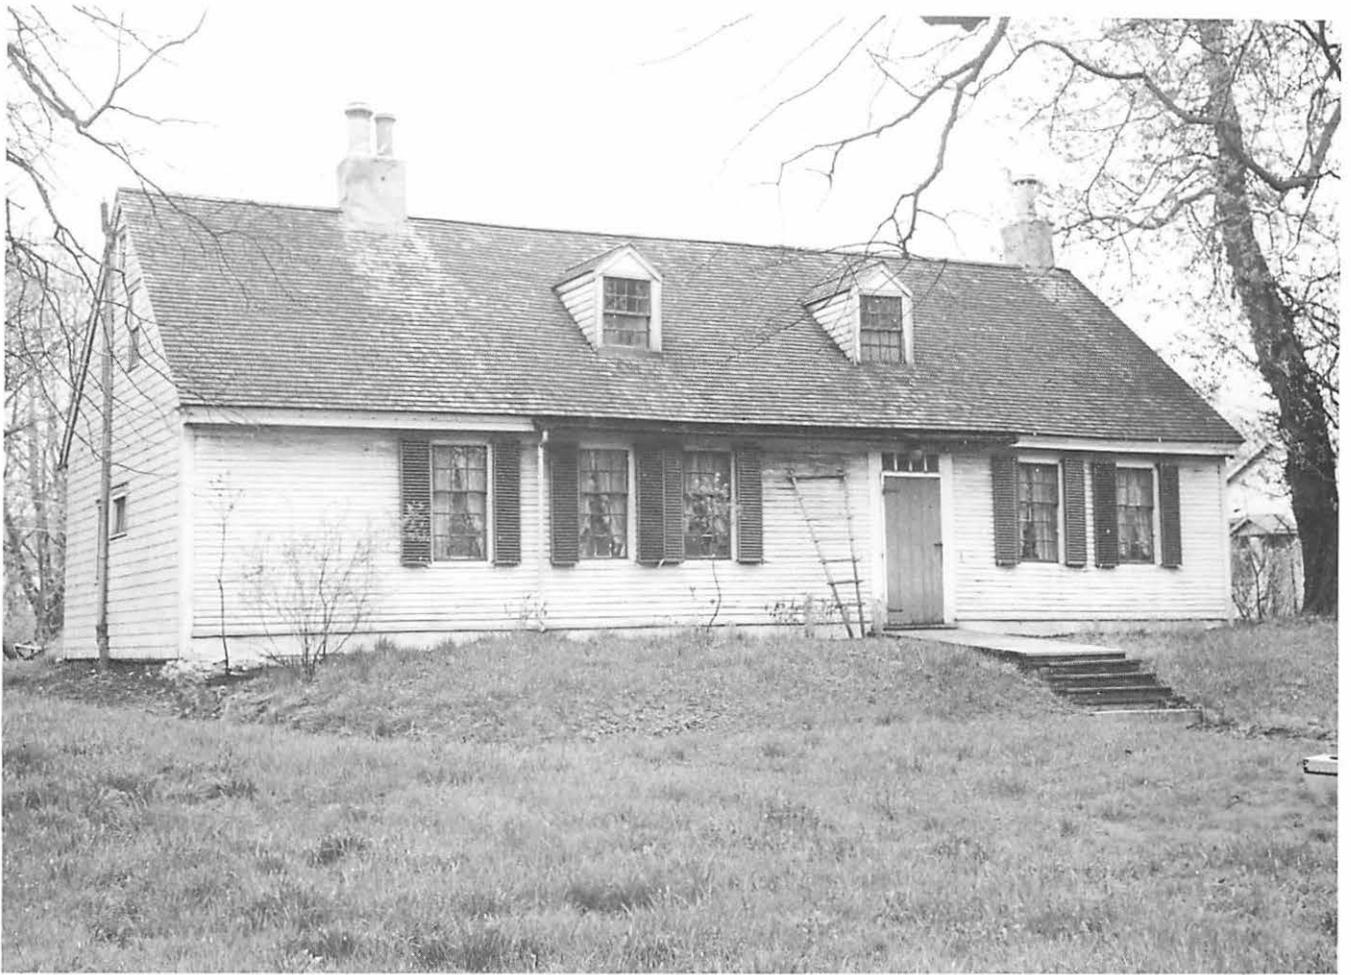
The north front in 1947. Note the horizontal window and plumbing stack on the east end, (left hand side) and the Victorian Gothic Chimney Pots. The overall deformation of the house can be seen by the drooping ends.

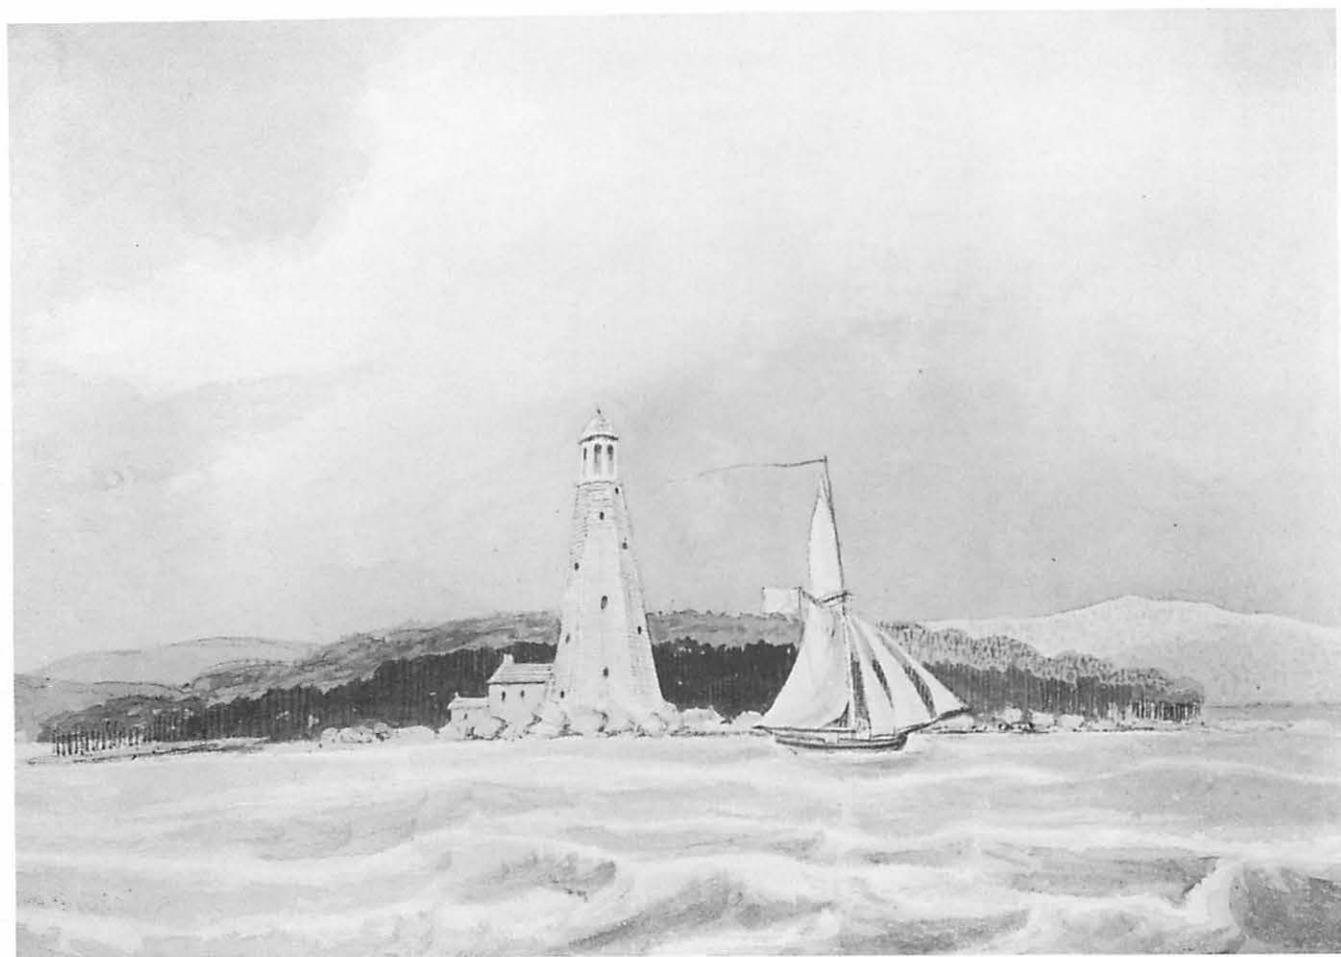
The Liverpool Lighthouse erected on the south end of Coffin's Island. Begun on 30 May 1811, when Simeon Perkins laid the foundation stone, it was completed on 13 Dec 1815, but was not lit until June 1816. The light revolved every two minutes and the total height was 75 feet. Liverpool is at the left in this drawing by J.E.Woolford in 1817.

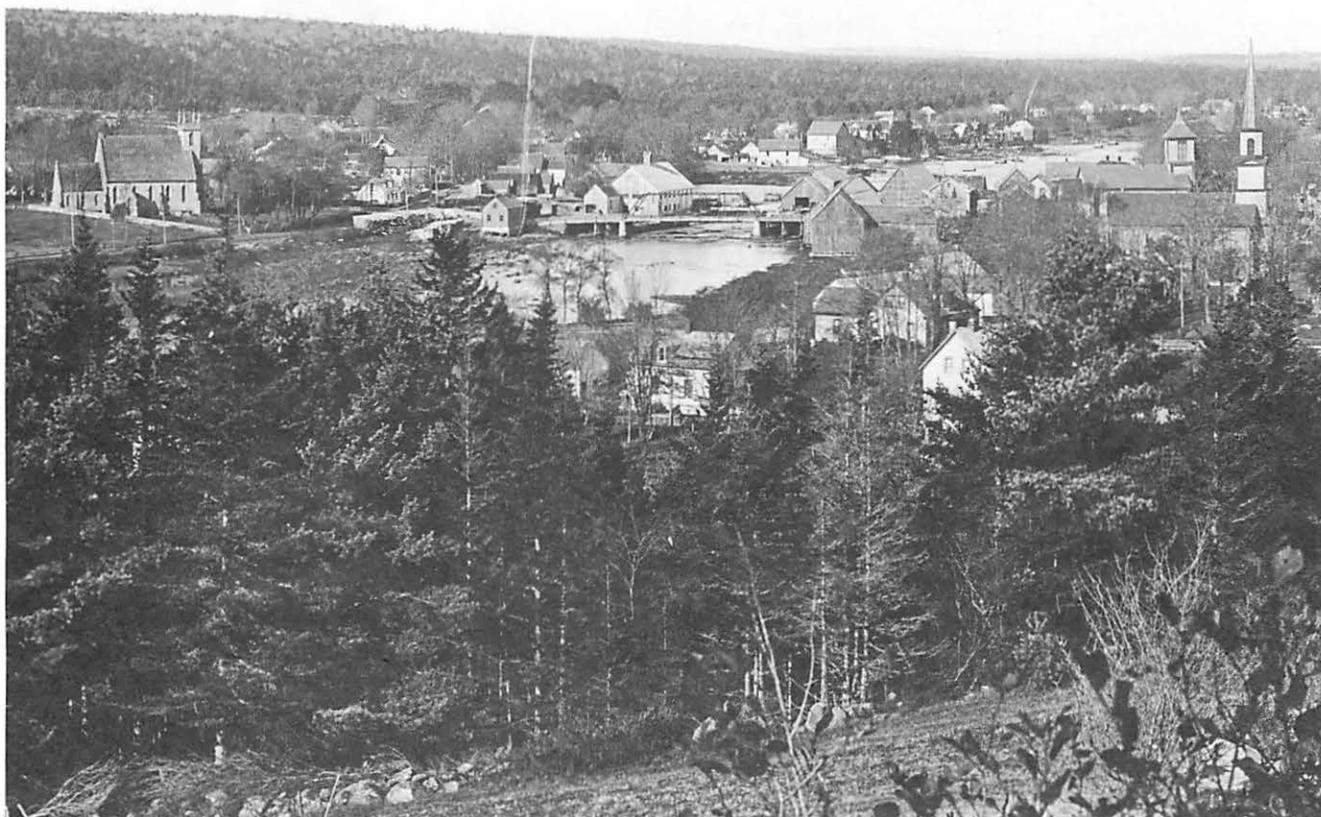
Milton, or the Falls as it was called in Perkins' time. The sawmills on either bank were subject to damage in the Spring run-off and were often rebuilt. None exist, but in this late nineteenth century view the sawmills are in operation still.

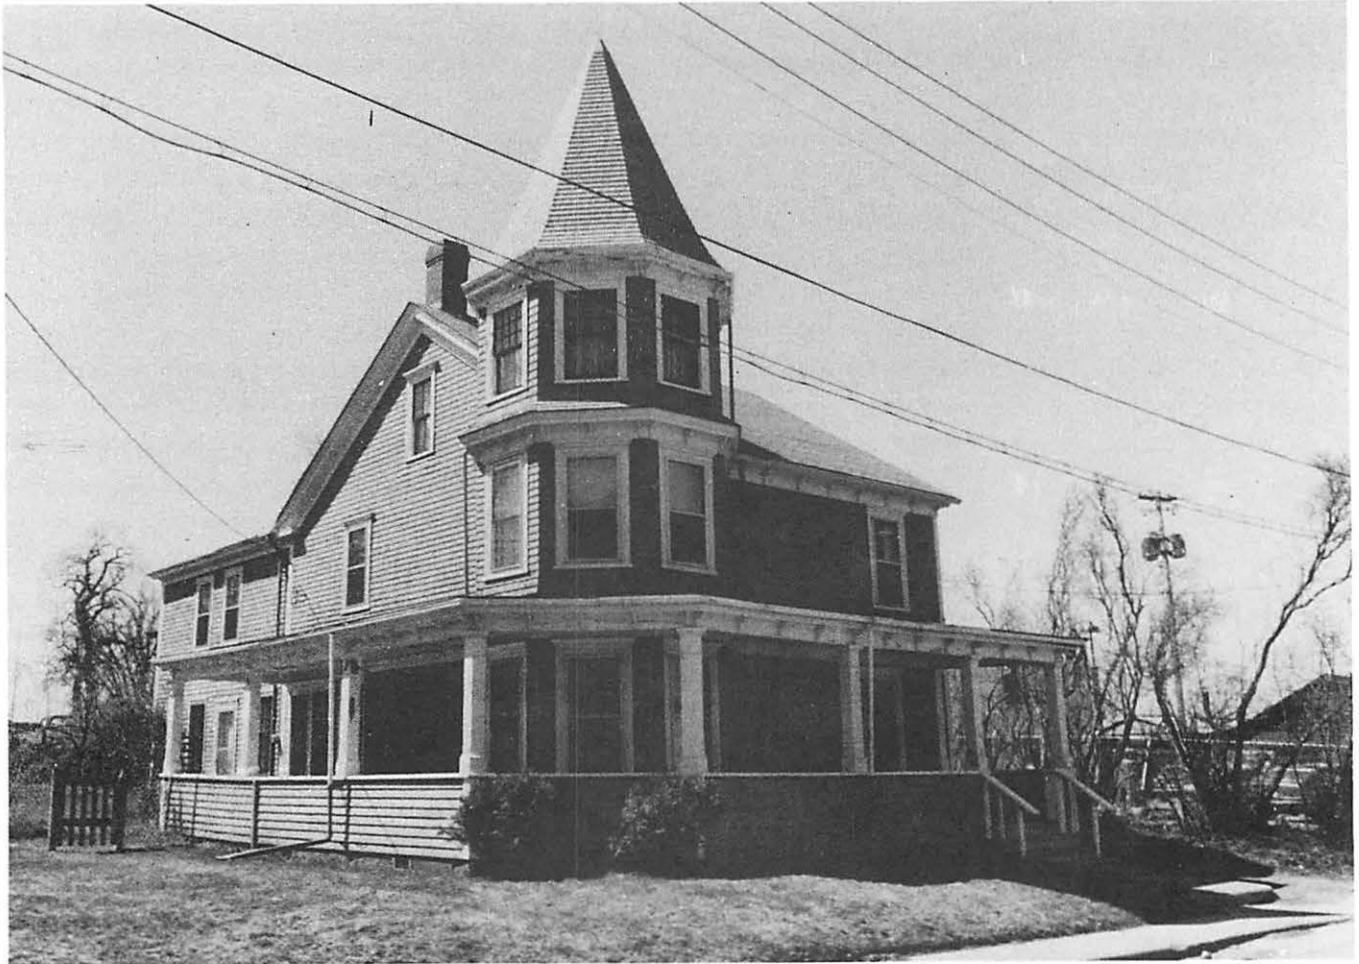
The John Perkins House at the bottom of Wentworth Street in Liverpool was built in 1810. It has been altered over time but because of a Diary entry we can fix the position of an office and a barn which previously stood here. The view of the harbour entrance meant that Perkins knew everything thing that was going on in the harbour.

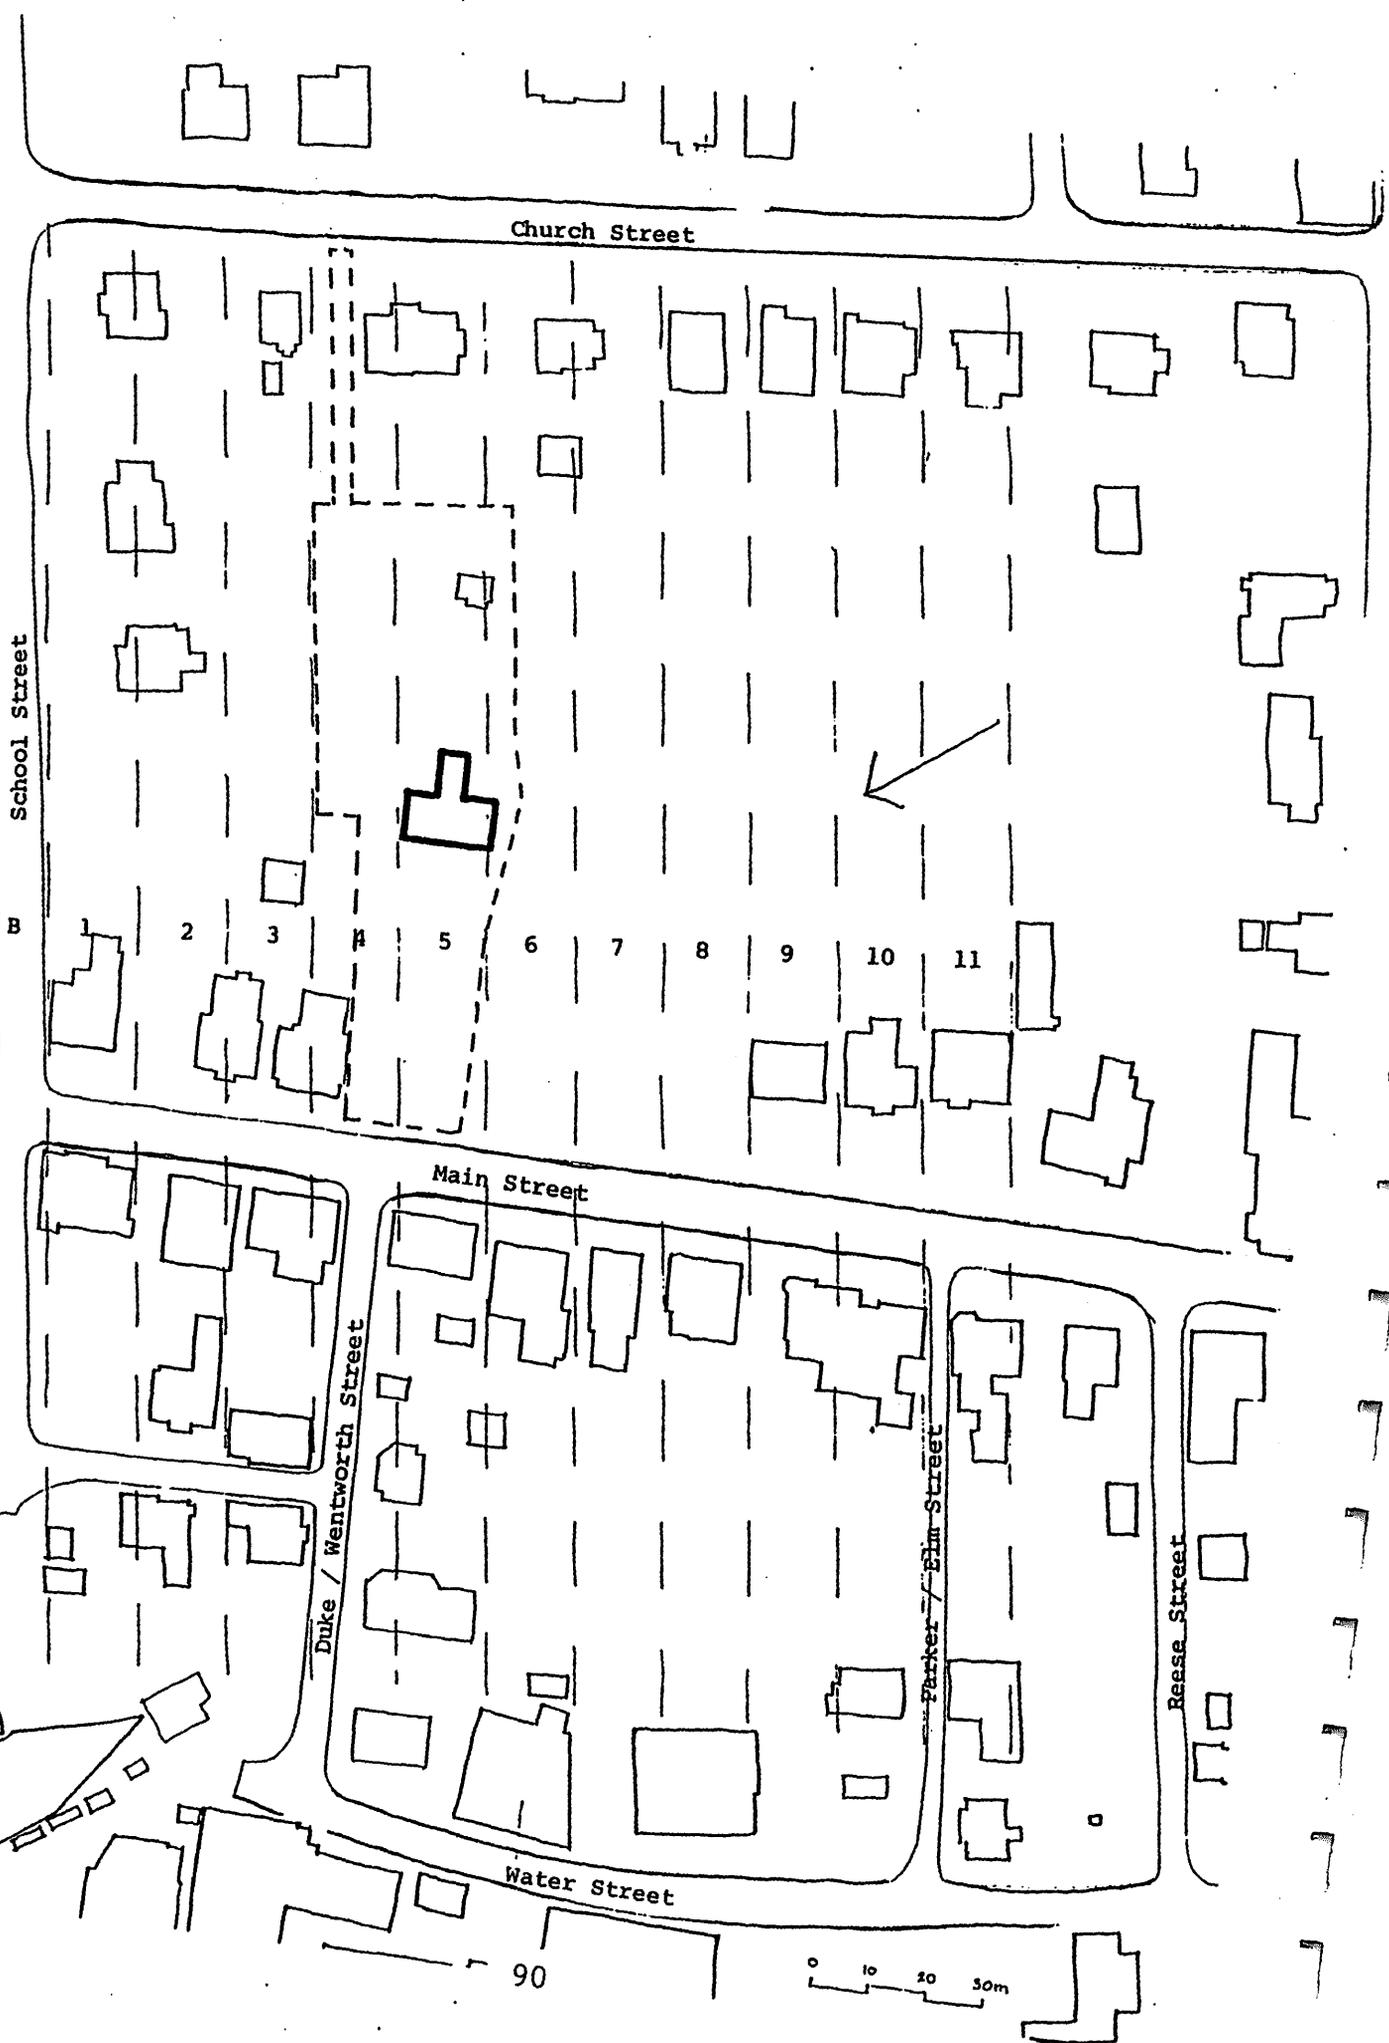
The earliest known plan of the property made at the time of transfer of the house from the Q.C.H.S. to the Province of Nova Scotia. From a drawing by B. L. Parker, P.L.S.

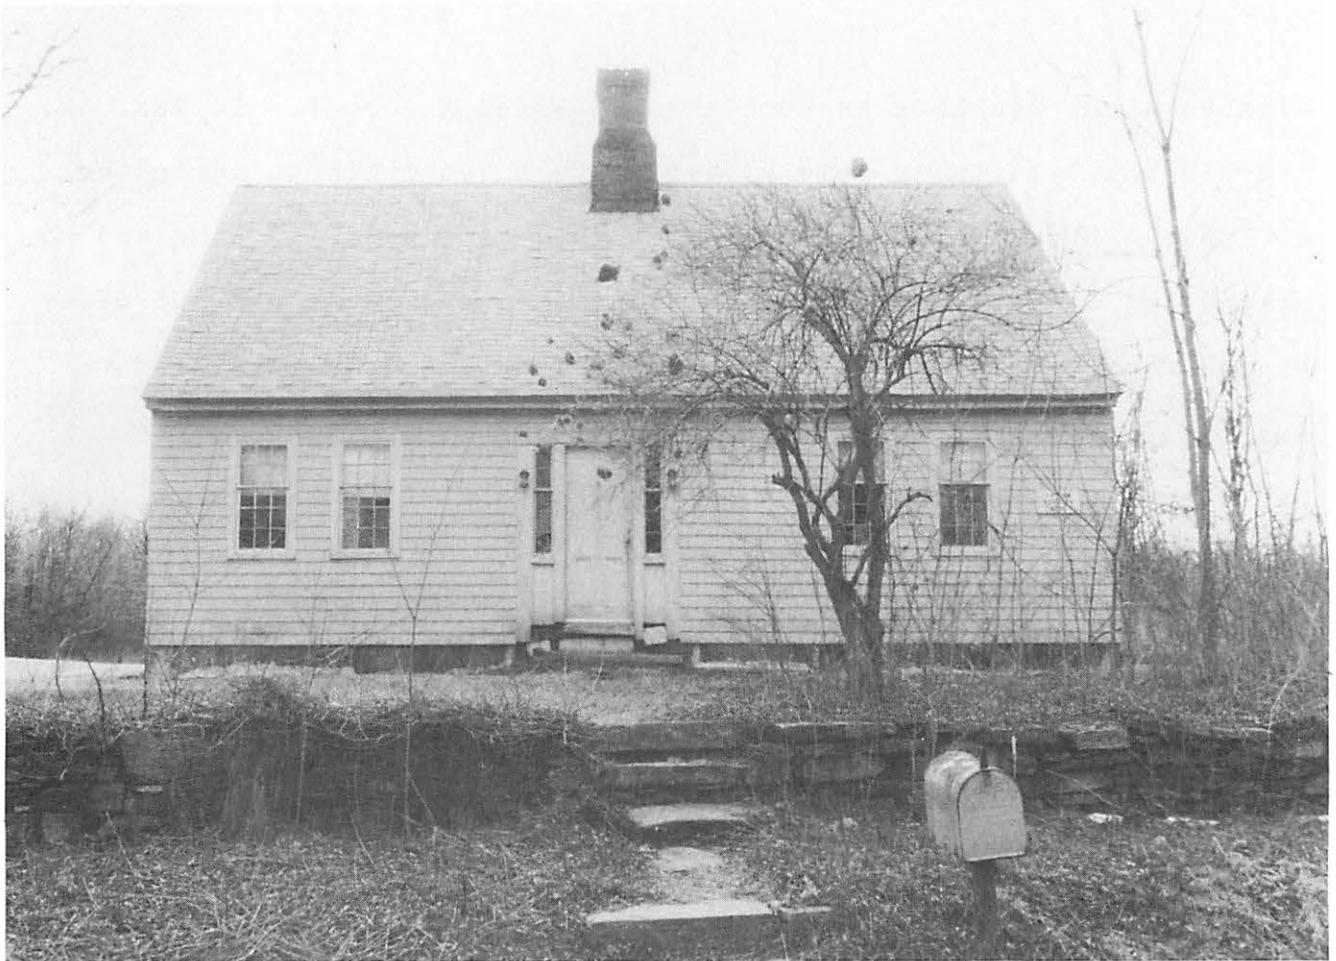
The Latham Forseth House built in 1764 at Salem, Connecticut, which shows the unmistakable central chimney and the rather obvious lack of concern over absolute symmetry.

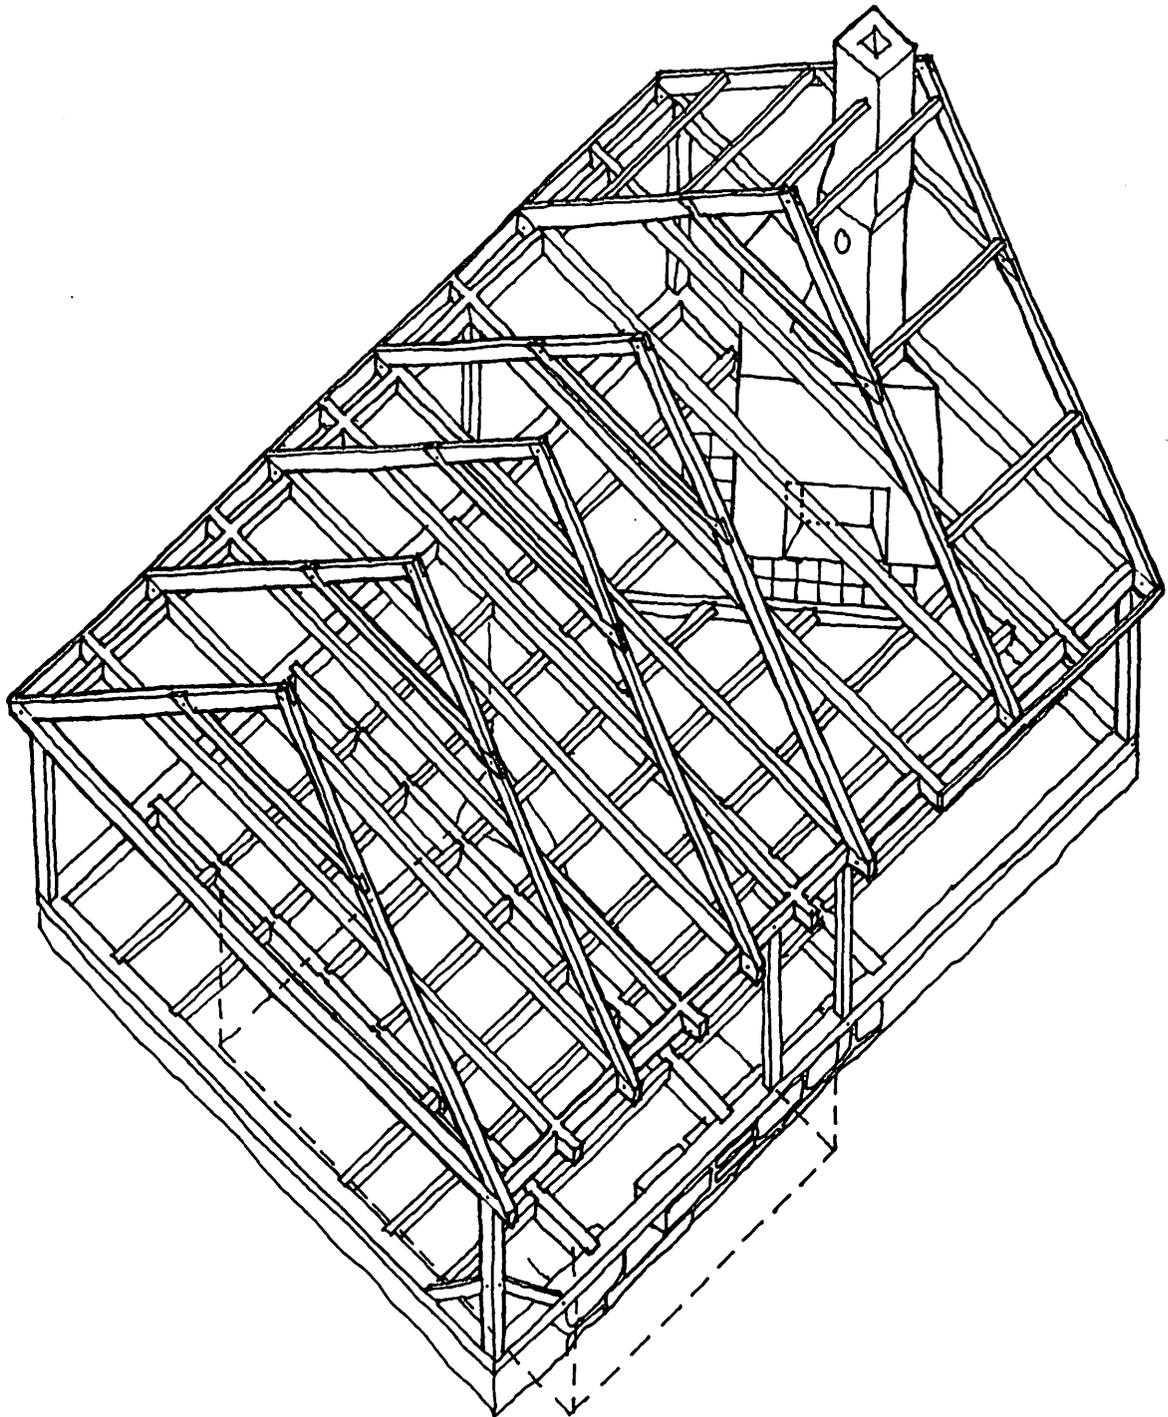
The frame of the Simeon Perkins House.

Note the small number of vertical posts, the relatively few number of rafters and the use of purlins between the rafters. No evidence of a summer beam has been found but there has been no attempt at destructive investigation to make sure, so it cannot be entirely eliminated. The small cellar provides support in the centre, but when first built there were no walls under the sills except at the cellar.

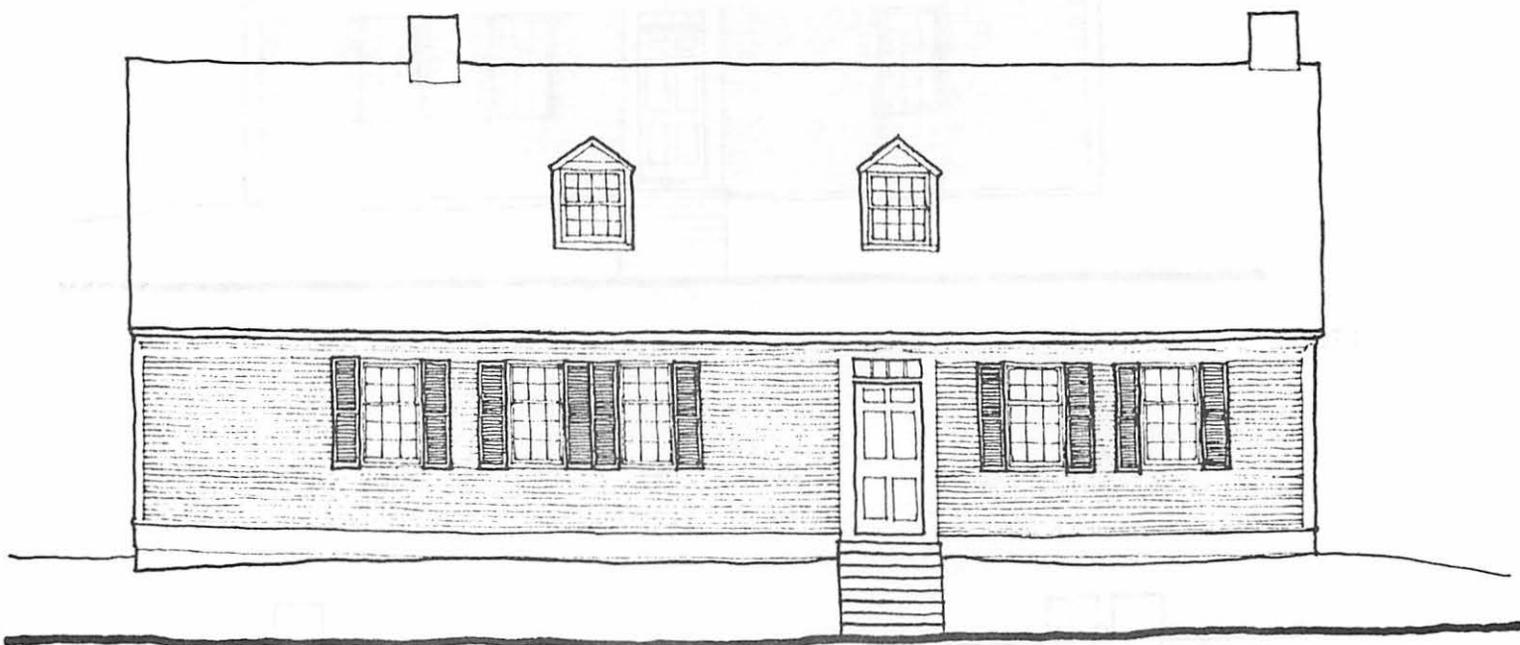
c) present

North elevation

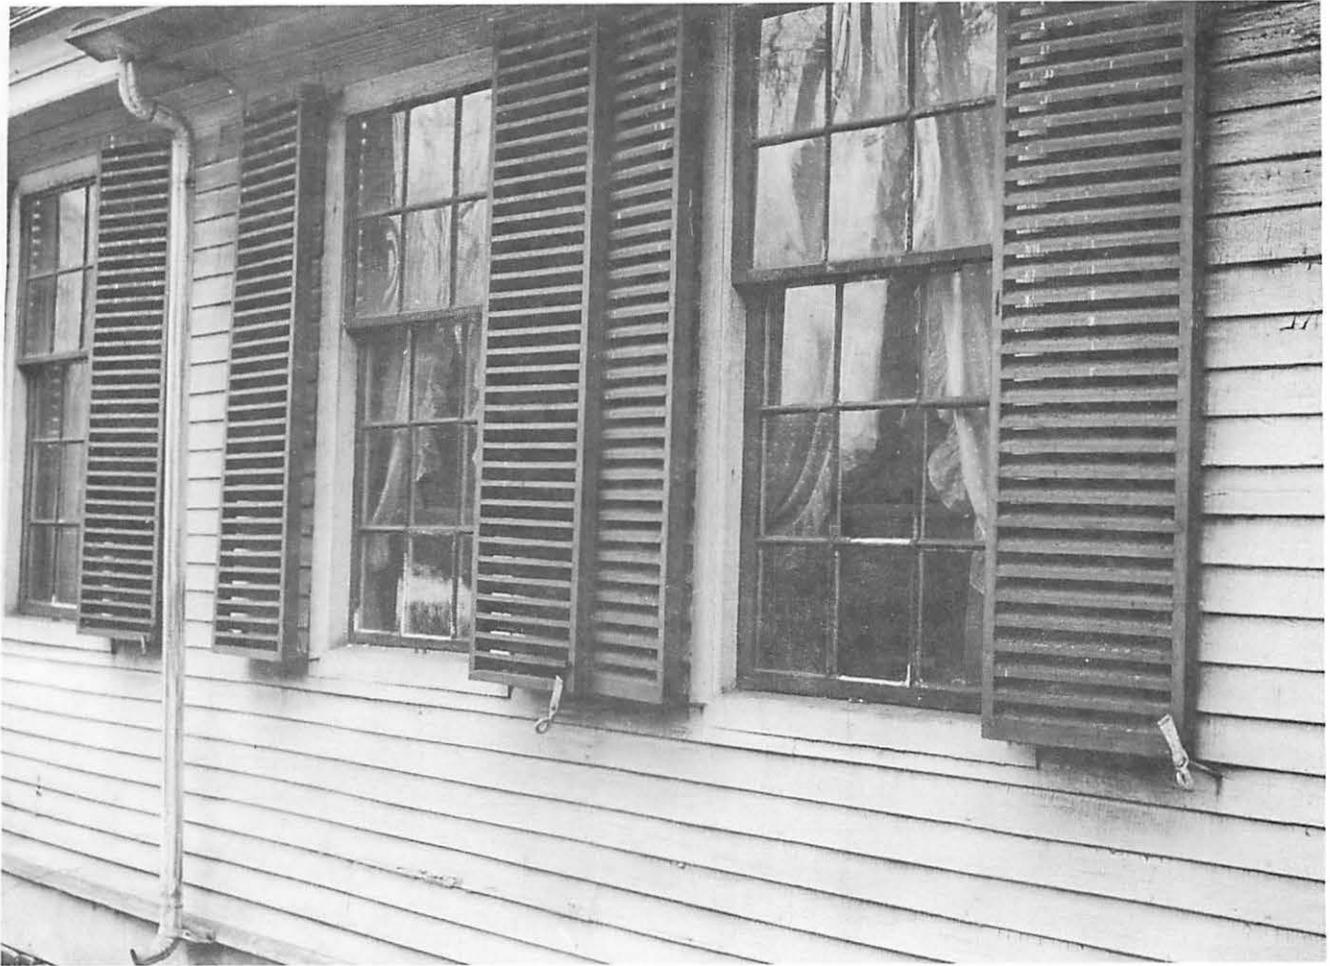
Part of the North front photographed in 1947, which clearly shows the sag at the left hand end due to the rotting of the timber sills. The original house ended at about the position of the Rainwater pipe as can be seen in the change in the roof shingles, The right hand shutters have been installed upside-down.

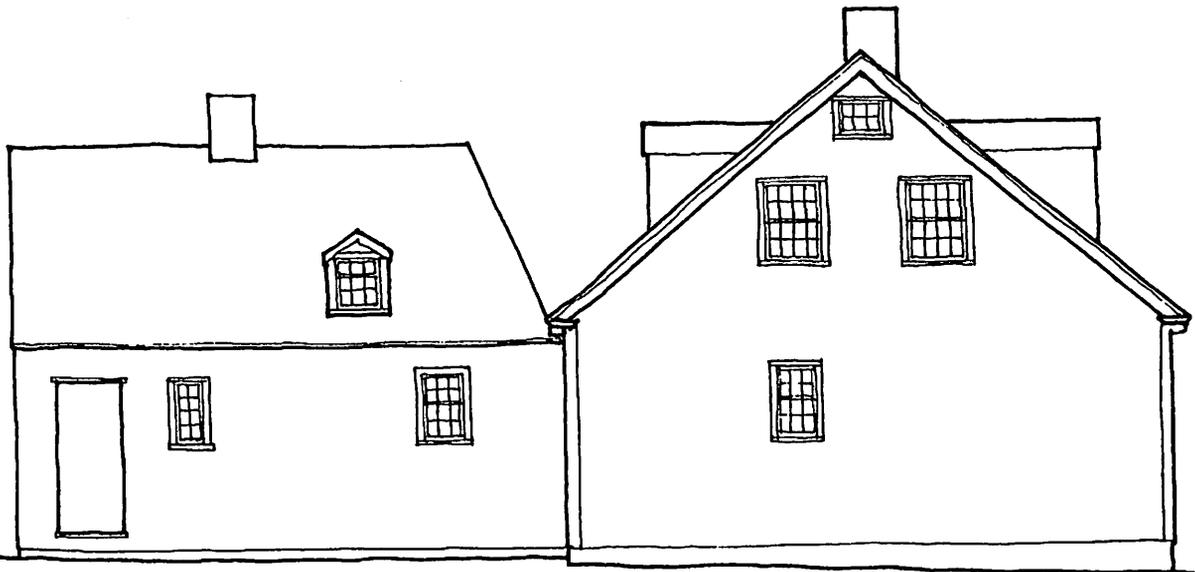
The East Elevation of 1792 clearly defines the addition of the kitchen. By holding the roof of the addition back from the original roof, the south-facing dormer could be maintained.

continued to meet the main roof it would have conflicted with a dormer window in the south slope of the main roof.<sup>68</sup> In order to keep the dormer window the roof was held back, given a steep hipped end and a valley gutter was formed. (see p 245 cross section) This was out of character with the rest of the building and seems curiously inept, as it caused snow and rain to accumulate with the potential for water to penetrate into the house below. (p 248)

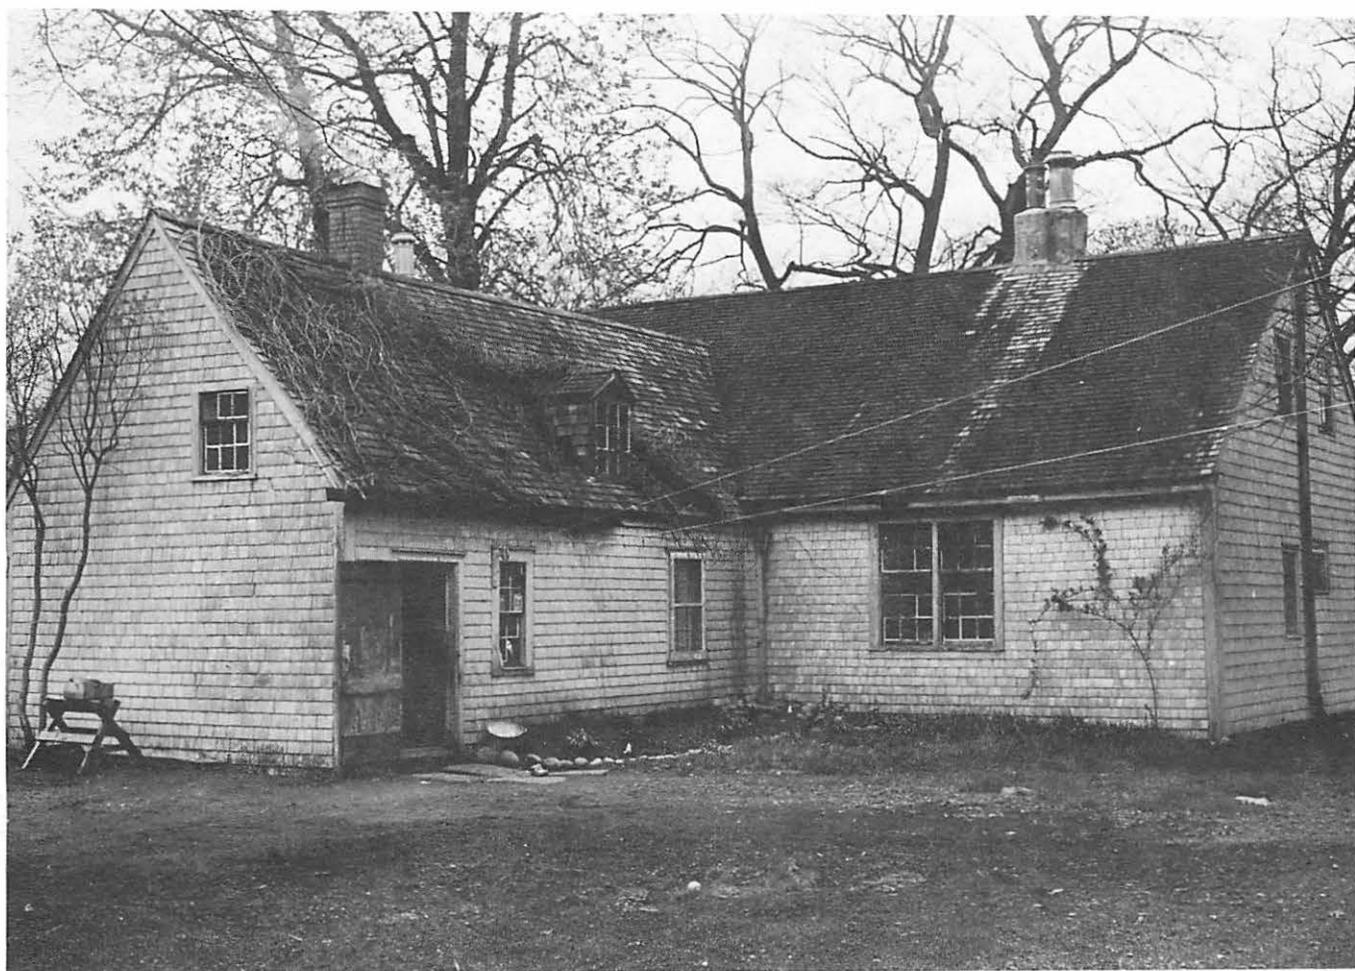
View from the southeast. This photograph was taken in 1947 before any repairs were carried out by the Province, but shows the state of the roof where it was repaired in 1935. Note the lack of window putty and paint. At the right-hand end can be seen the vent pipe from the plumbing installed this century. Victorian chimney pots and a stove chimney can be seen. The banked up soil and creeper on the roof provide clues to causes of rot.

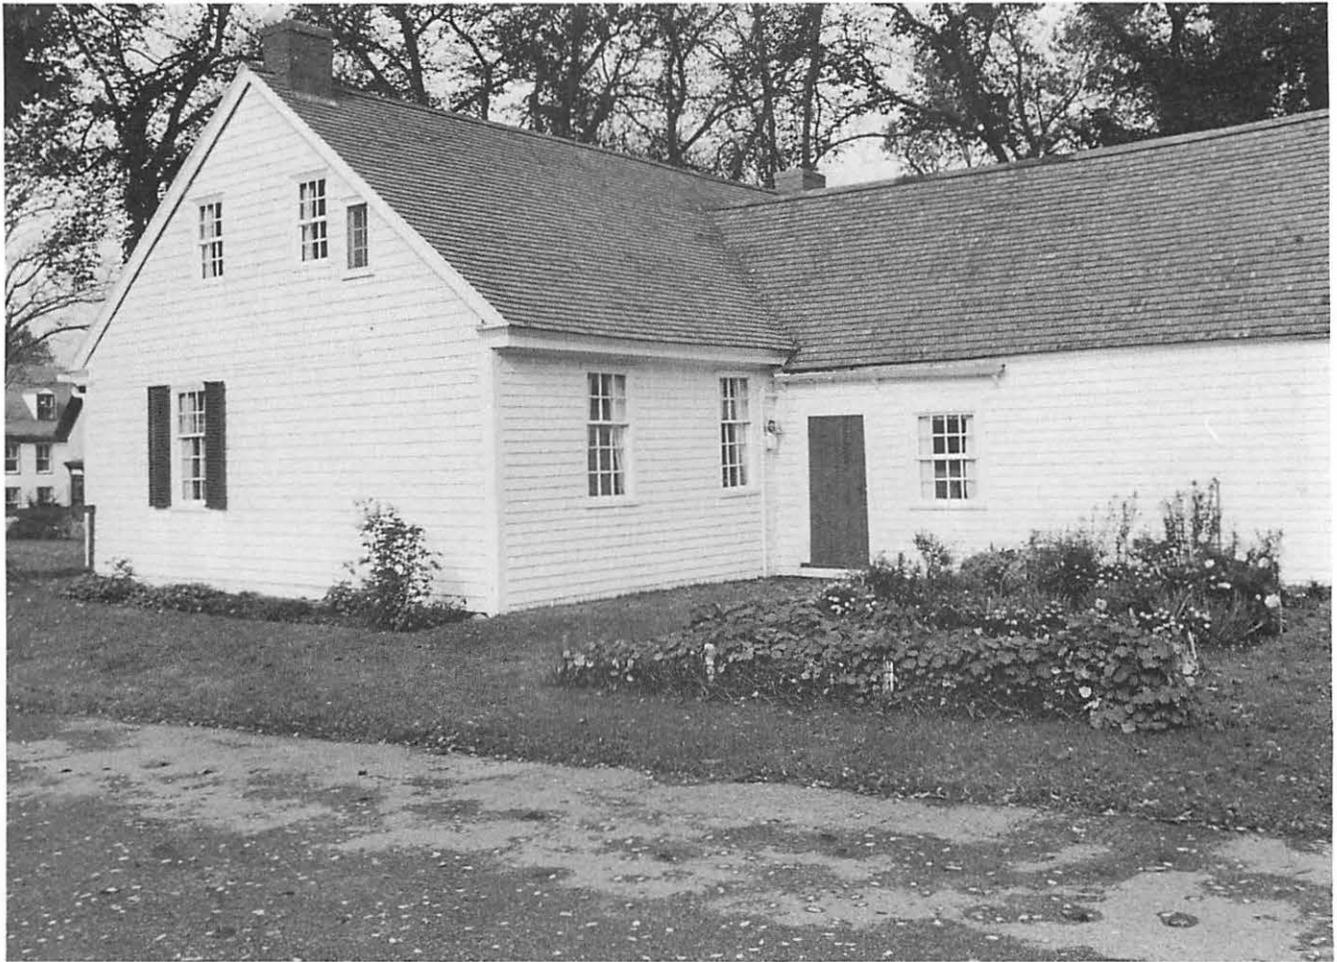
View from the south west showing the roof gap filled in, perhaps in about 1840.

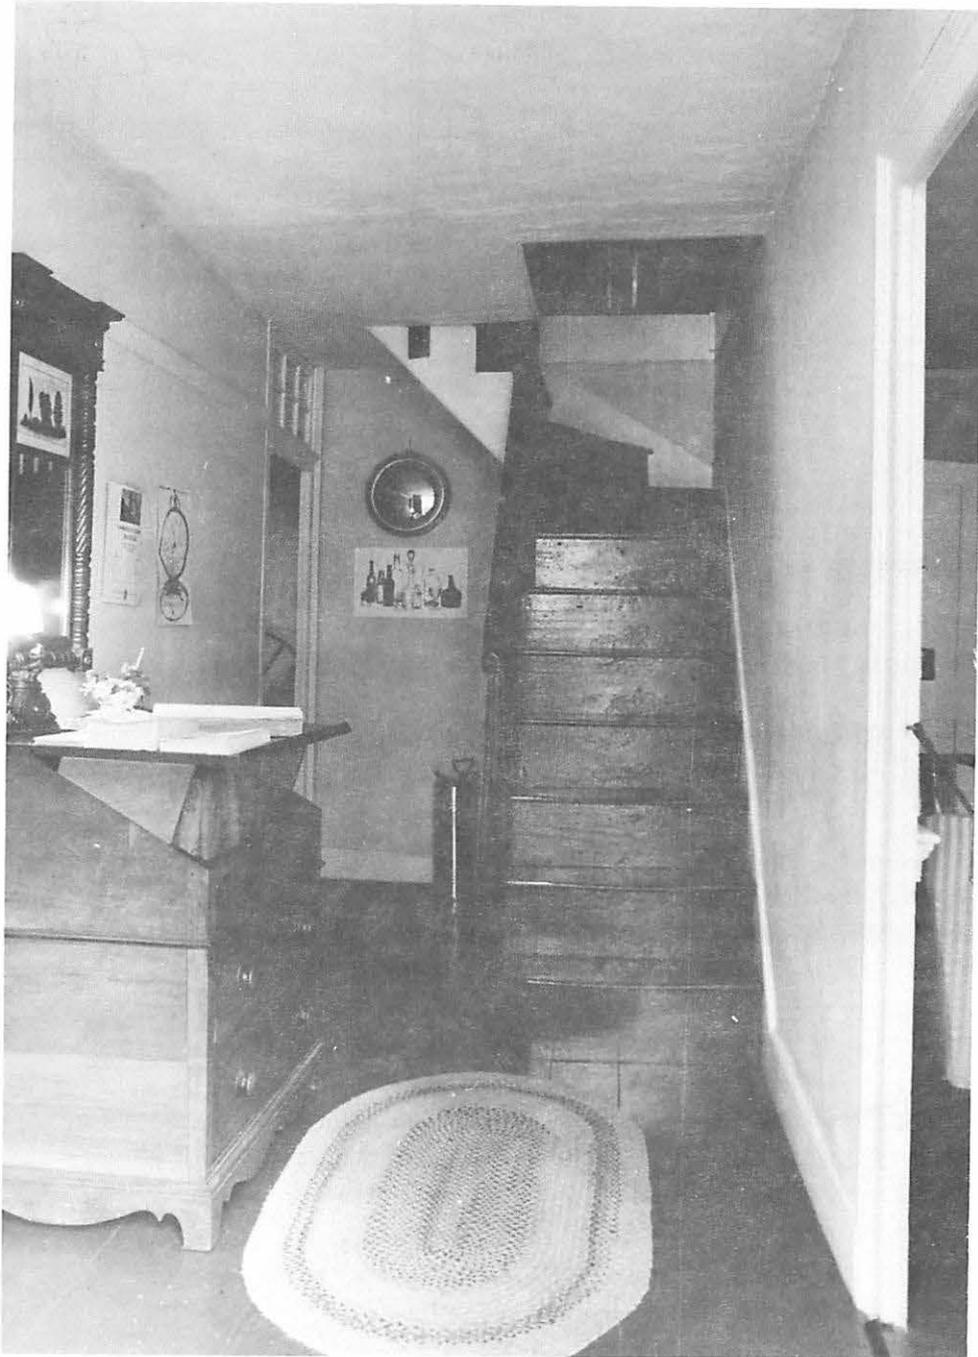
The main stair and basement stair locations. It would appear that the existing staircase is the fourth main stair. The first, built 1766-7, was either replaced or remodelled in 1787, and was itself replaced in about 1840 by the rear stair, which in turn was replaced by a new front stair in 1949.

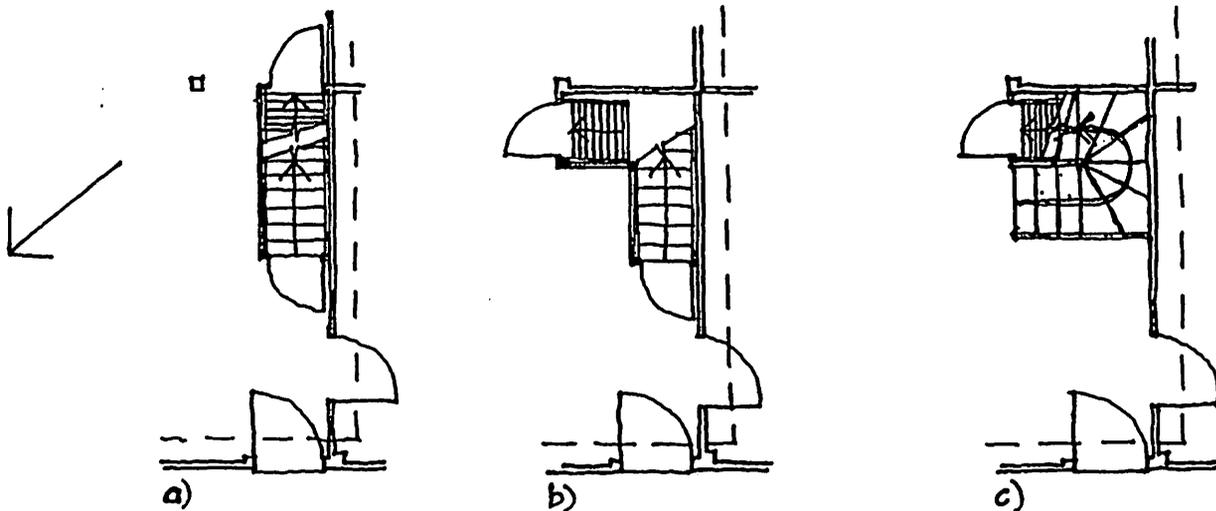
The Entry.

d) 1949.  
Although we know that the stairs were built in 1787 when the Entry was altered, we know nothing of what it looked like. The stairs were removed in about 1840 and were replaced in 1949.
