Curatorial Report Number 60

# The Simeon Perkins House: an Architectural Interpretation 1767-1987

By Allen Penney  
February 1987

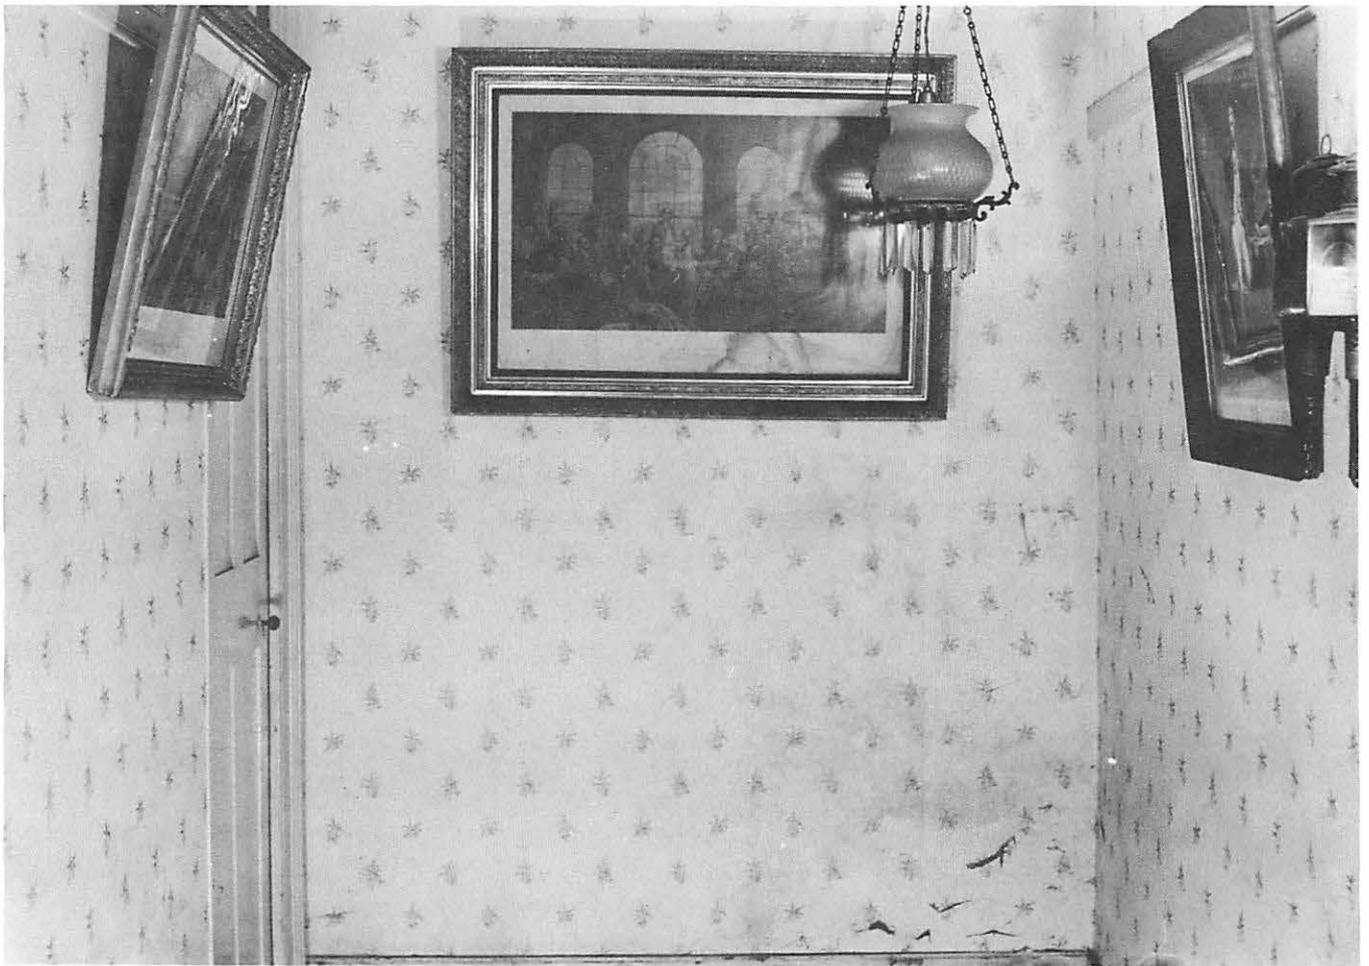
The Entry in 1947. The space to the right is now occupied by the stair rebuilt in 1949.

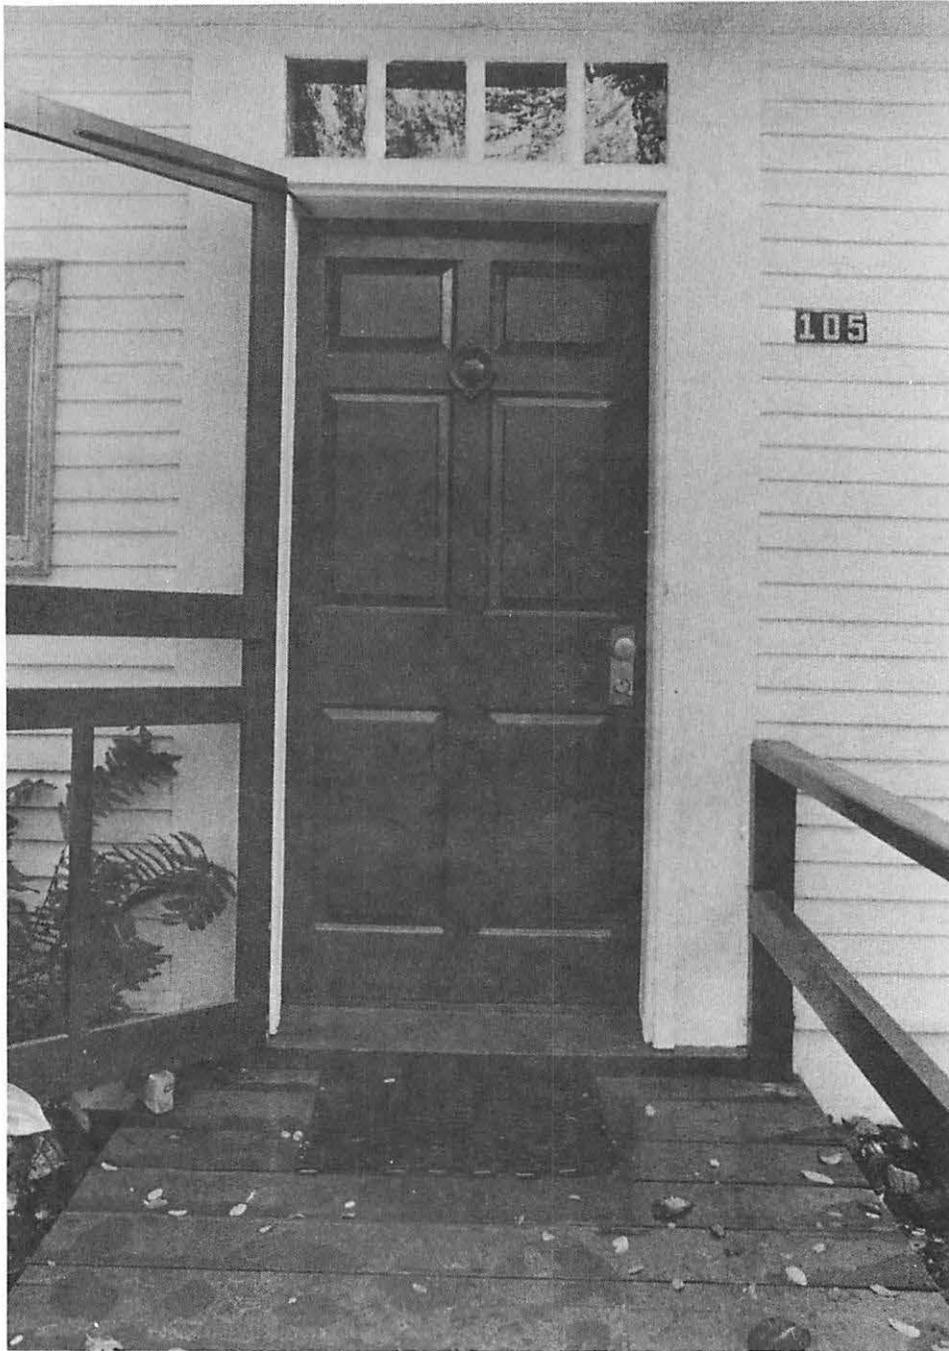
The Entrance Door in 1978. The door itself is solid and may be original though the handle and lock are modern.

The front door is quite fine with six raised panels and delicate mouldings to the frame. The door may be original and date from 1767, but is most probably later, though still from the eighteenth century. It has modern door furniture, and holes can clearly be seen from previous hardware. It is mounted on rising butt hinges, which must have been added at a later date. The main argument against the door being original is that hinge marks in the post supporting the front door do not match up with marks on the door itself and therefore suggest that the present door is a replacement dating from as early as 1787, but possibly even later.<sup>8</sup> (See p 162 )

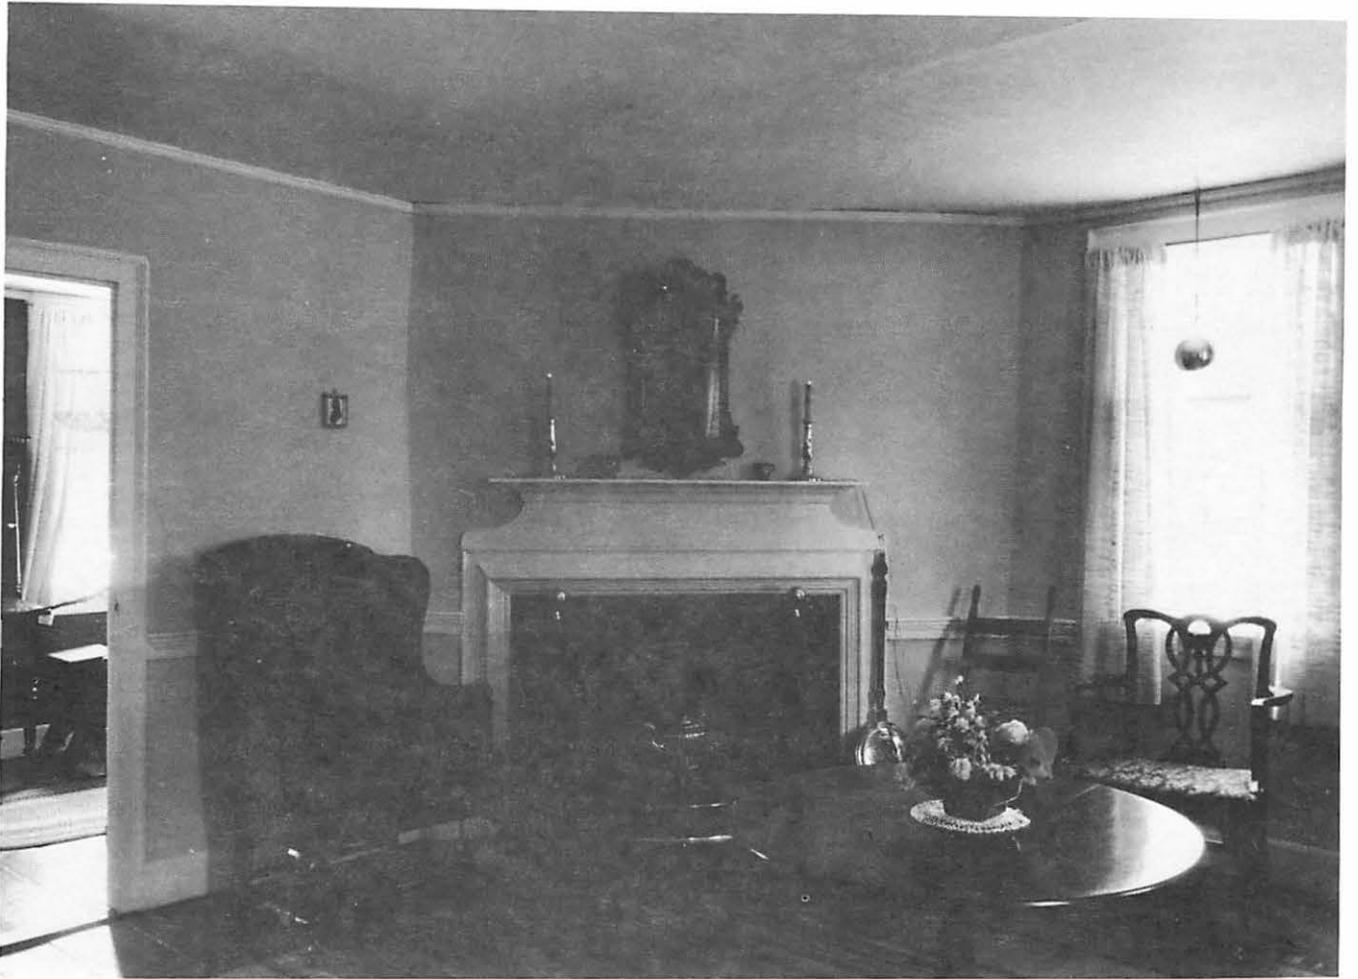
Parlour looking southwest. The mantel shelf was added but the fireplace surround appears to be authentic to 1767.

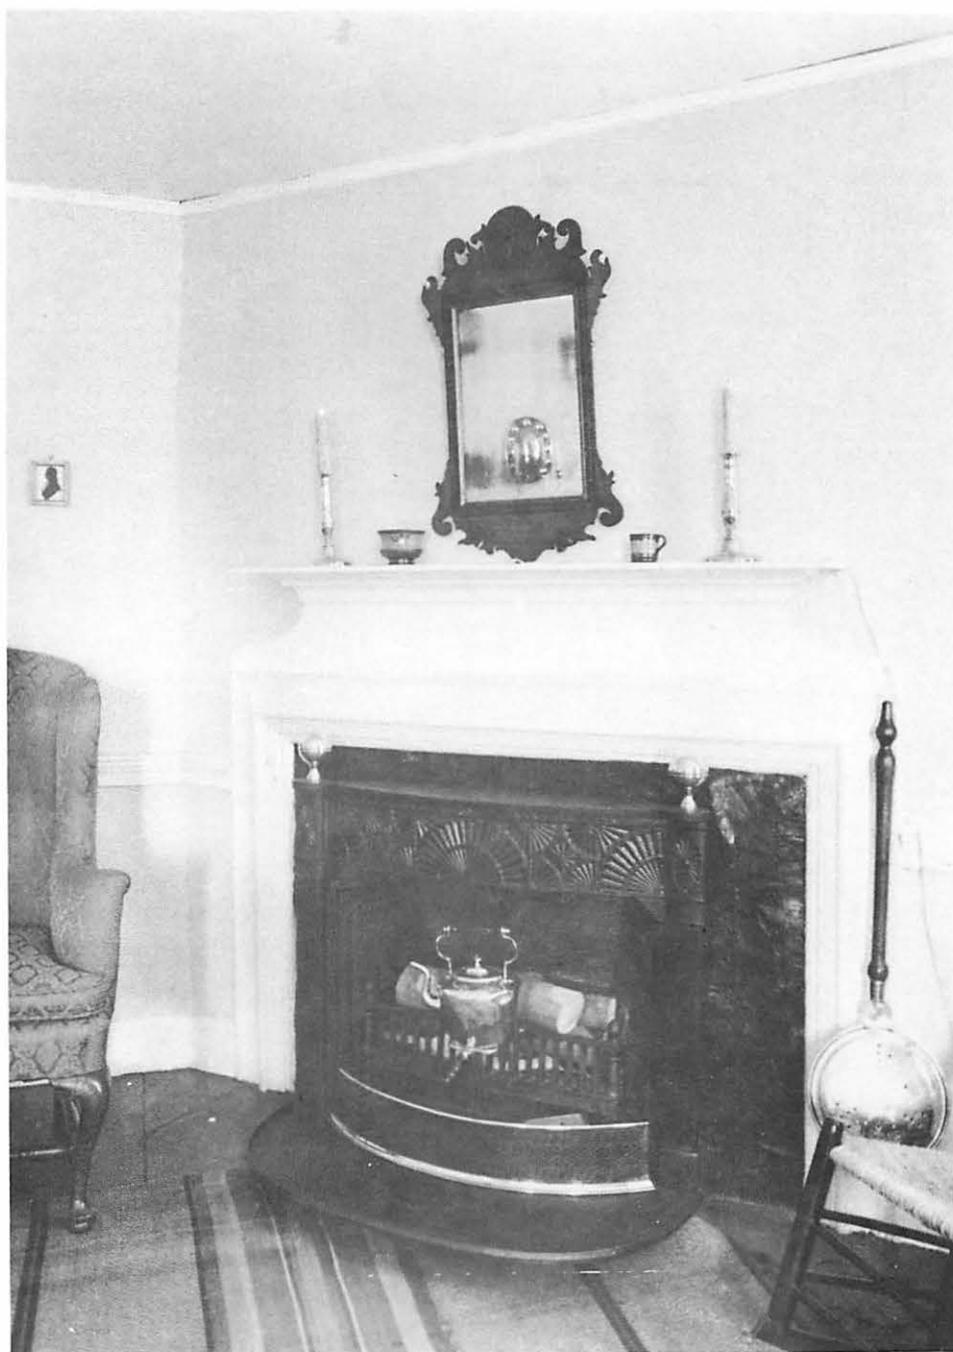
The Parlour fireplace with its original surround and later mantel shelf. The cast iron stove was manufactured by Thompson, Thompson and Clusman in New York. The mirror is Chippendale style.

The fireplace was originally open, and in 1805 caught fire but did no damage.<sup>17</sup> Also in 1805 "we have stove set by Keezer in the small Parlour."<sup>18</sup> The stove manufactured by the Fulton Iron Foundry of New York,<sup>19</sup> and presumably original, added to safety and comfort just in time for Christmas. Above the original fireplace surround was later added a mantelshelf.<sup>20</sup> From behind it, the author was able to retrieve a piece of early wallpaper coated with an olive green paint.<sup>21</sup> This could originally have been blue which has deteriorated with age.<sup>22</sup>

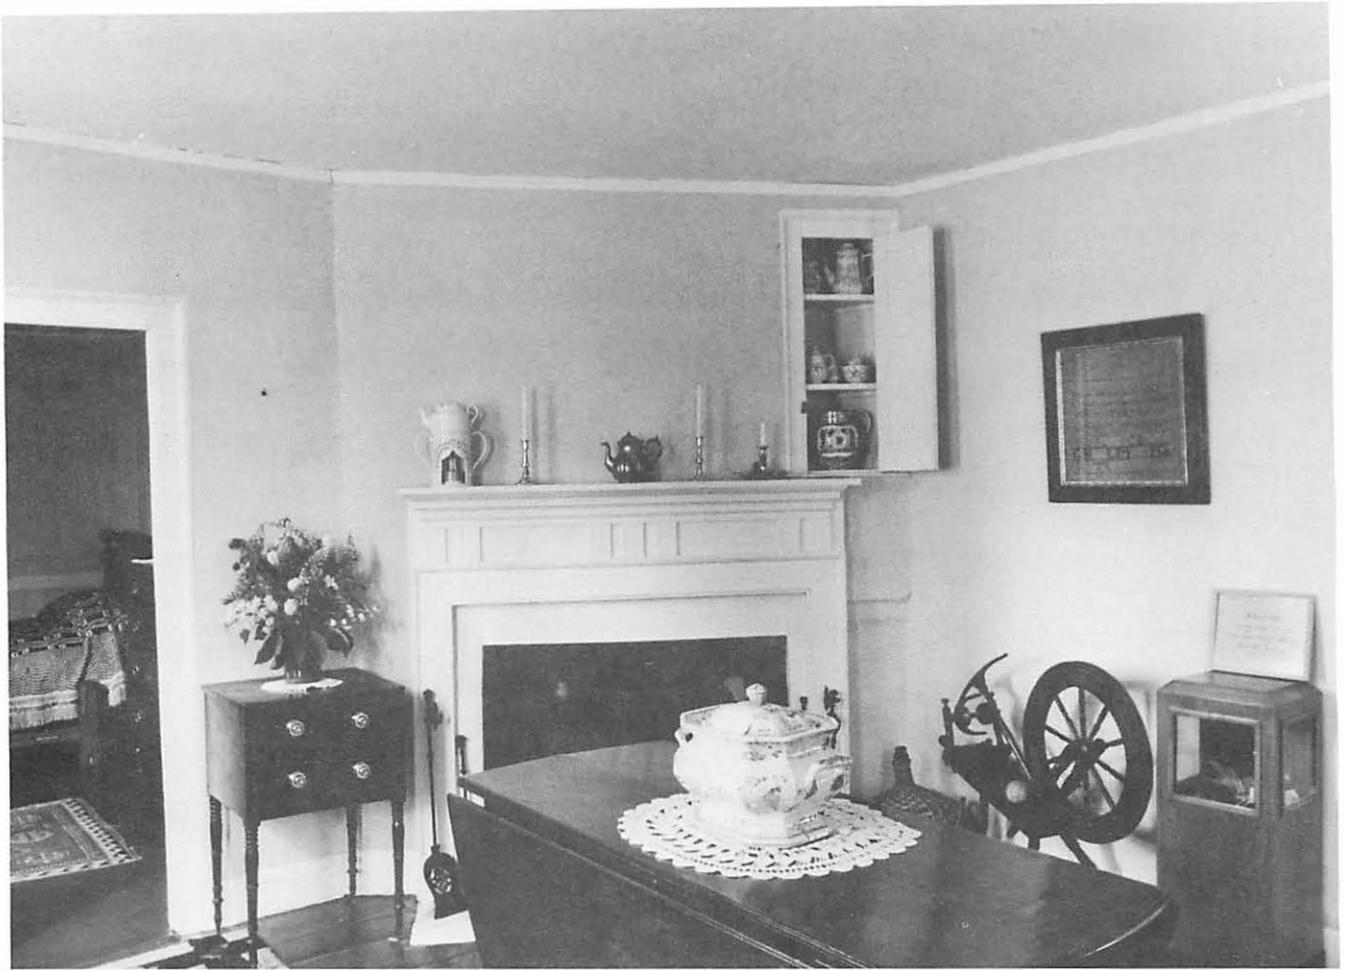
The Keeping Room looking southeast. The fireplace, built in 1781, includes a cupboard over it in which the tinder box would be kept. As a major reception space, the keeping room contained a display of the family belongings. The chamber can be seen through the door on the left.

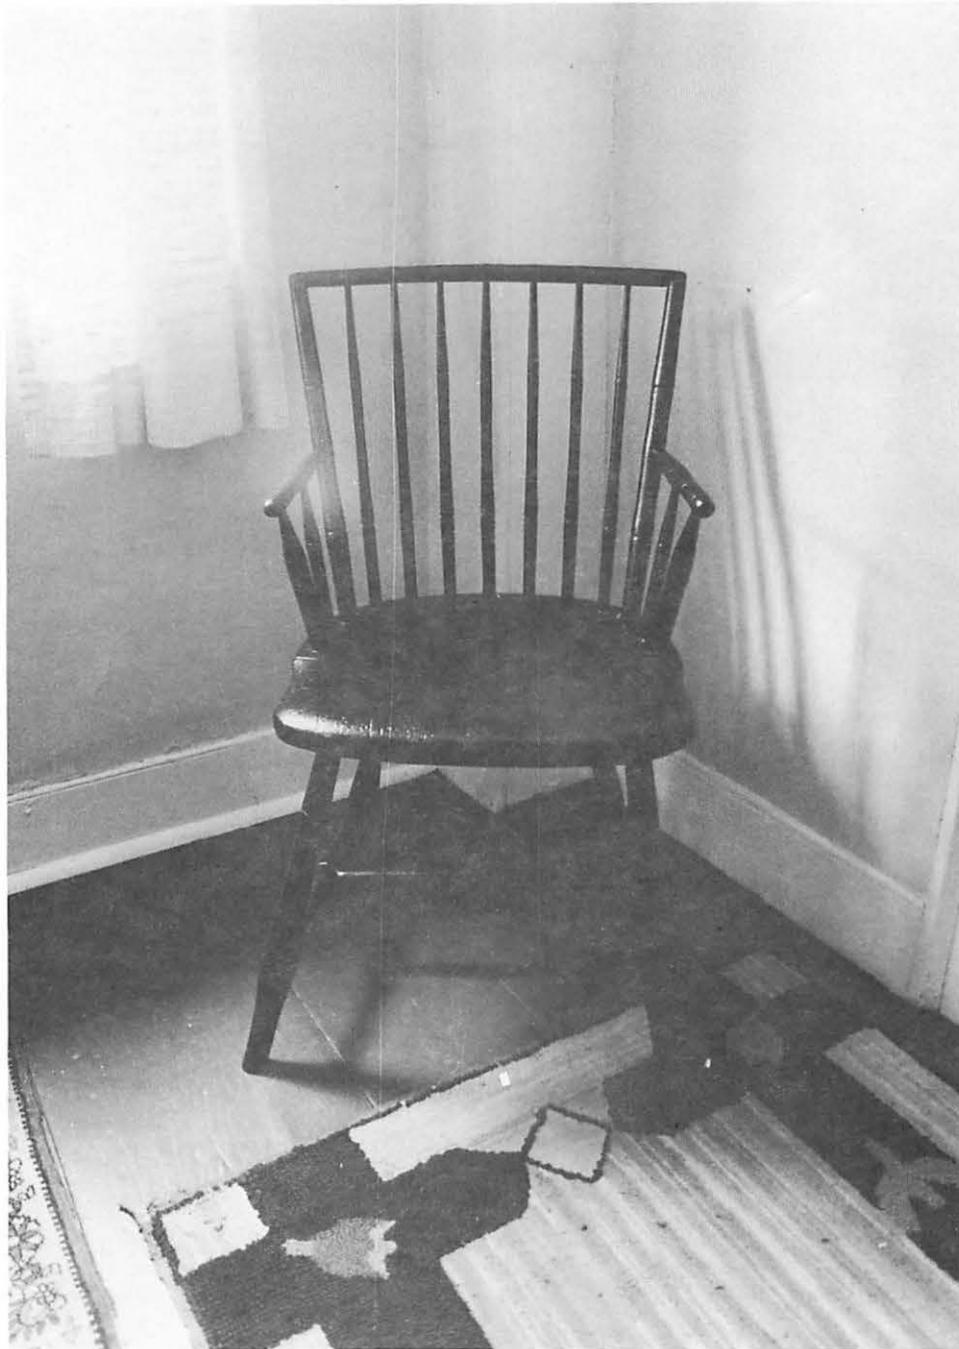
The Keeping Room. A Windsor chair.. Chairs in sets appear to have been numerous in houses of the time. They were easily moved and were often kept in sets both in reception rooms and bedrooms. From the diary it would seem that at least fifteen to twenty chairs would be required for the members of the Perkins household. Note filled mortices in corner post where diagonal braces were fitted prior to 1781.

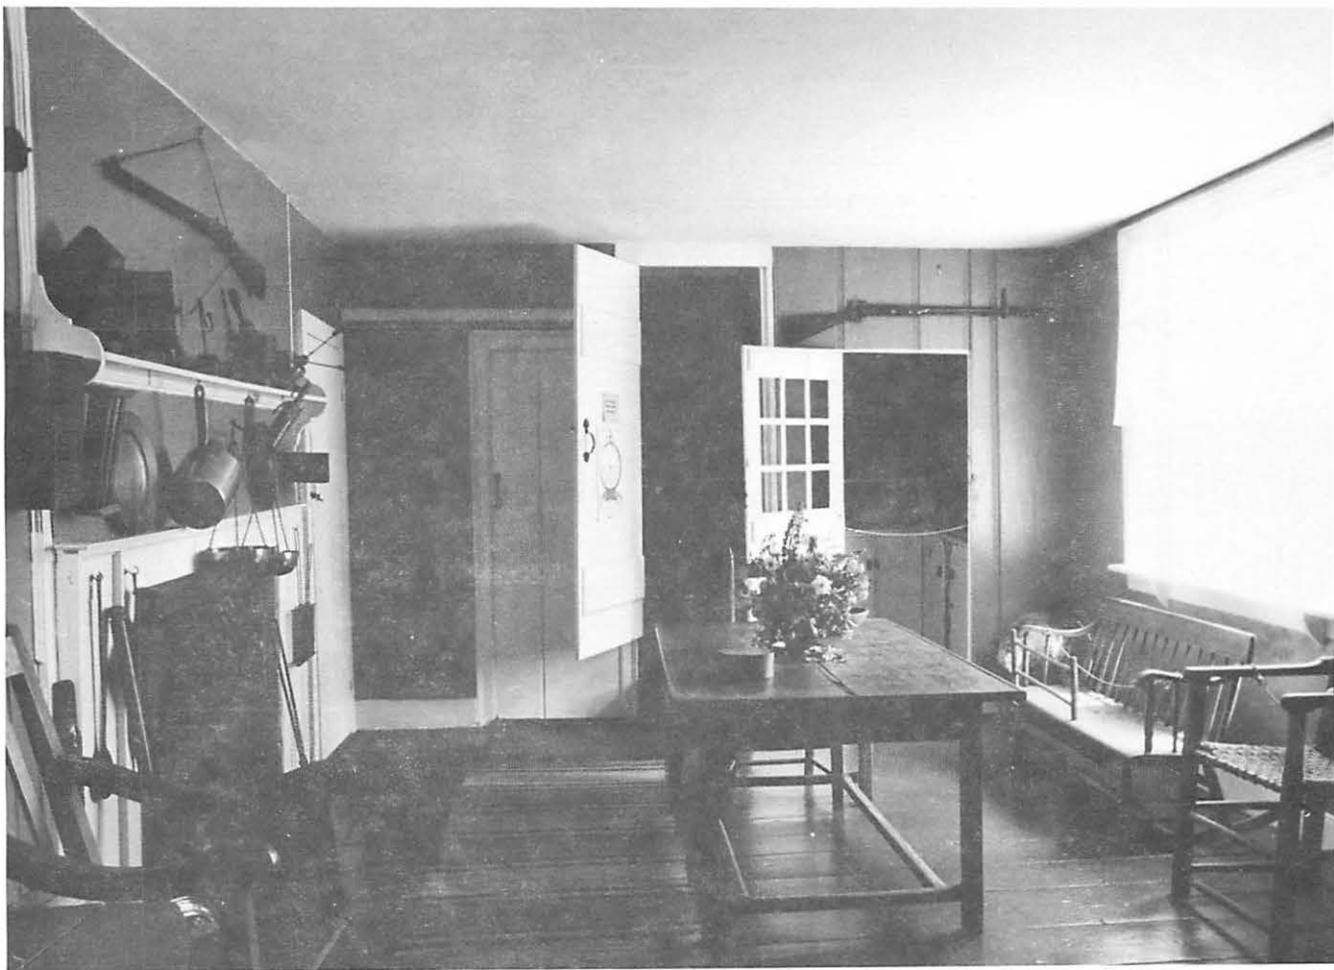
The Kitchen looking east. This end of the room was altered by the addition of the stair in 1782. As storage is integral with the stair, it would appear that the pantry was built at this time as well.

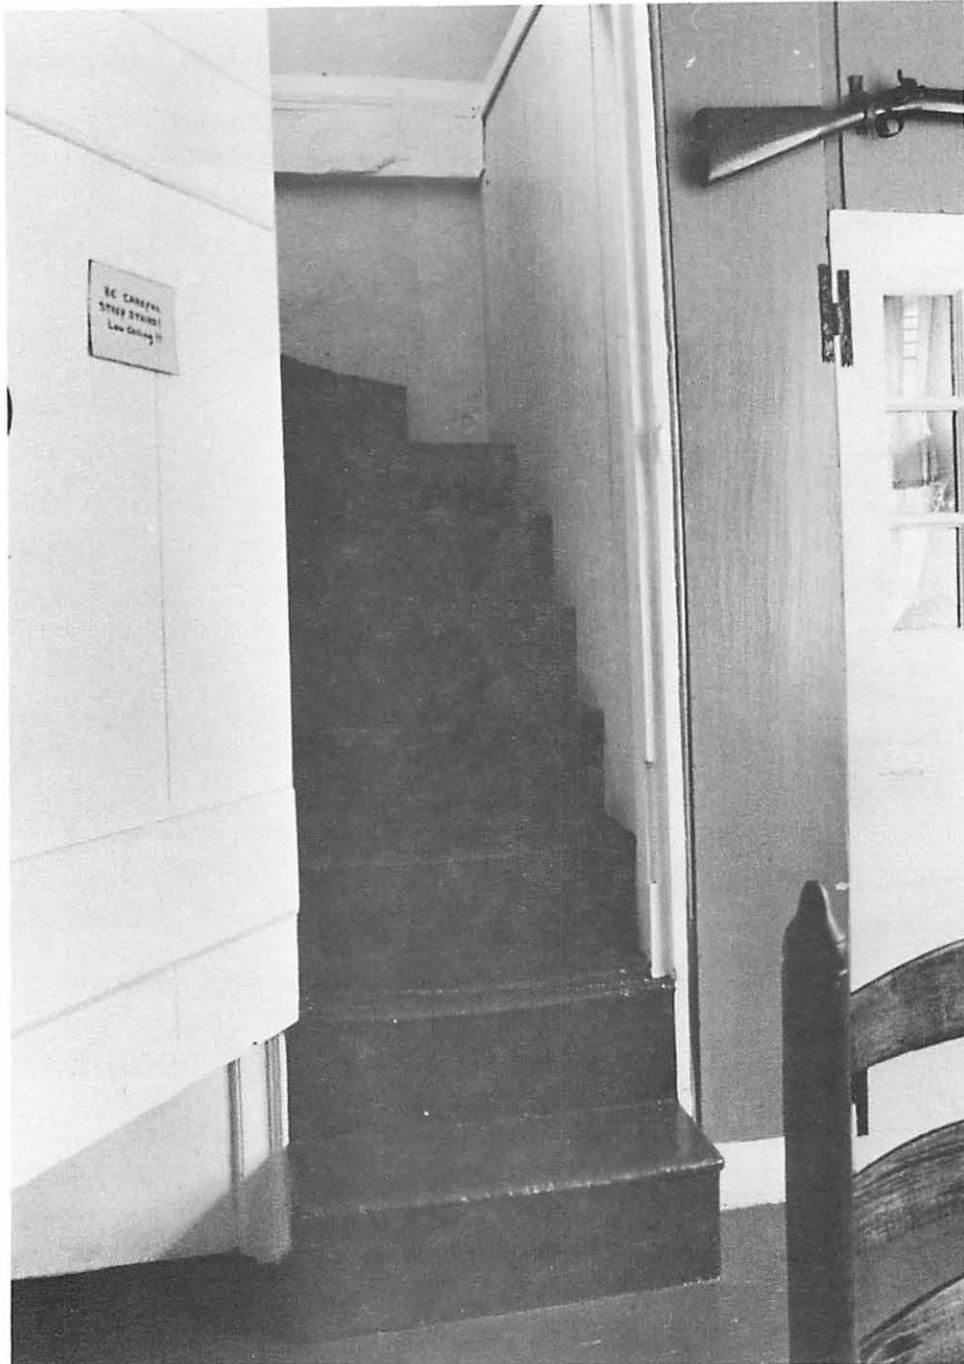
The Kitchen. A second staircase built by Mr. Bangs on 4 October 1782, a year after the kitchen had been built.

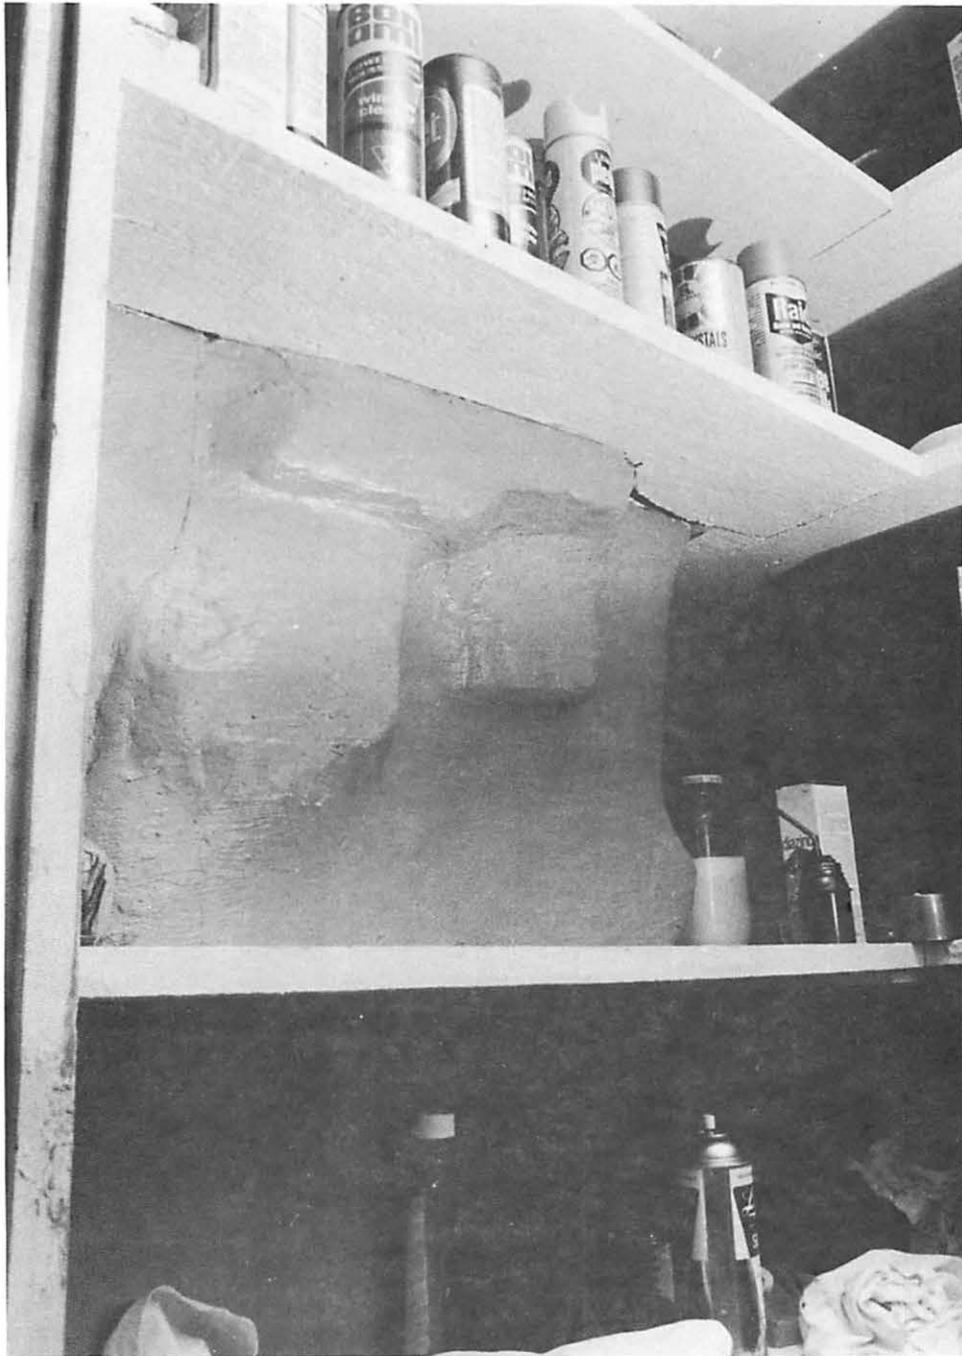
The Kitchen. In the closet to the right of the fireplace the remains of a brick oven can be seen. The oven was removed on April 28, 1800, to form this closet.

At some time prior to 1947 this second chimney must have been removed, for a brick chimney for a stove was located behind the wall, not in front of it, or alternatively the wall may have been moved, relative to the chimney. Because the 1781 brick oven was removed from the Back Parlour in 1800,<sup>12</sup> an alternate oven is likely to have been built in brick, until this was all replaced by a stove with integral oven.

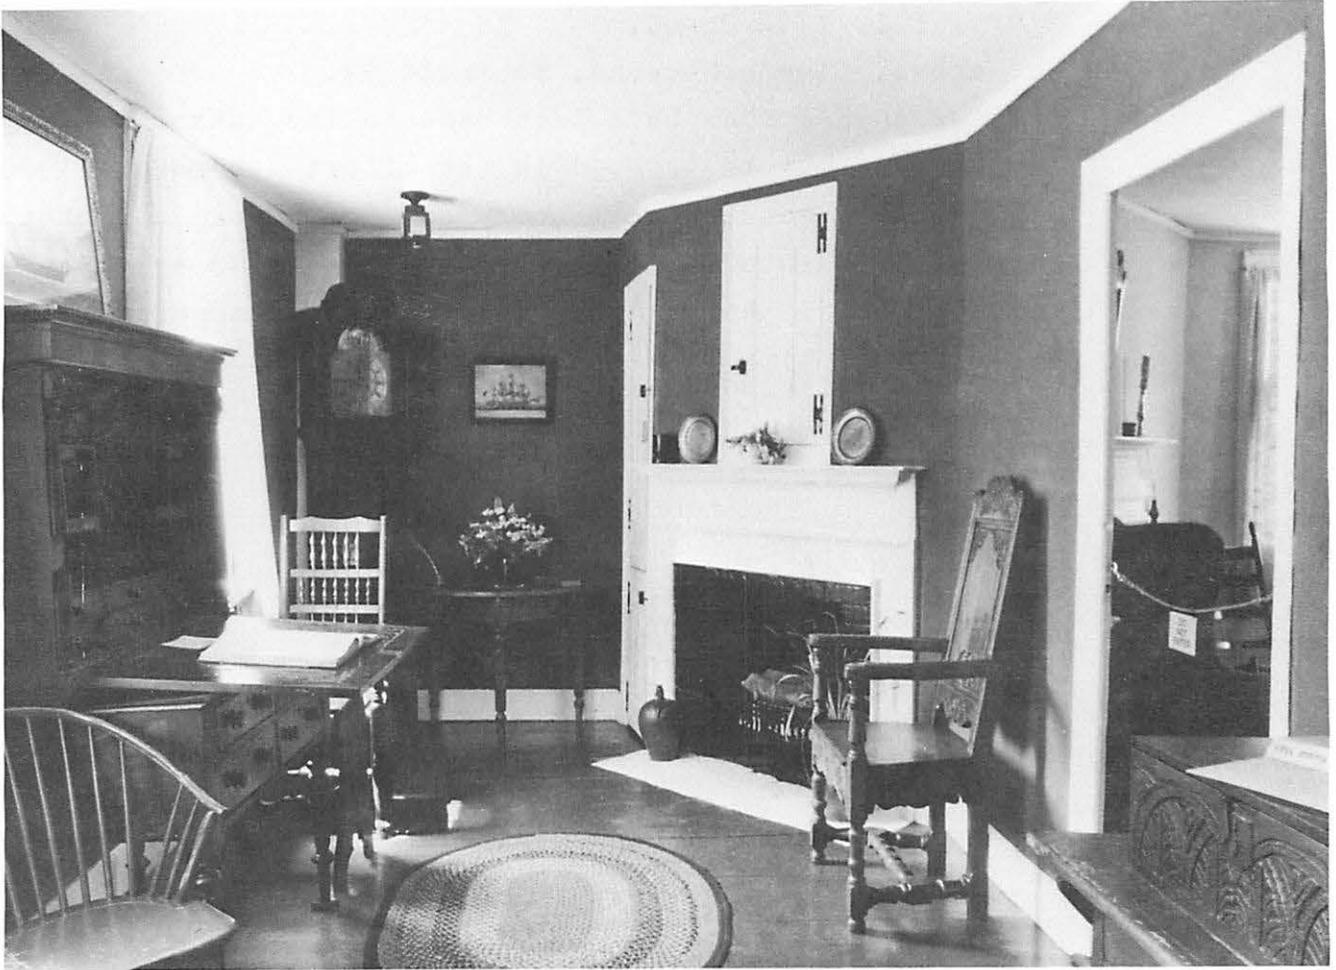
The Office, looking west. At the end of the left-hand wall, there are still visible signs of an external door which has since been blocked up. The Scottish clock, made in 1751, partially obscures the cornerpost. Both corner fireplaces seen in the photograph from the office and the parlour lead into a common flue, hence the small size of the chimney on the roof.

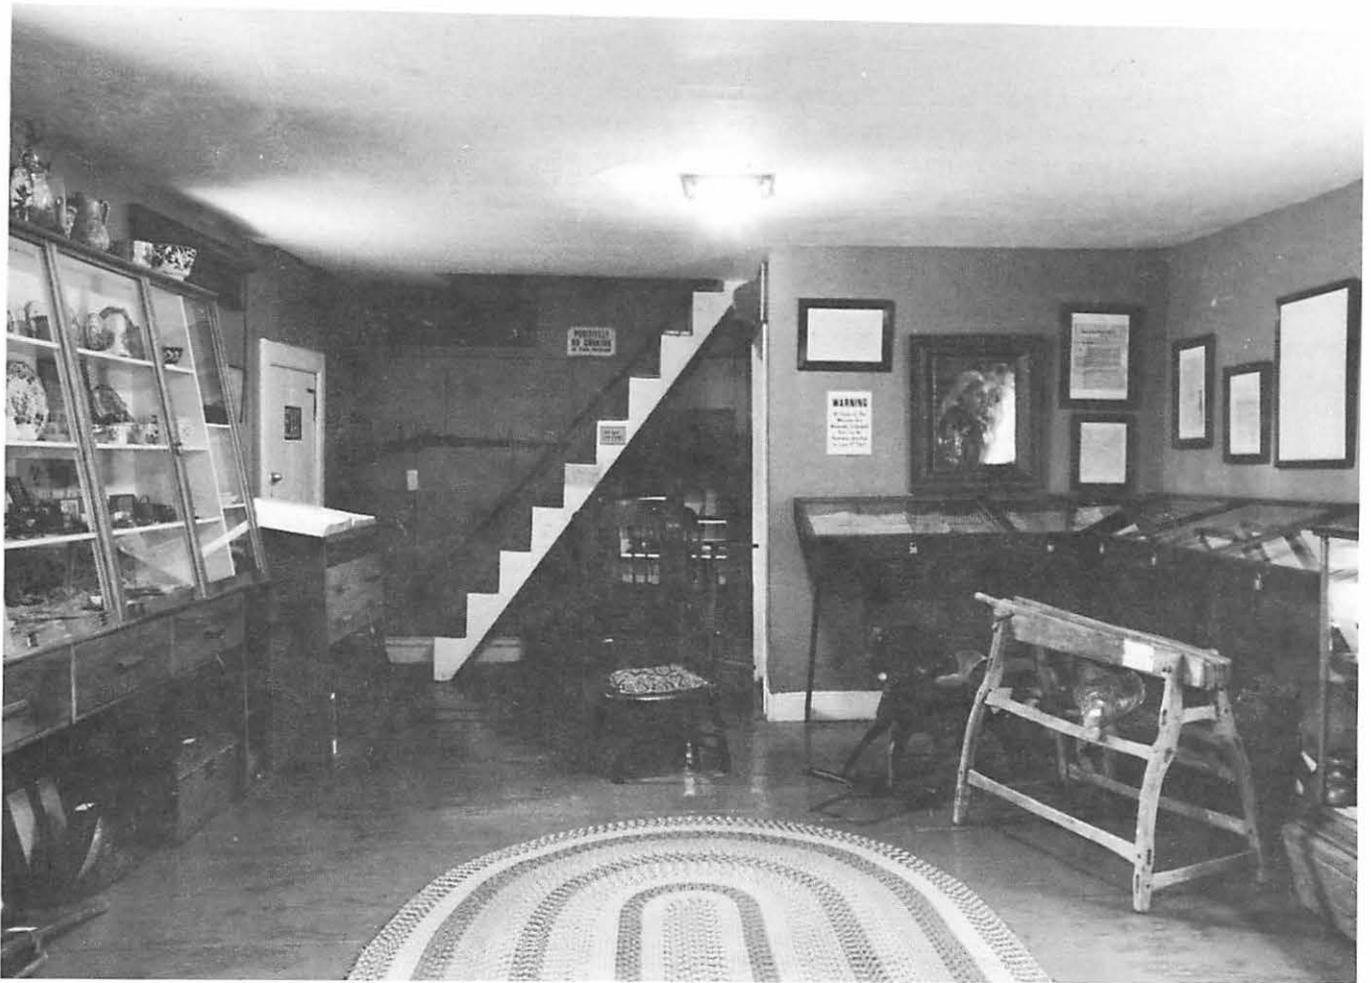
The Back Kitchen looking south. Note staircase to the attic space over the kitchen. In 1949, a washroom was installed to the right. An external door can be seen to the left.

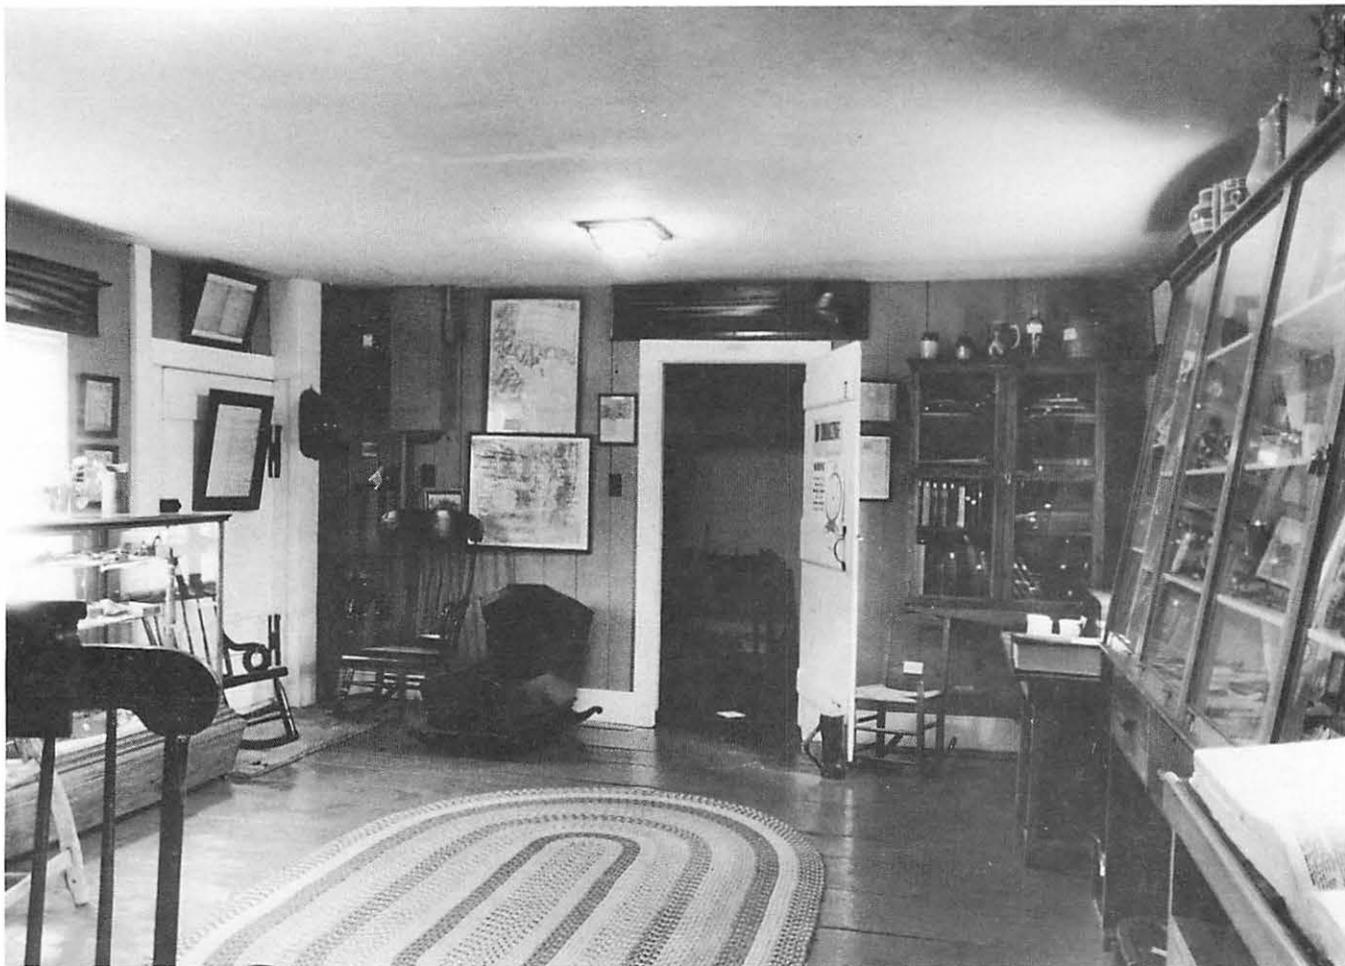
The Kitchen Addition looking north. The central door leading into the main house was installed during the 1949 alterations, replacing two separate doors. At the left is an external door and beneath the crib is a trap door giving access to the cellar.

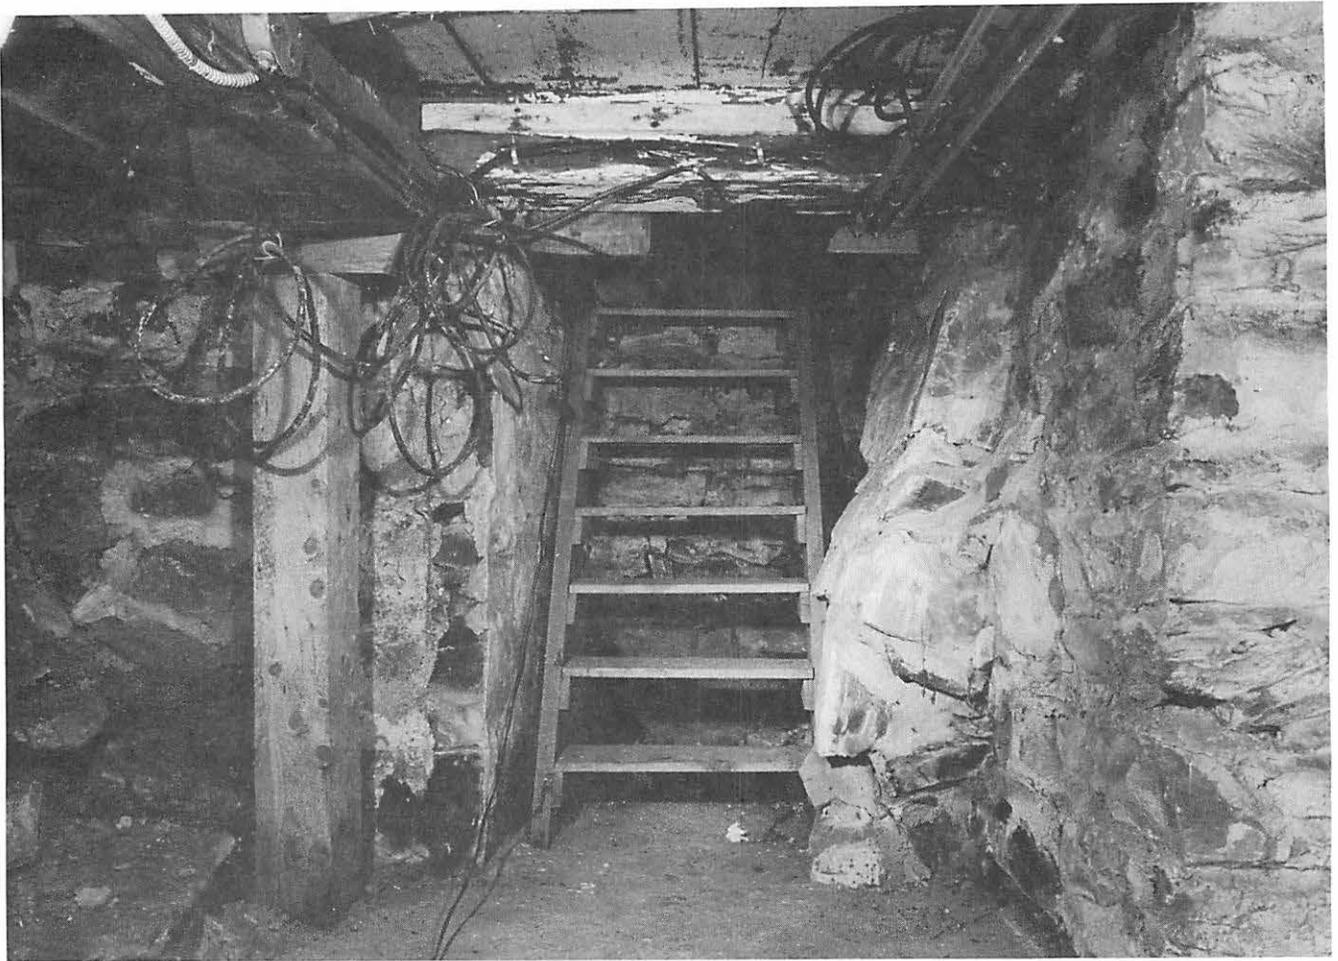
The Cellar looking south. To the right of the steps can be seen a bulging wall, which the author believes to have been the result of external pressure. The recess behind the steps is of early construction and most probably was the original external access, although the steps appear to date from 1949. Between the steps and the post, which also dates from 1949, can be seen the location of a door frame or partition. Typical electrical wiring of the 'out of sight, out of mind' sort can be potentially dangerous to the investigating architectural historian. The wiring was tidied up in 1982.

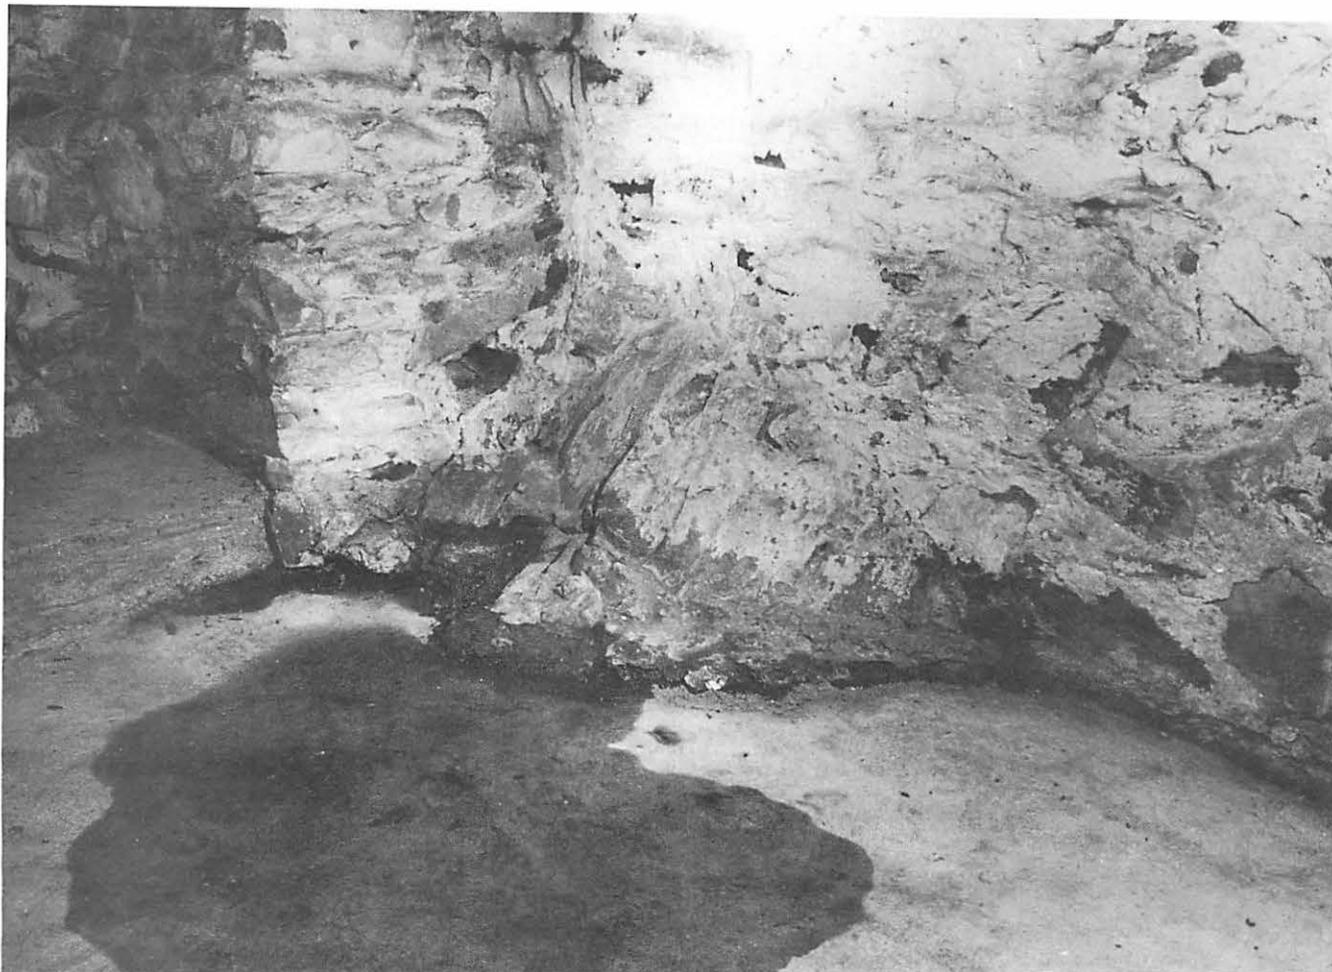
The Cellar. The stone outcrop seen in the southwest corner may be part of the reason for limiting the cellar size. A concrete floor was installed in 1949. Access is to the left.

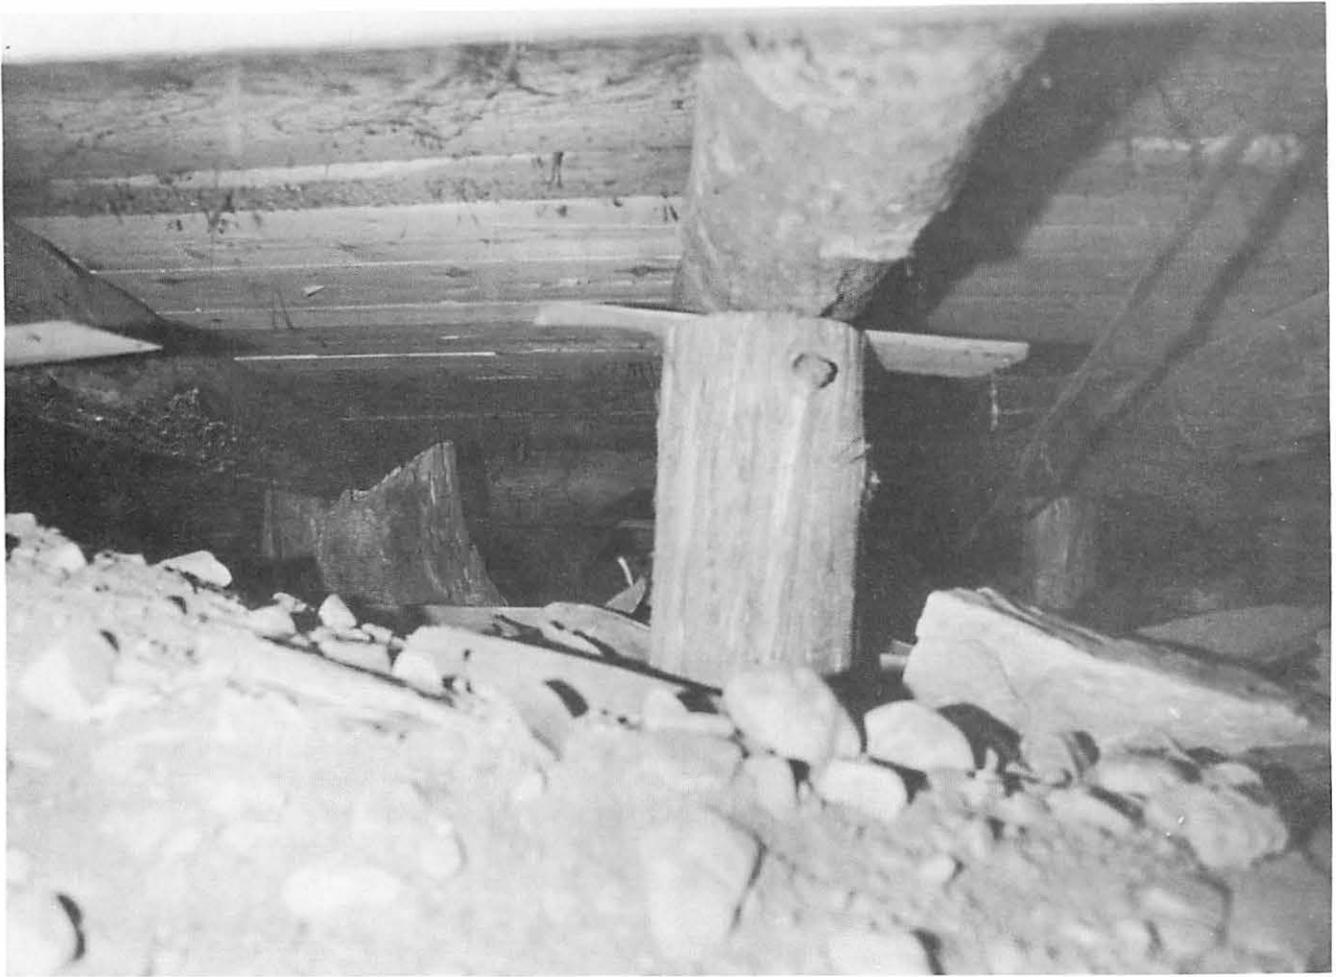
The Cellar looking west under the parlour floor. The new floor supports were installed in 1949. What appears to be a tree stump, left centre, may really be one! If so, it supports the theory that speed of construction was important, and no time or expense was wasted on grubbing out tree roots.

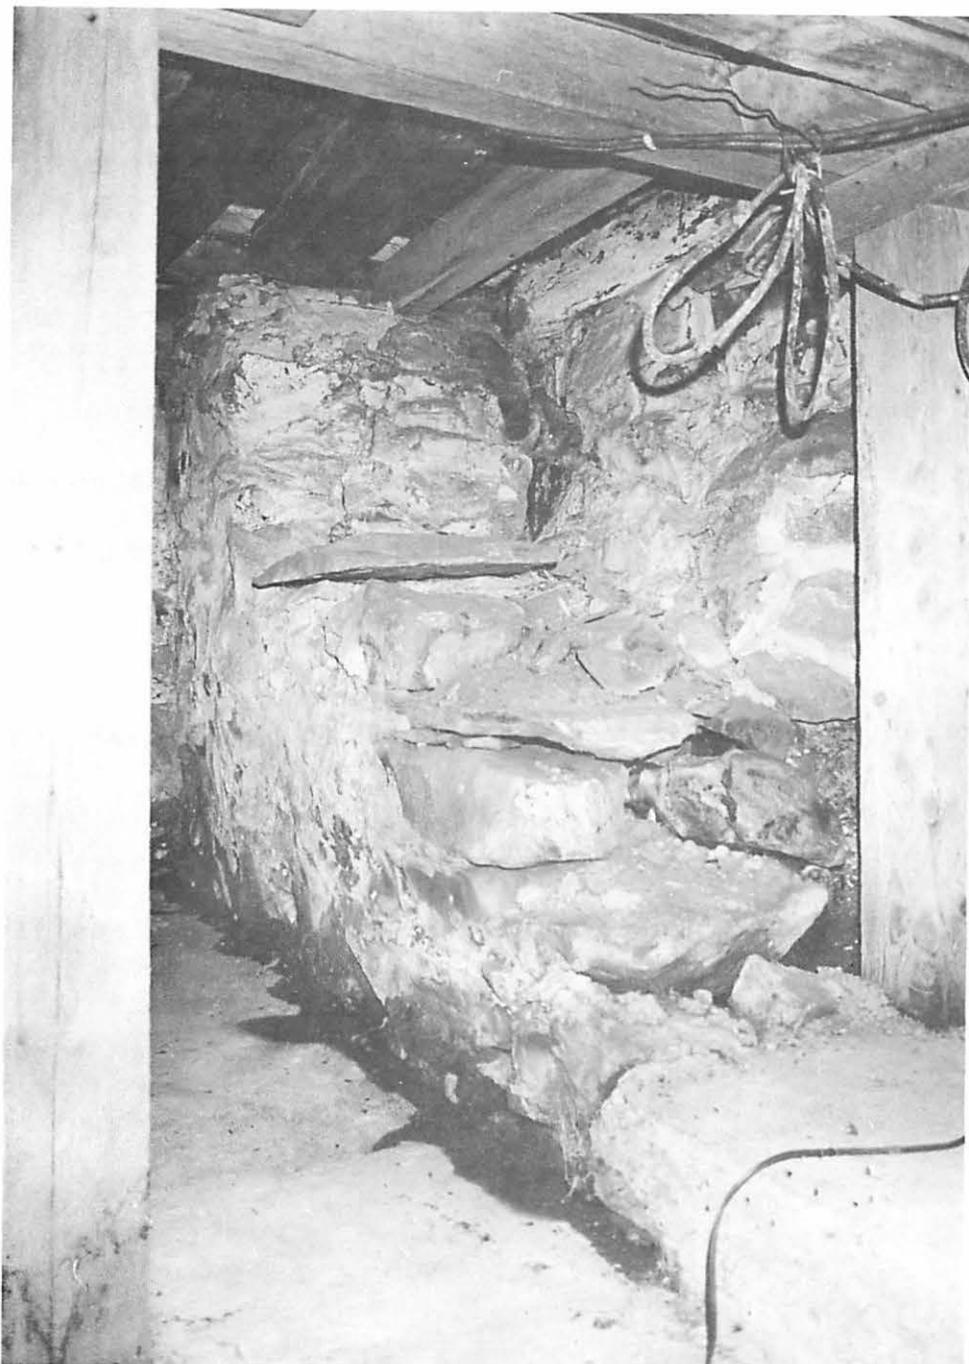
The Cellar. The double wall has given trouble in its interpretation. For a long time the author thought that the stones carried another meaning, as a staircase to the Kitchen above, but following the collapse of the north wall, it is now believed that the extra stone is really a buttress to prevent the collapse of the south wall. The original wall shows some bulging and the walls to the access stair show even more. At the extreme right can be seen a new post holding up the old beam. Extra timber has been added either side to strengthen the beam.
