Curatorial Report Number 60

# The Simeon Perkins House: an Architectural Interpretation 1767-1987

By Allen Penney  
February 1987

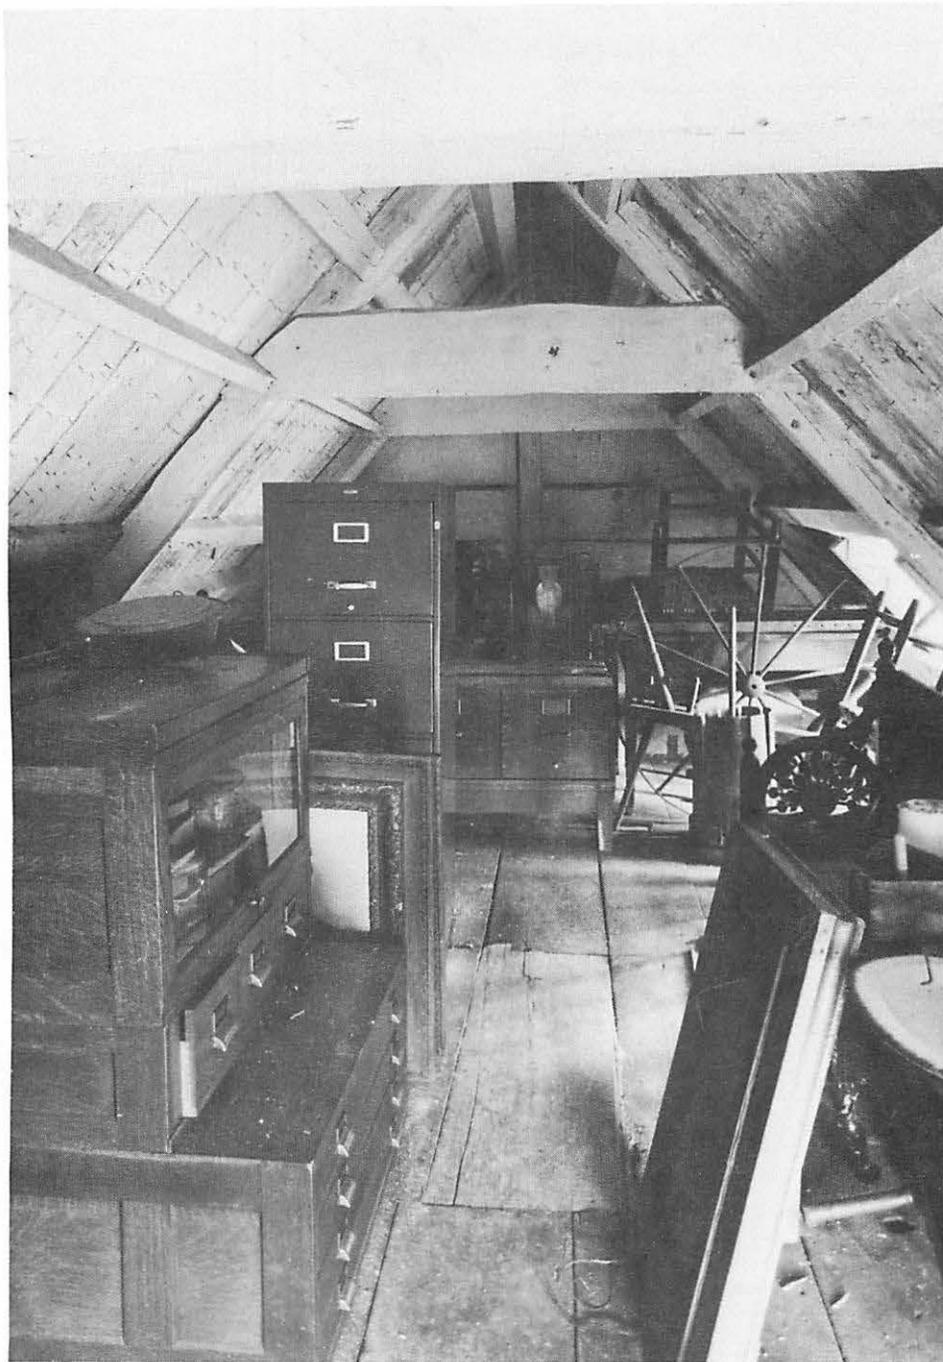
The Kitchen Attic looking north. Note the low dormer window height and the high roof space. At the far end is the 1792 roof slope with horizontal boarding. In the foreground can be seen the patch in the flooring where the brick flue was located prior to 1949. Substantial reconstruction of the roof has taken place as modern purlins and boarding show.

- 10 There are three types of purlin to be seen. The earliest and probably original is rough log, whereas the latest is rough sawn 2"x4" dating from 1949. Sheathing shows the typical parallel sawcuts of the water-powered sawmill in the earlier wide boards and the circular-saw cuts on the face of the later narrow boards. The original rafters are axed or adzed.

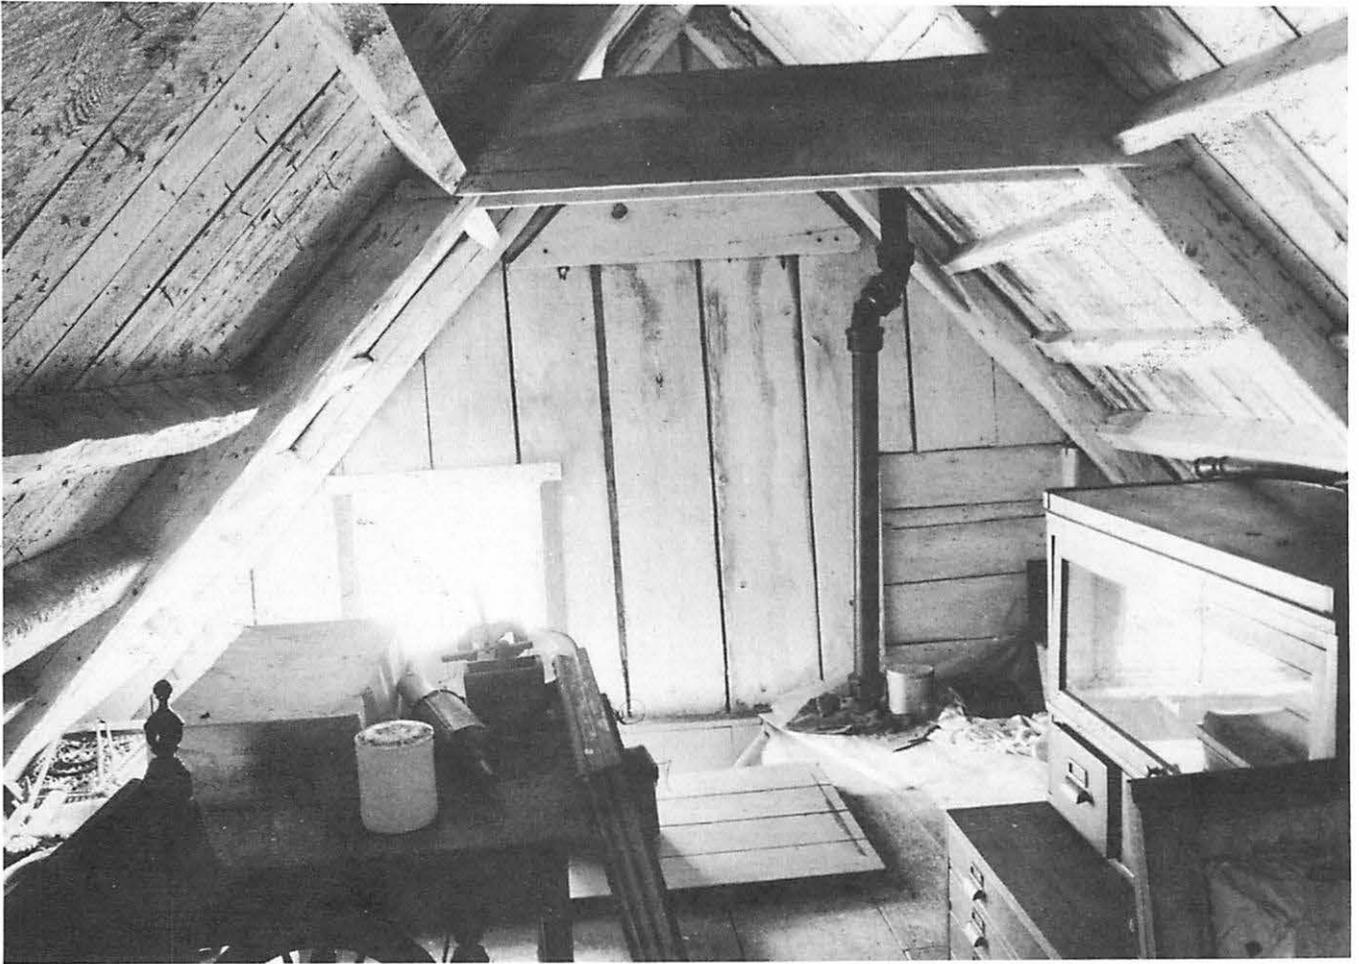
The Kitchen Attic looking south. Note the second south facing window, which has been filled in to the right, and the low window height.

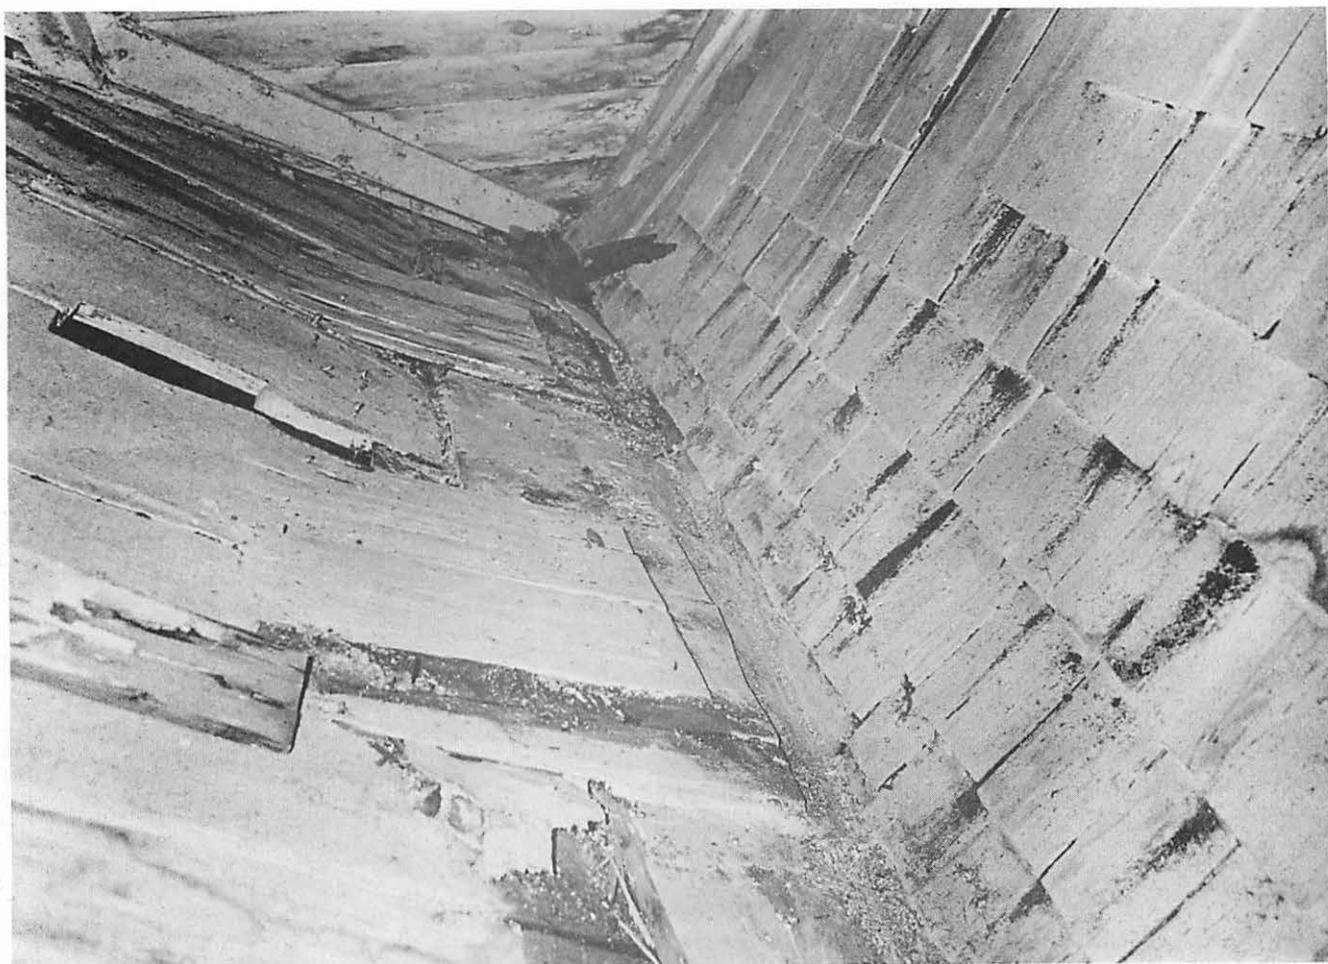
The Roof Junction. The original roof can be seen on the left with some shingles still in place at the bottom of the slope. As these are above the valley gutter, the shingles themselves must date from 1792. The shingled roof of 1792 is on the right. The surfaces have been whitewashed at some time.

by the later connecting roof, are the original shingles of the 1792 addition. (See p 248 ) They are well worn, and exhibit all the signs of having been on for several years before the valley between the roofs was finally covered in.<sup>8</sup> Retaining the dormer window on the main roof slope generated an unfortunate valley gutter which would have been subject to water penetration from collectd snow. In order to windproof the roof as far as possible, canvas strips were tacked over the butt-jointed horizontal sheathing boards before the wood shingles were applied.<sup>9</sup>

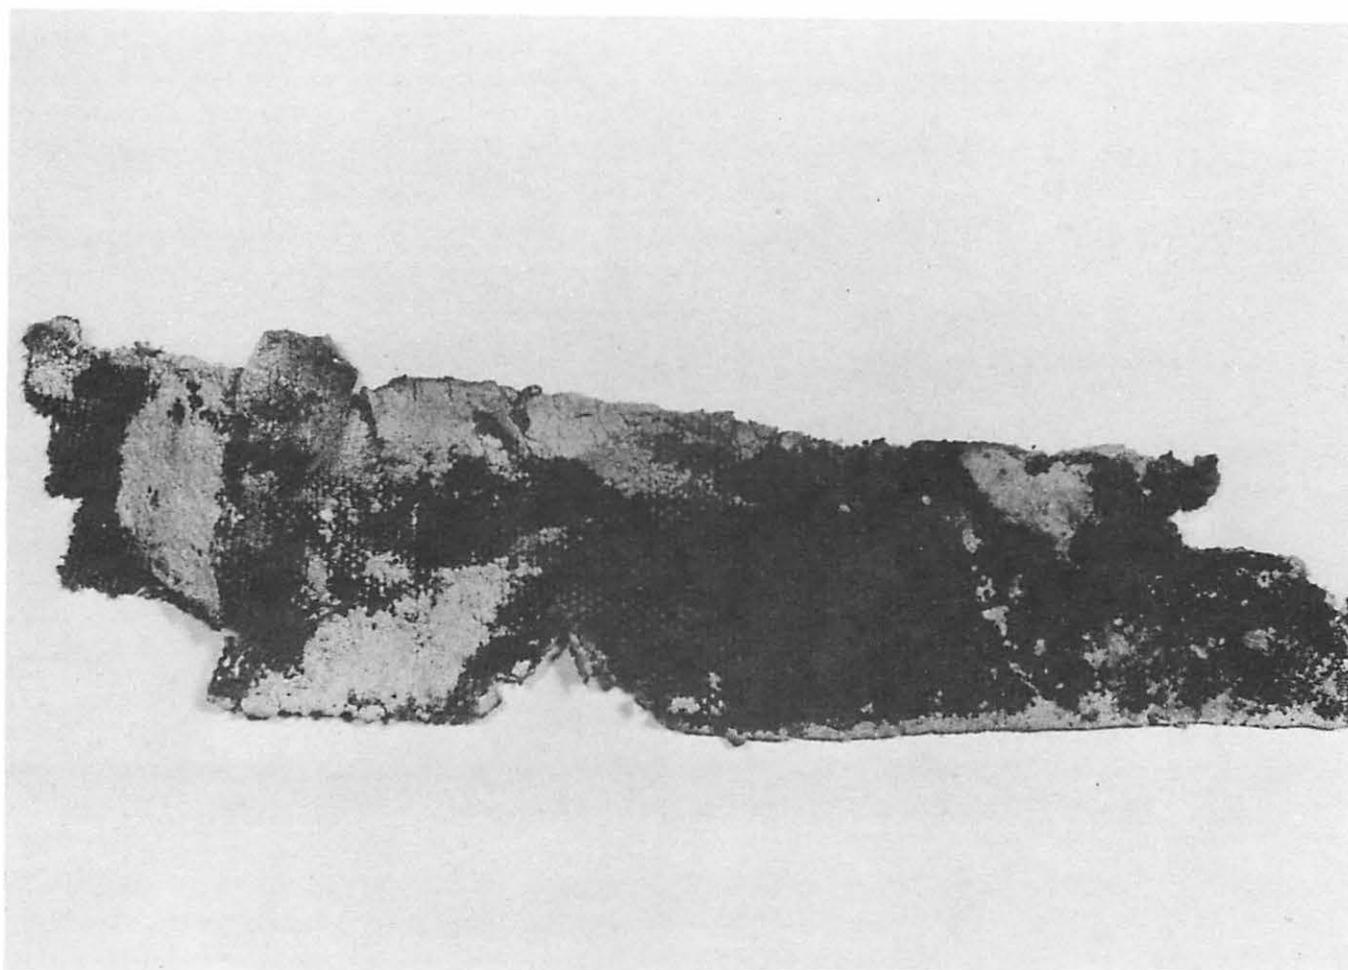
A Piece Of Canvas. Found beneath the shingles on the 1792 roof slope to the attic over the Kitchen Addition, this piece of cloth, possibly cut from an old garment, was found nailed to the sheathing under the shingles, presumably to reduce the air flow into the attic. The author found no signs of birch bark being used.

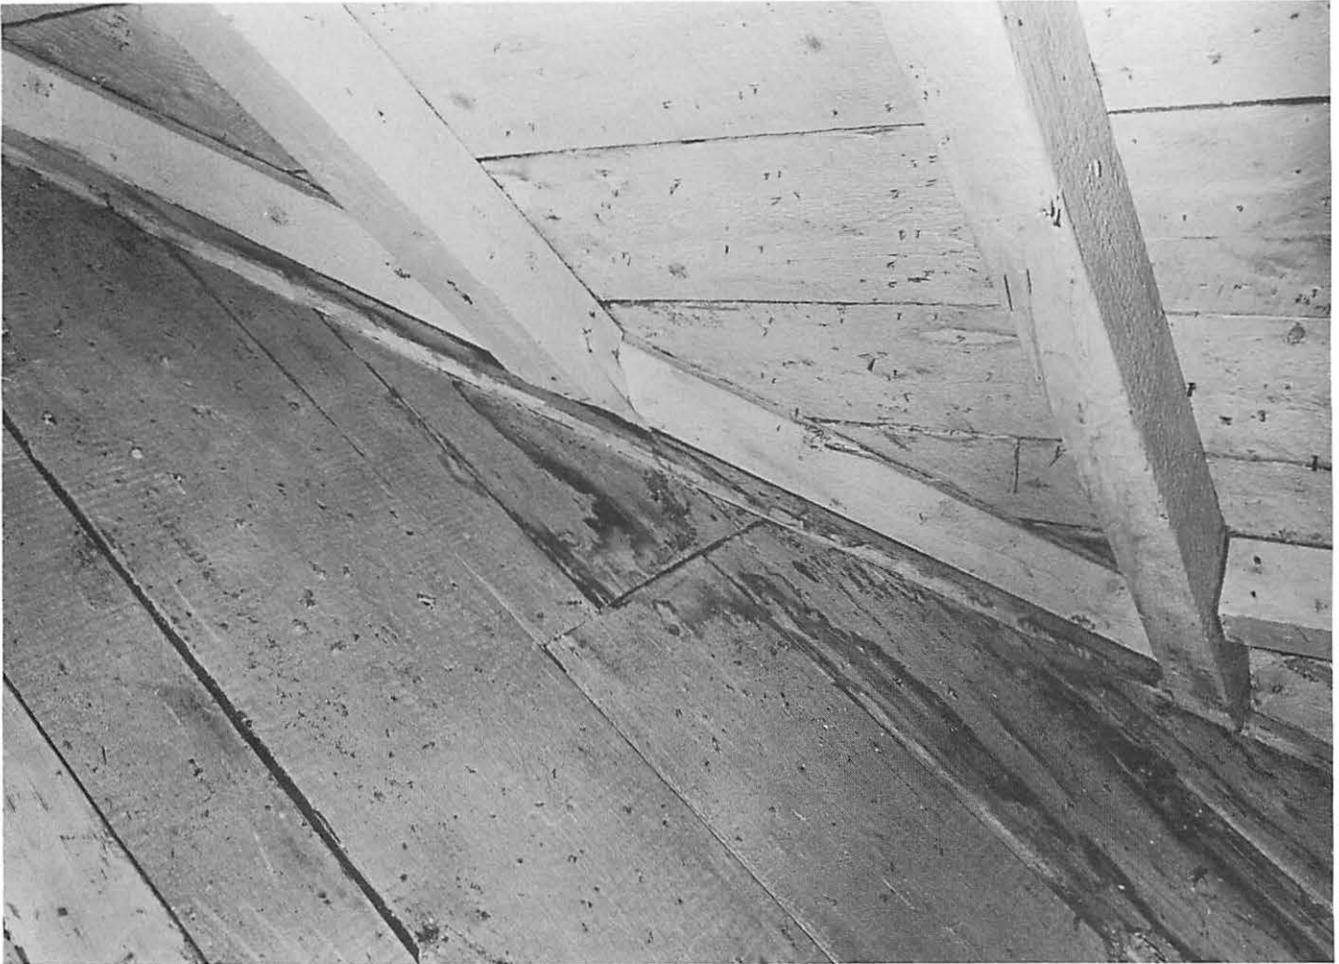
The Kitchen Attic. At the bottom is the original roof sheathing. In the centre is the break in the boards where the dormer was located until after 1792. At the top is the infill roofing, with horizontal boards possibly installed around 1840.

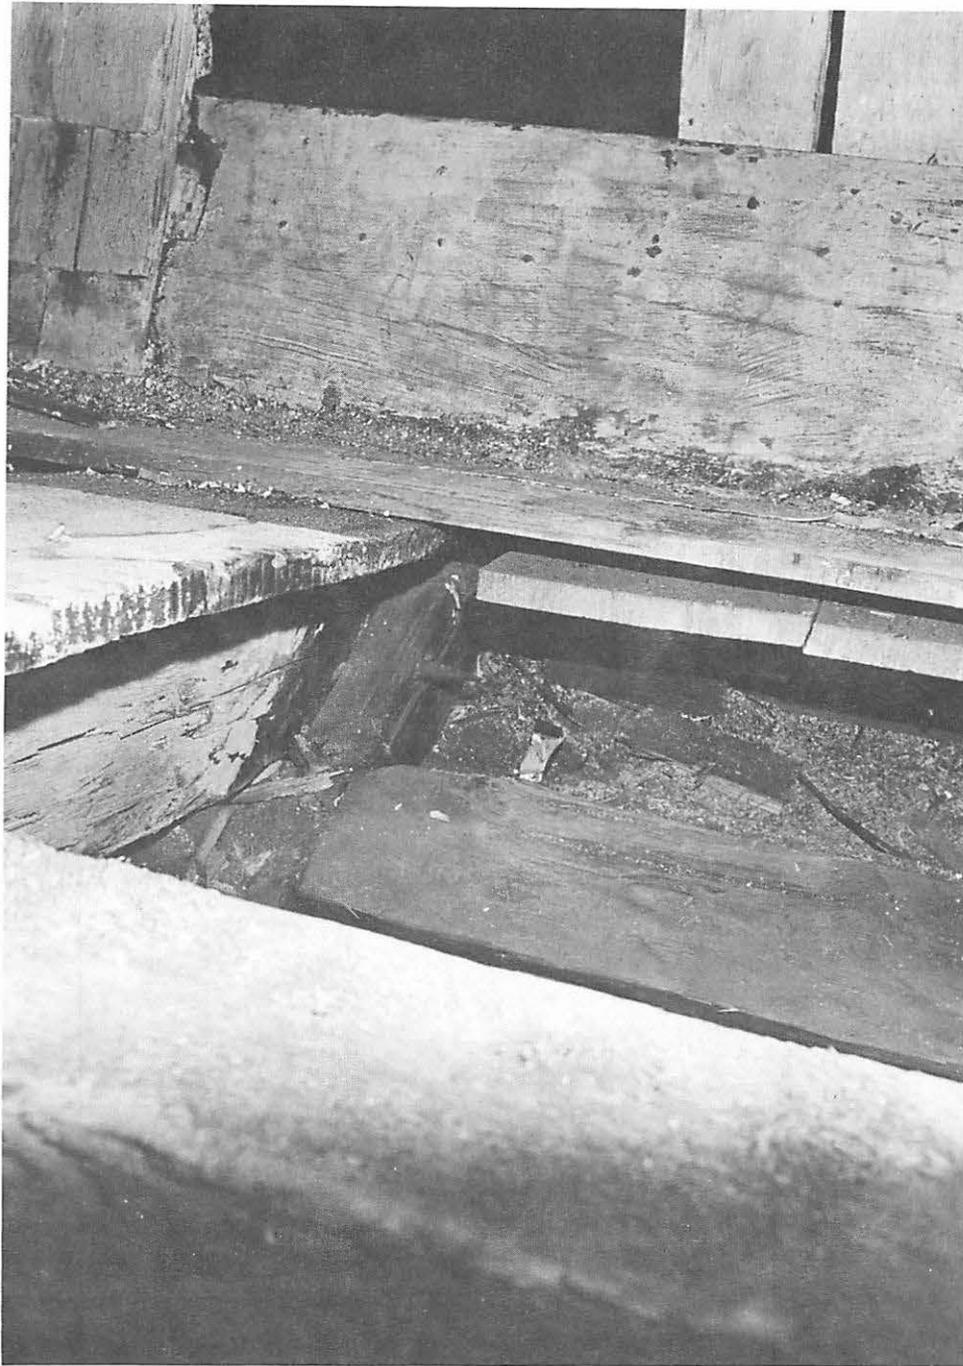
Kitchen Attic looking down on the original valley gutter of 1792. At the middle left can be seen the tree-nail at the joint between the rafter and horizontal tie beam which acts as a floor joist. In the immediate foreground is a purlin. The hole at the top leads into the attic roof space over the kitchen. This space is beyond the reach of visitors. At the top left are the 1792 shingles.

Initially built in 1792, the valley gutter was formed by building simply and making the least effort. Retention of the south facing dormer window suggests that Bedroom 2 may have been divided at this time.

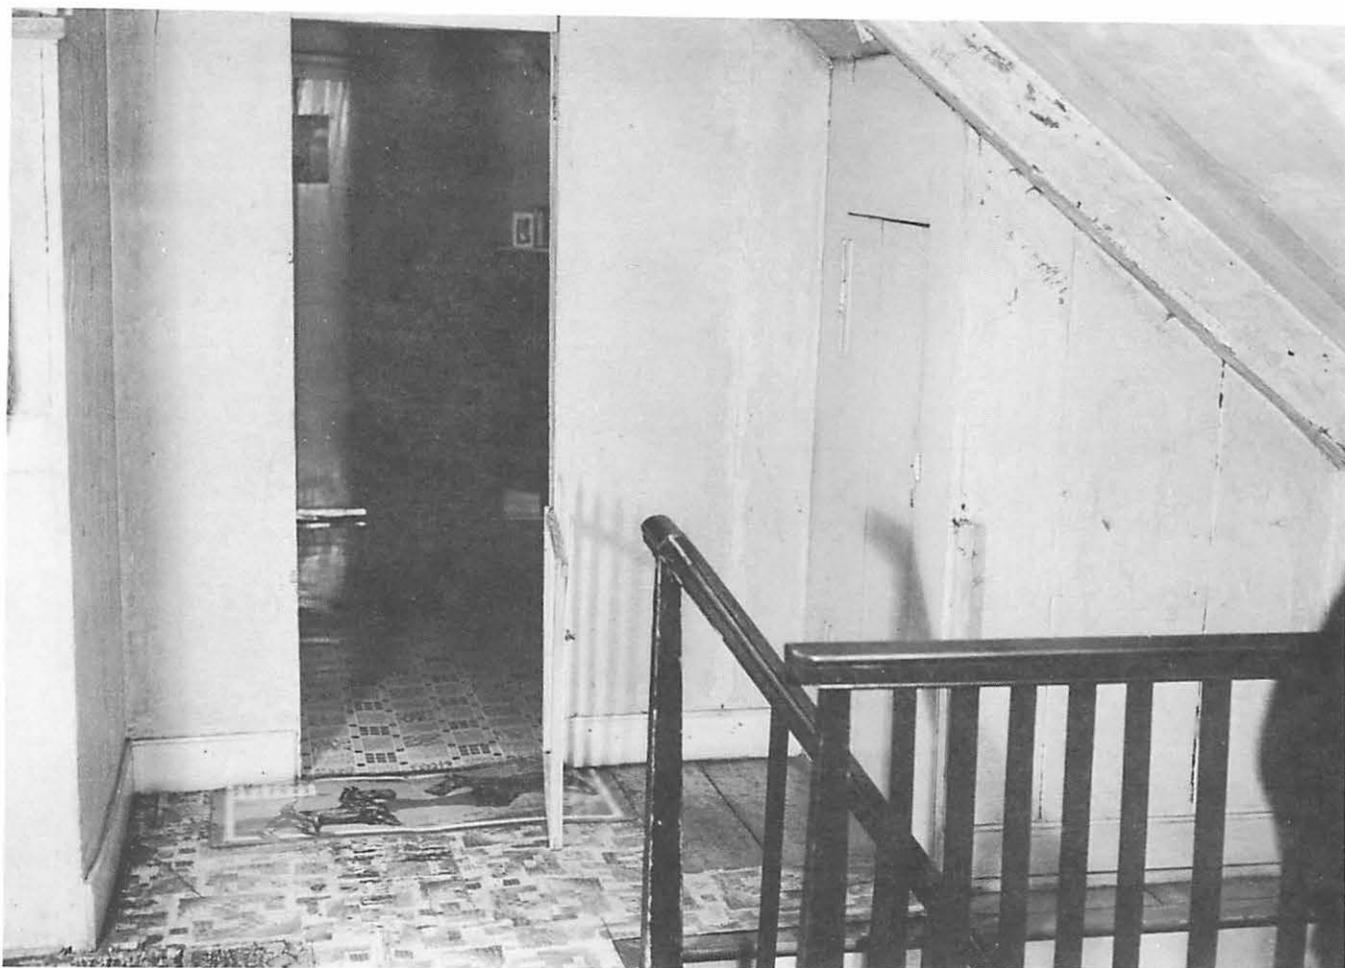
The Stair Landing. This photograph was taken by Hedley Doty in 1947 showing the rear location of the staircase, with Bedroom 2 as it appears today.

Major renovation work was carried out at the house in 1949 using materials taken from the Freeman house next door which had recently been dismantled. ( p 15 )<sup>14</sup> The house was known as 'Elmwood'.<sup>15</sup> Authentic old materials make it much harder to discern new work from old or original. When the stair was rebuilt in 1949<sup>16</sup> repairs to the flooring and walls were carried out in these old materials and only the drawings of 1947<sup>17</sup> (p 131 ) give an indication of which parts are new and which are of earlier date. The stair and handrail are both clearly from 1949, though identical in design to the rear stair photographed in 1947.<sup>18</sup>

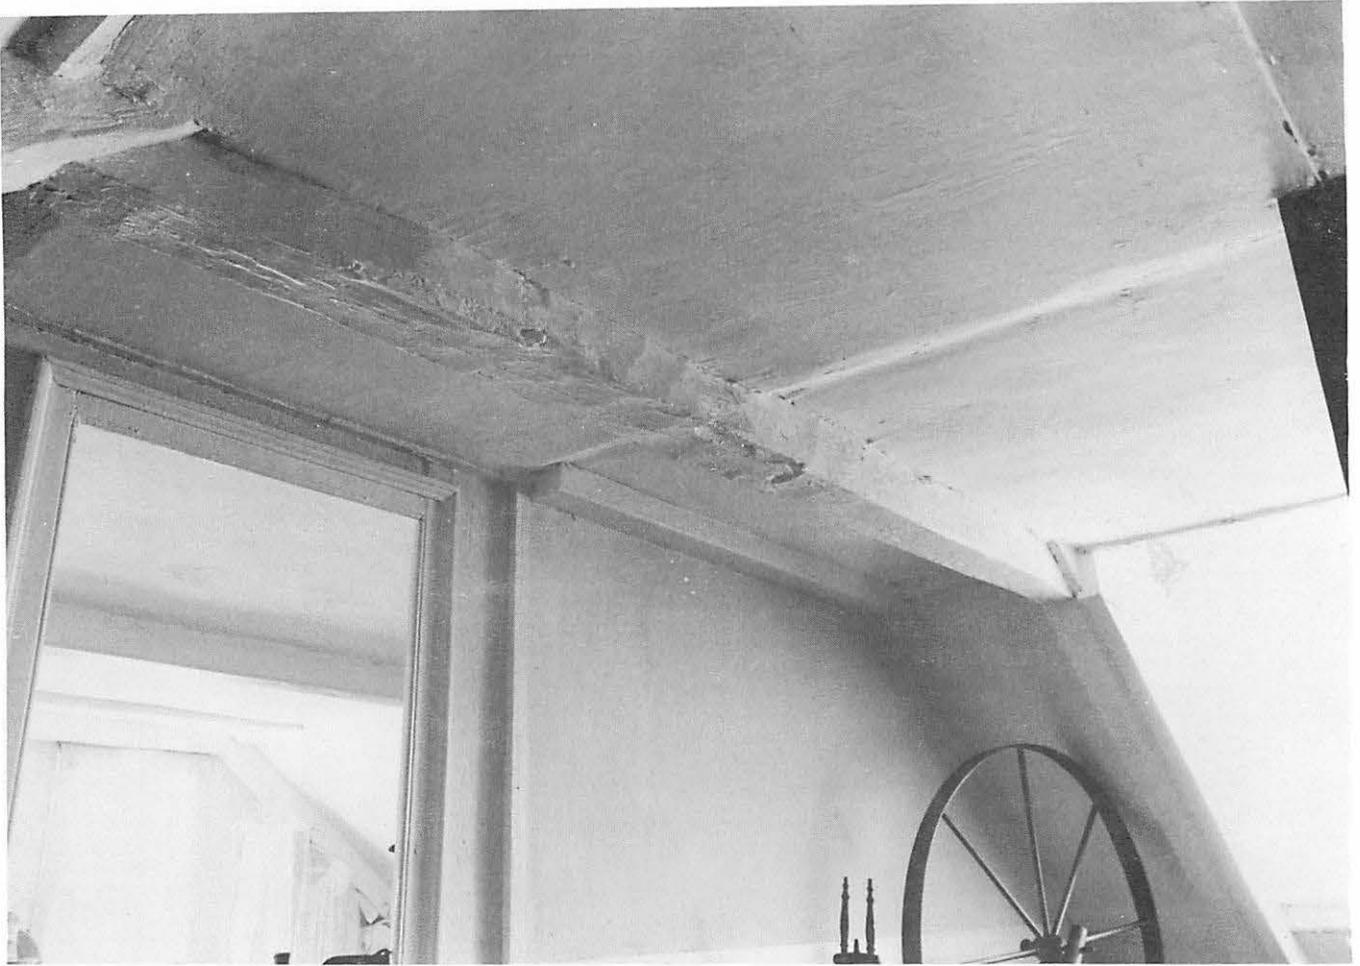
The Stair Landing ceiling 1979. Some traces of change can be plainly seen in the plaster ceiling, while others, for example an access hatch, have been hidden by it. The marks of the adze can be clearly seen in the ceiling beam.

A number of changes can still be seen in the ceiling. A roof access hatch over the head of the stairs has been hidden by later plaster.<sup>10</sup> This plaster work presumably dates from 1949<sup>11</sup> when the stairs were again moved and a vertical post was carried up to the ceiling to increase staircase rigidity. A small piece of vertical boarding which predates the 1949<sup>12</sup> alterations, suggests that there was a partition at first which made the Landing a rectangular room. It is located on the rafter just outside the door to Bedroom 2. ( p 257 ) A large cupboard, adjacent to the wall of bedroom 1 appears in the drawings of 1947. (p 132 ) The position of the cupboard door can still be clearly seen in the paint marks on the floor.<sup>13</sup> (p 260 )

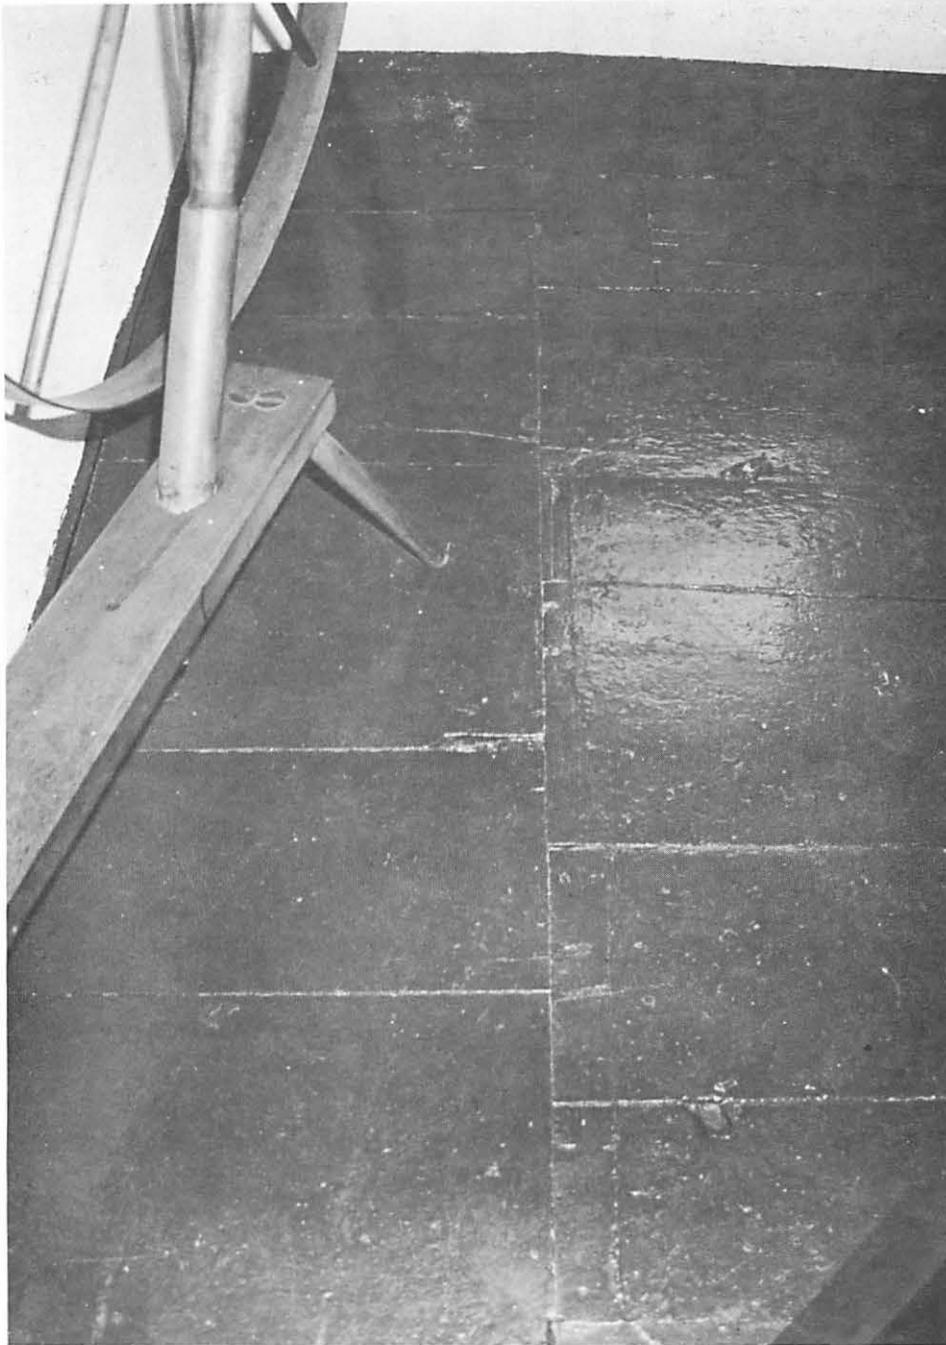
The Stair Landing Floor. The location of an old closet door can be traced in paint markings on the floor. The closet was removed in 1949. The joints in the original flooring show where a beam is located below. In order to prevent sagging between the widely spaced joists a double layer of floor boards is used, which has the added advantage of reducing noise transfer and is the eighteenth century solution to the need for tongued and grooved boarding. It suggests a system of construction in process of development and an ability to use wood extravagantly.

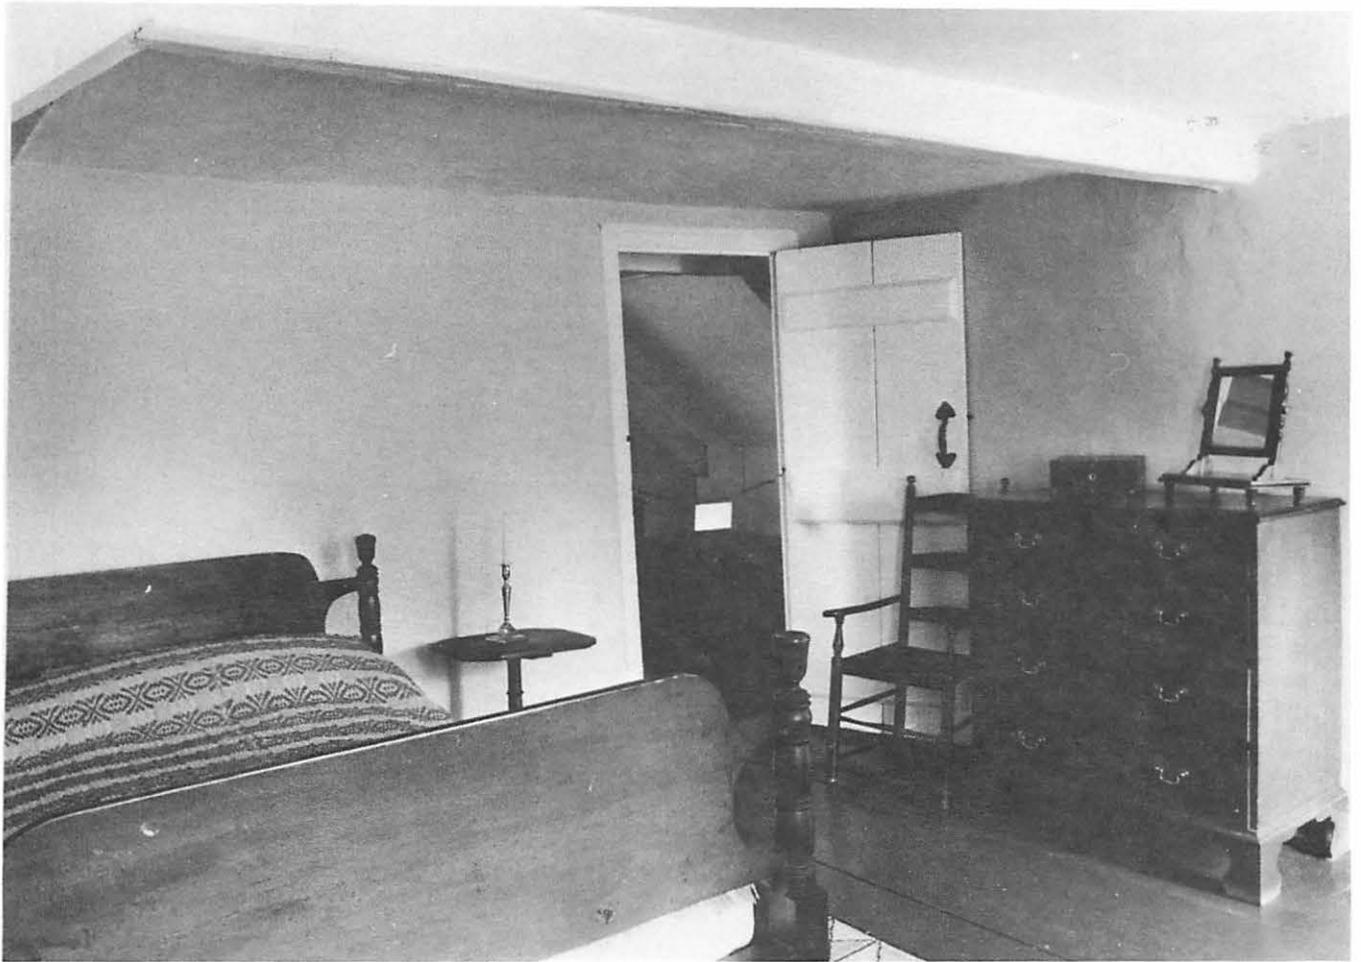
Bedroom 1 looking southeast. The low headroom, further reduced by the beams, gives a cosy feel to the upper floor, but should not be construed to imply that the Perkins family were necessarily short people. The 1781 door, made from just two pieces of board, is curiously hung with the battens on the outside.

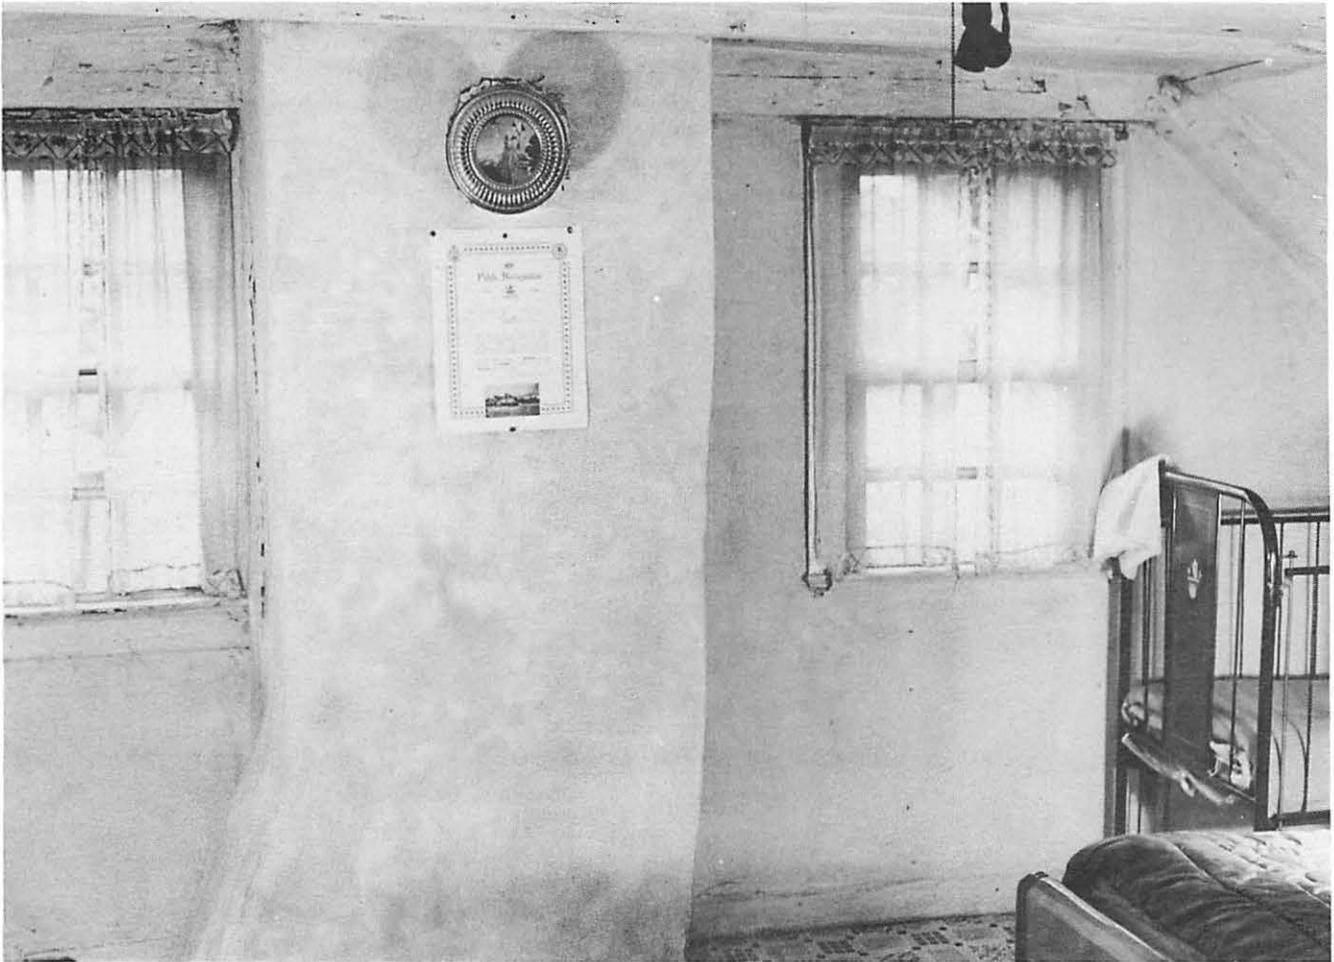
Bedroom 1. Photograph of 1947. A cap over the stove pipe connection is a reminder that Simeon Perkins poured water in here to douse a chimney fire started in the office below. This is only possible because the three fireplaces shared a common flue.

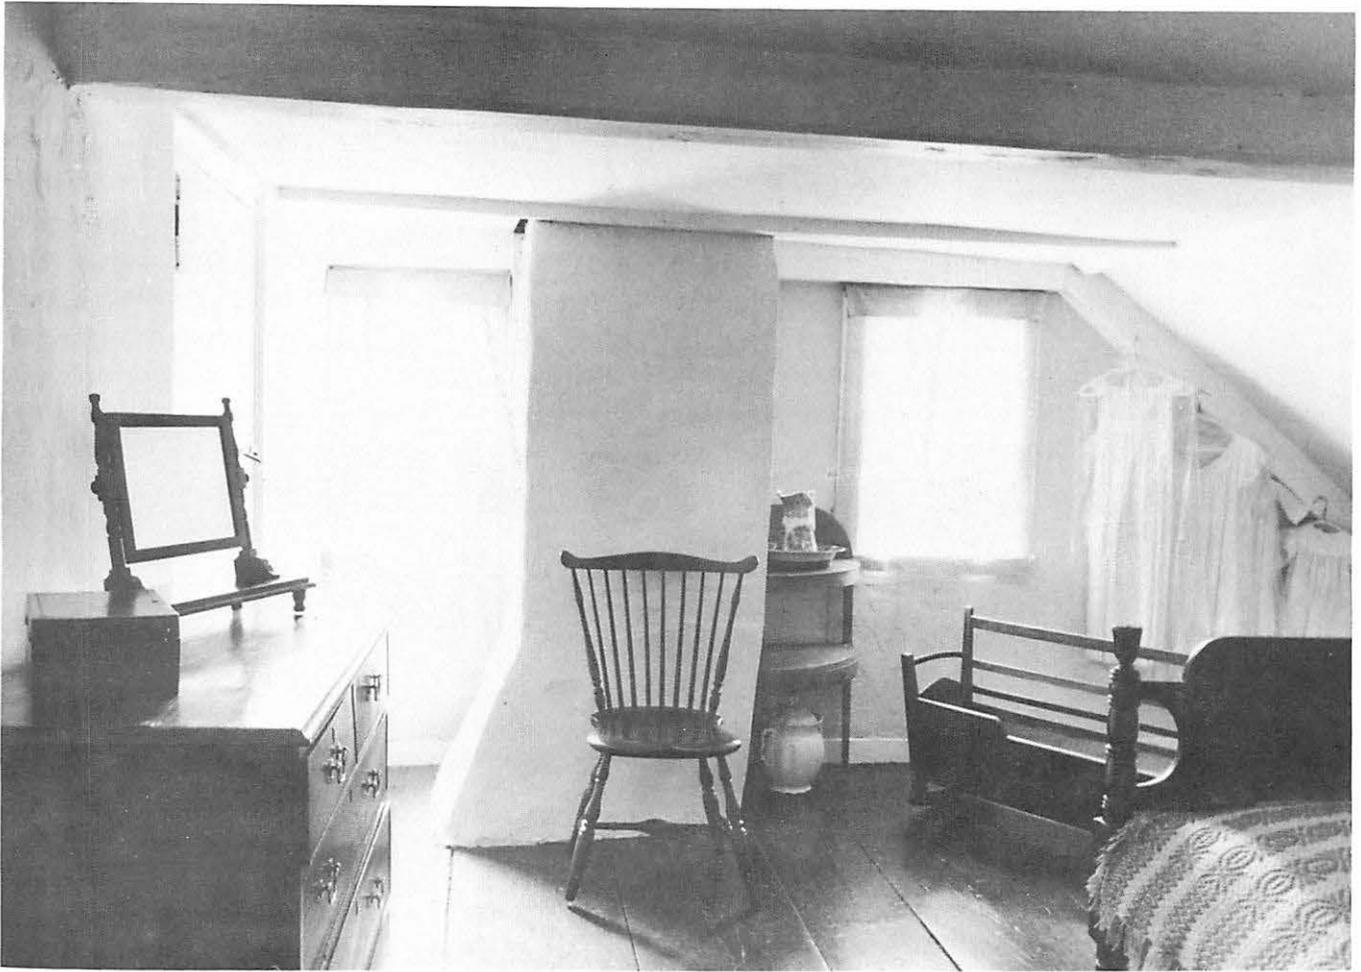
Bedroom 1 looking west. The structural frame and chimney are visible with the 2 flues from the Office and Parlour gathering into one to eject smoke close to the peak of the roof.

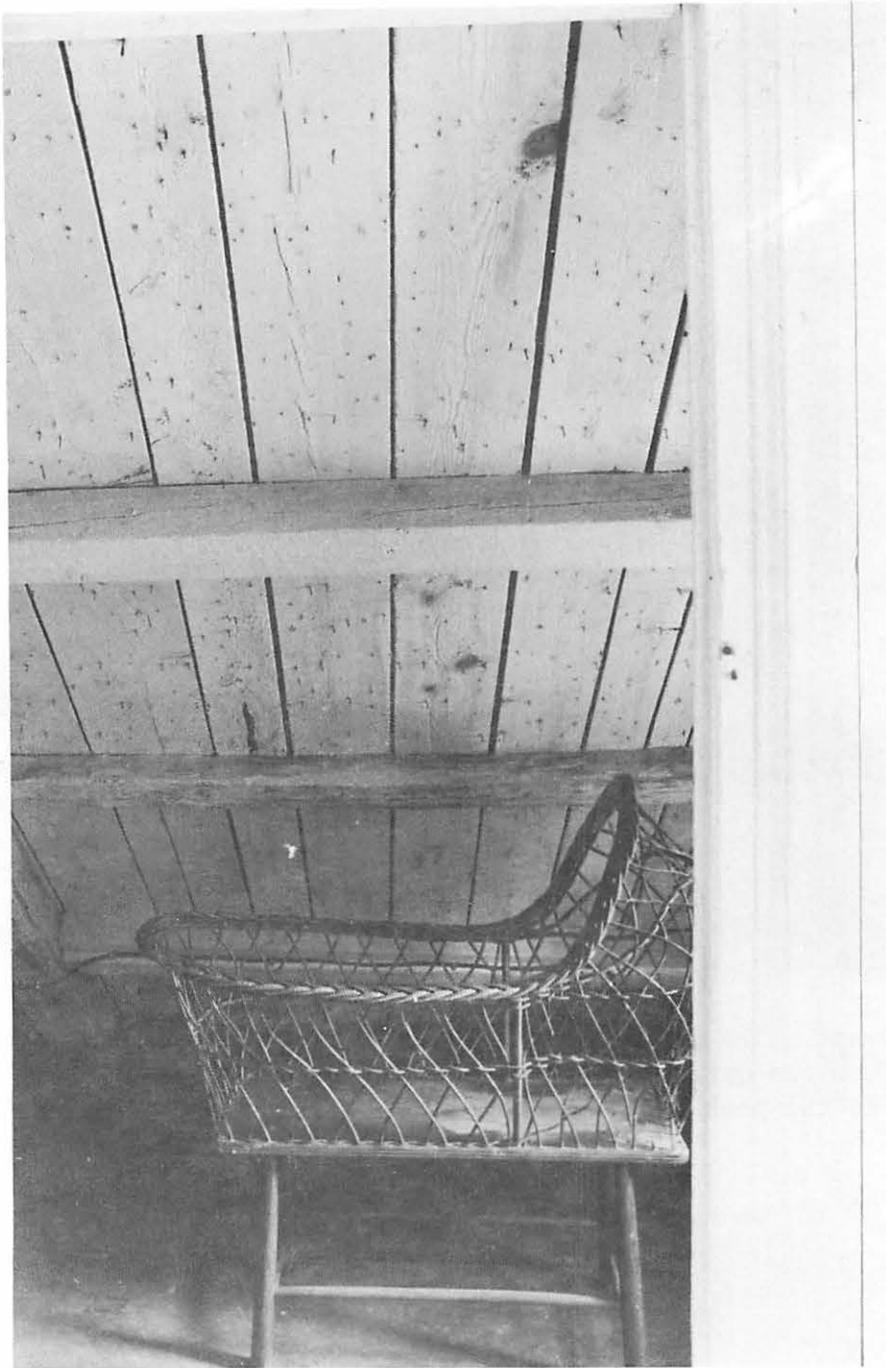
Bedroom 1 Closet looking south. The horizontal purlins spanning between the rafters and vertical boarding can be clearly seen through the open doorway. In contrast to the original boards, those used in 1935 are much narrower. See next photograph.

partition, is nailed into woodstrips attached to the wooden floor and ceiling. Vertical joints in the boarding are a simple half lap joint.<sup>15</sup> Split laths,<sup>16</sup> nailed on horizontally to provide more stiffness, are then plastered over. In the wall to the south closet space the wall is plastered on one side only, whereas between this bedroom and the landing the wall is plastered on both sides to give an overall thickness. Connecticut precedents used vertical boarding for internal walls where the boards were given a bead at the joint and left without plaster.<sup>17</sup> An example of this can be seen in the door to the south closet. (See p 276 ) Presumably the whole room was finished in this way until papered in 1776.<sup>18</sup> Although plaster may have been a status symbol it would have greatly improved audio privacy but not thermal insulation, except for a reduction in draughts. In the large closet to the south there is an added window which appears to have been installed this century. (p 275 ) No functional requirement for this window can be found, except to permit ventilation to lower the temperature under the south-facing roof slope during the summer. Typical examples of this form of house from New England have smaller windows in these locations, presumably for the same reasons.<sup>19</sup> ( p98 )

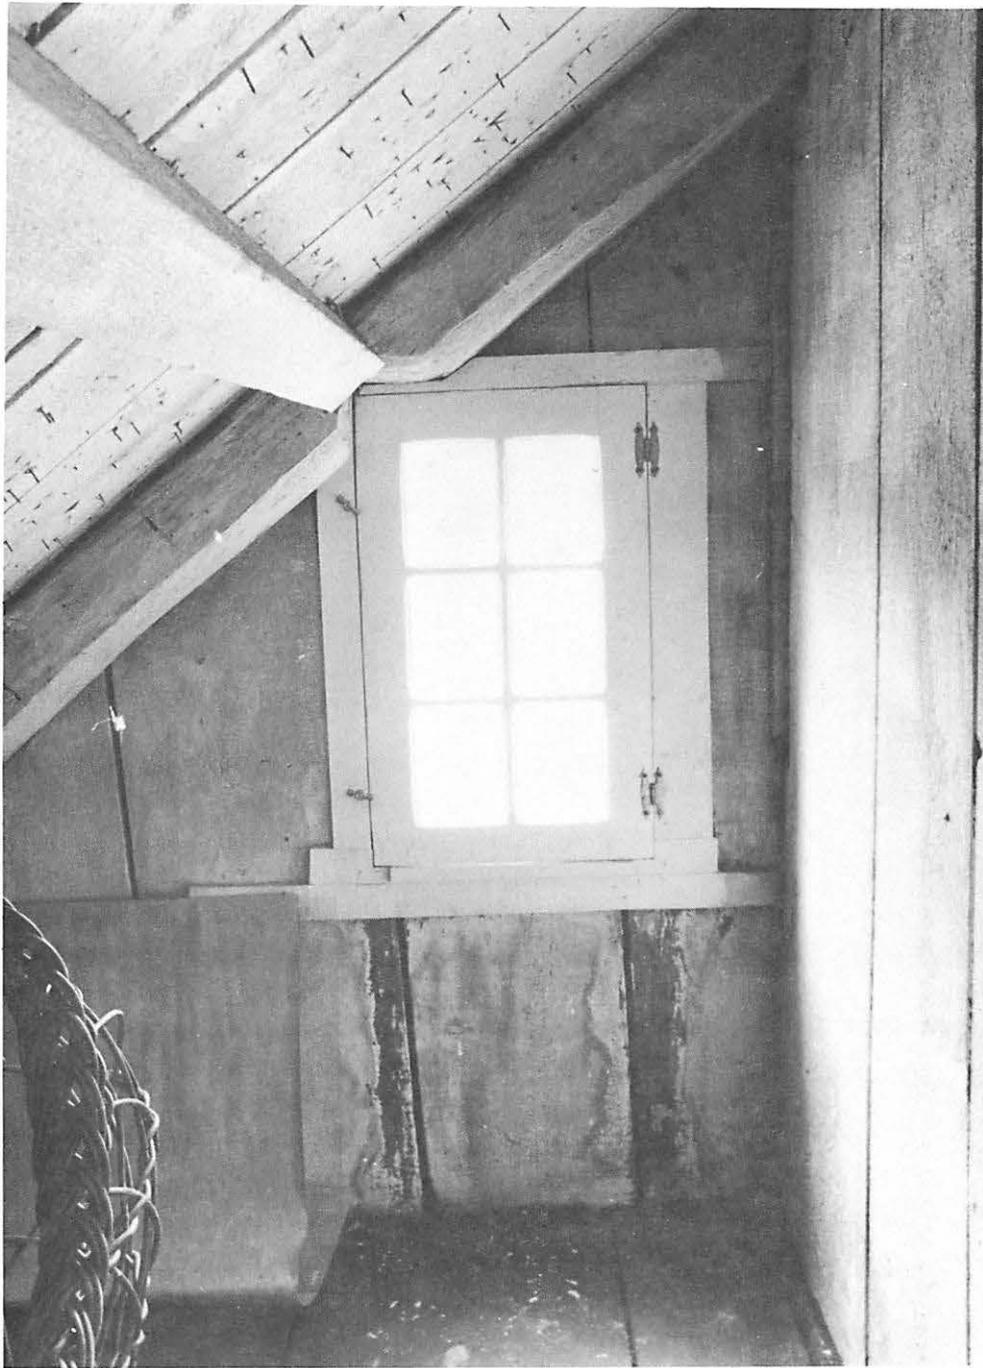
Bedroom 1 Closet looking west. Inside the closet a window opening of recent date can be seen, probably installed to improve ventilation. Note how the main rafter has been cut at the top left-hand corner to allow it to open.

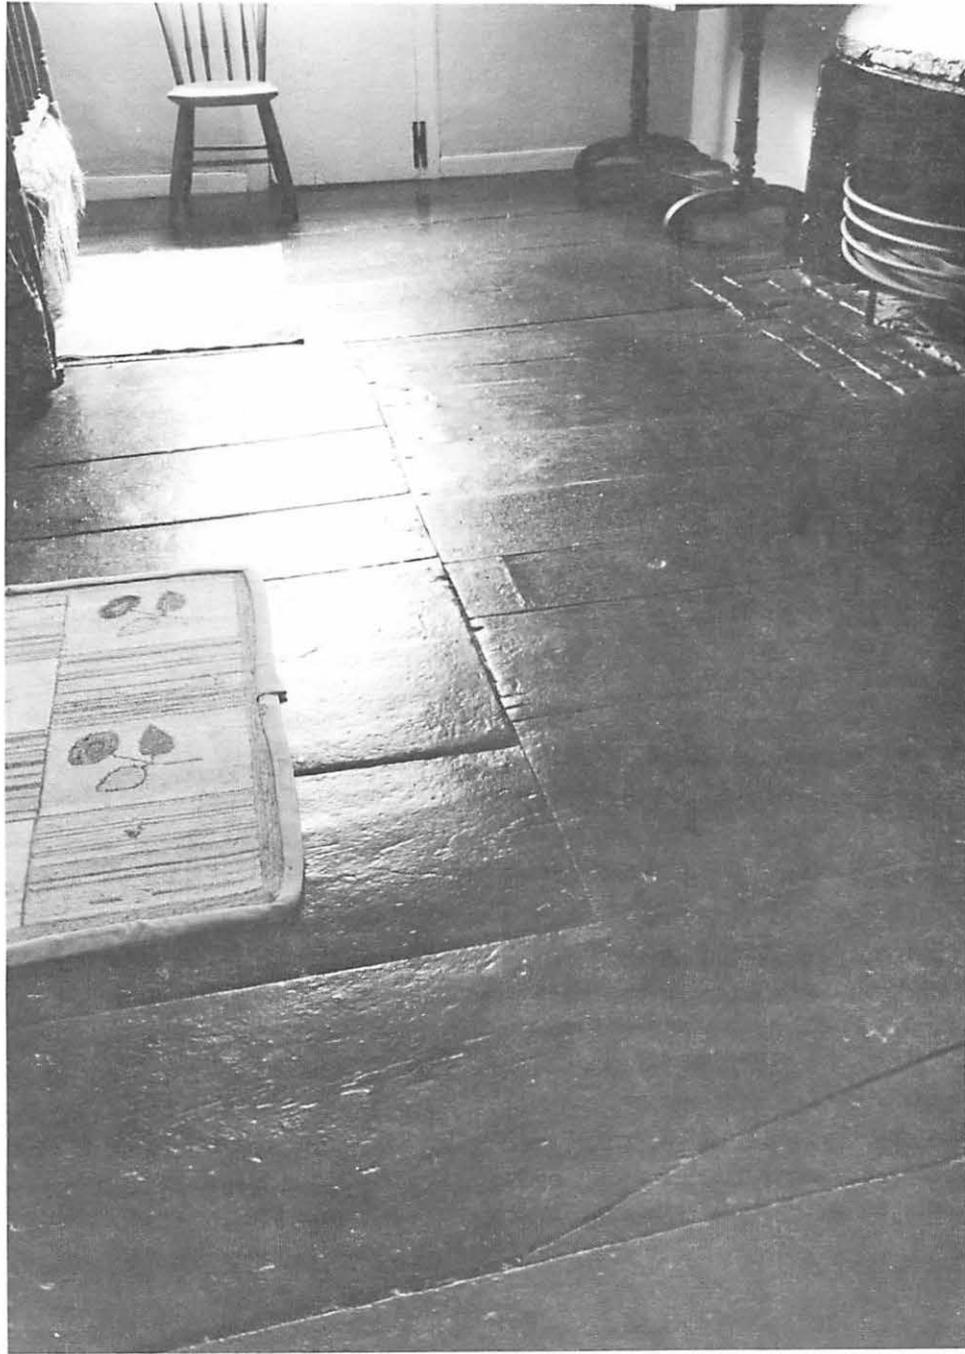
The joints in the floor boards show where the original 1767 kitchen fireplace chimney was removed. In 1781 it was rebuilt the other side of the original end wall, allowing the fireplace to merely penetrate the wall, and so provide a larger bedroom.

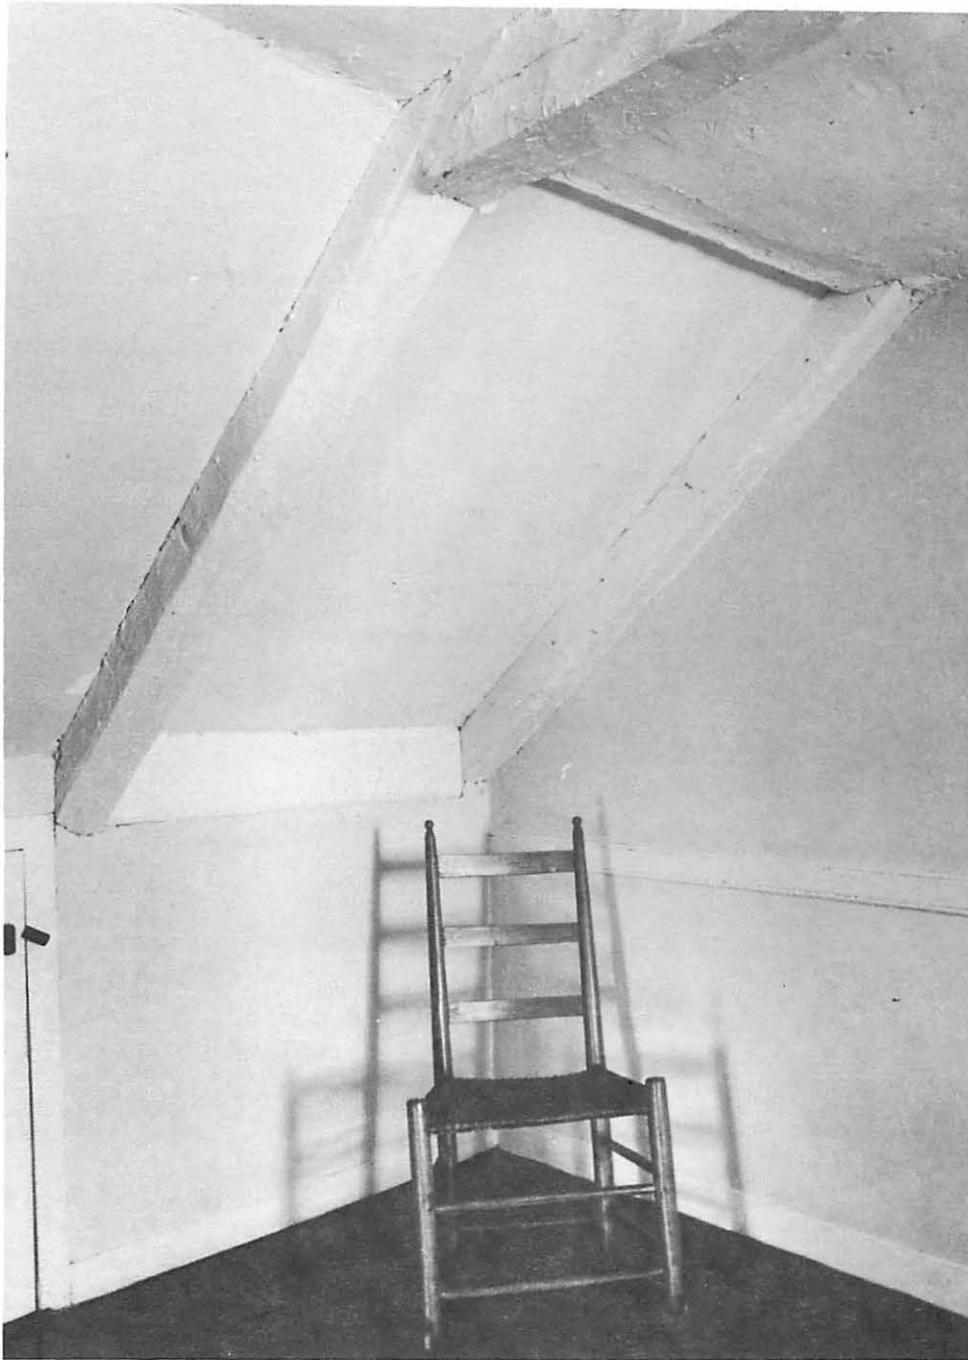
Bedroom 2. The filled-in dormer window in the southwest corner. Not required until after 1781, when the end windows would have been blocked by the addition, the dormer was in use after 1792 when the kitchen wing was added. It is not known when it was removed but presumably it could have been taken out when the stair was altered about 1840.
