Curatorial Report Number 60

# The Simeon Perkins House: an Architectural Interpretation 1767-1987

By Allen Penney  
February 1987

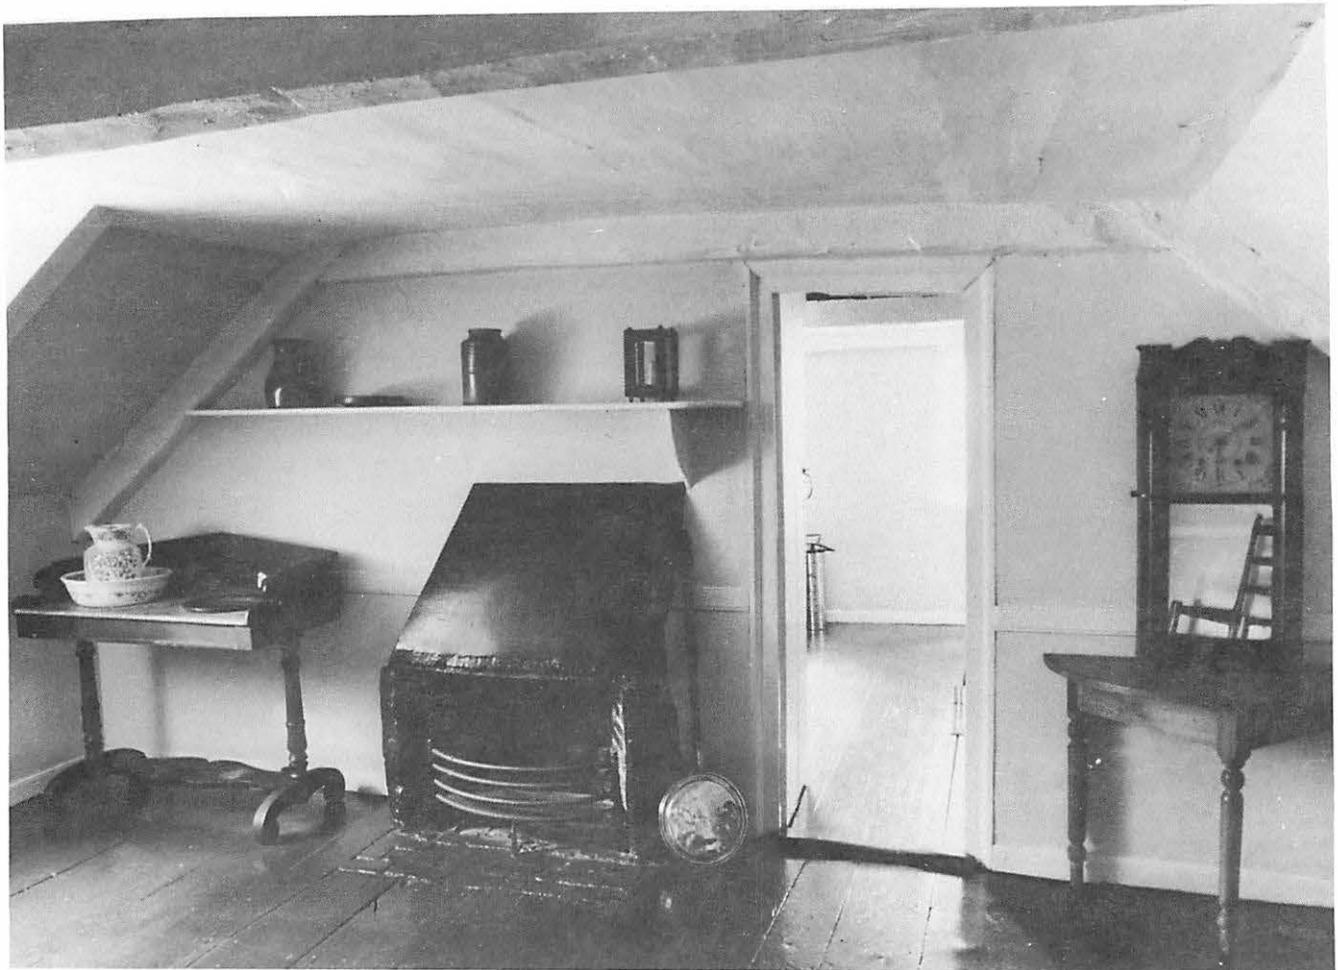
Bedroom 2 looking east. The original end wall and curious fireplace which is the only one on the upper floor. This fireplace probably dates from 1782 when the whole chimney was rebuilt.

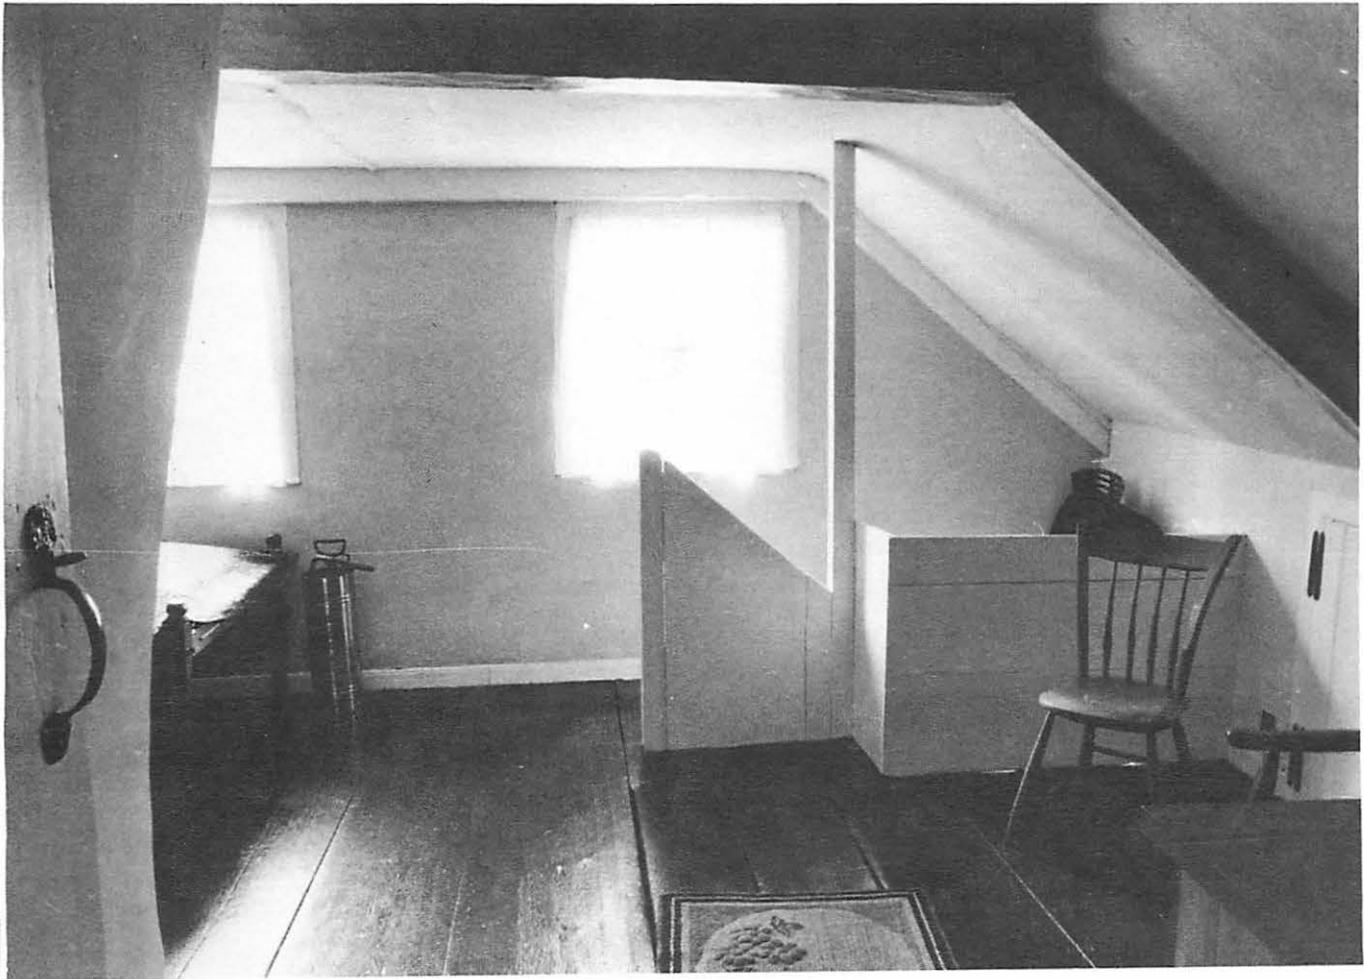
Bedroom 3 looking east. Marks in the end wall and ceiling suggest a partition has been removed, which would have divided this room into two rooms, each with a window.

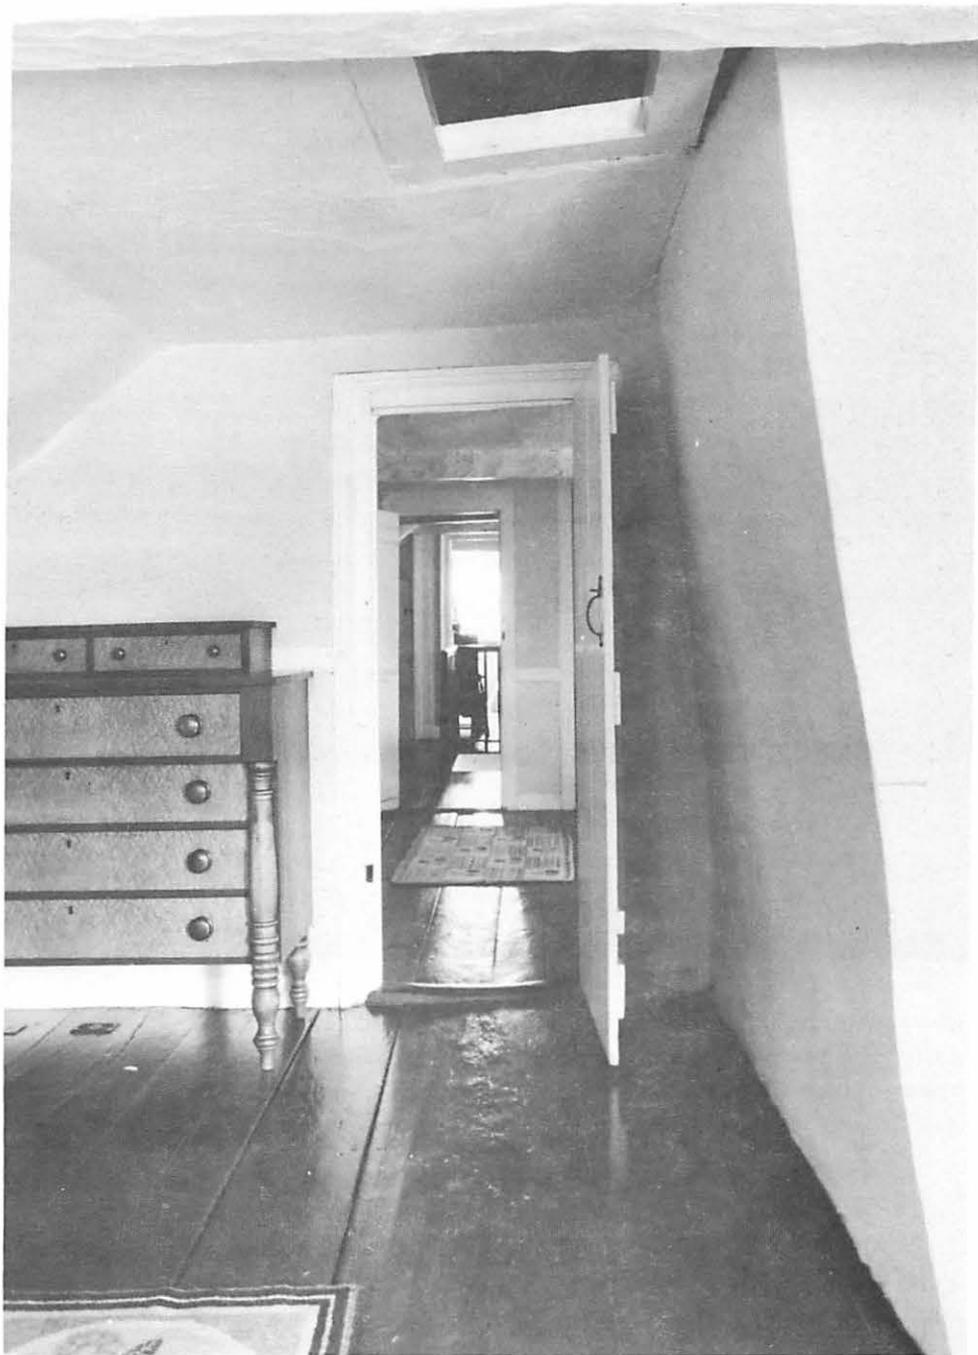
Bedroom 3 looking west through length of house. The lack of privacy can still be experienced throughout the upper floor. The large chimney at the right is for the 1782 kitchen fireplace. It leans to the left in order to exit through the ridge of the roof.

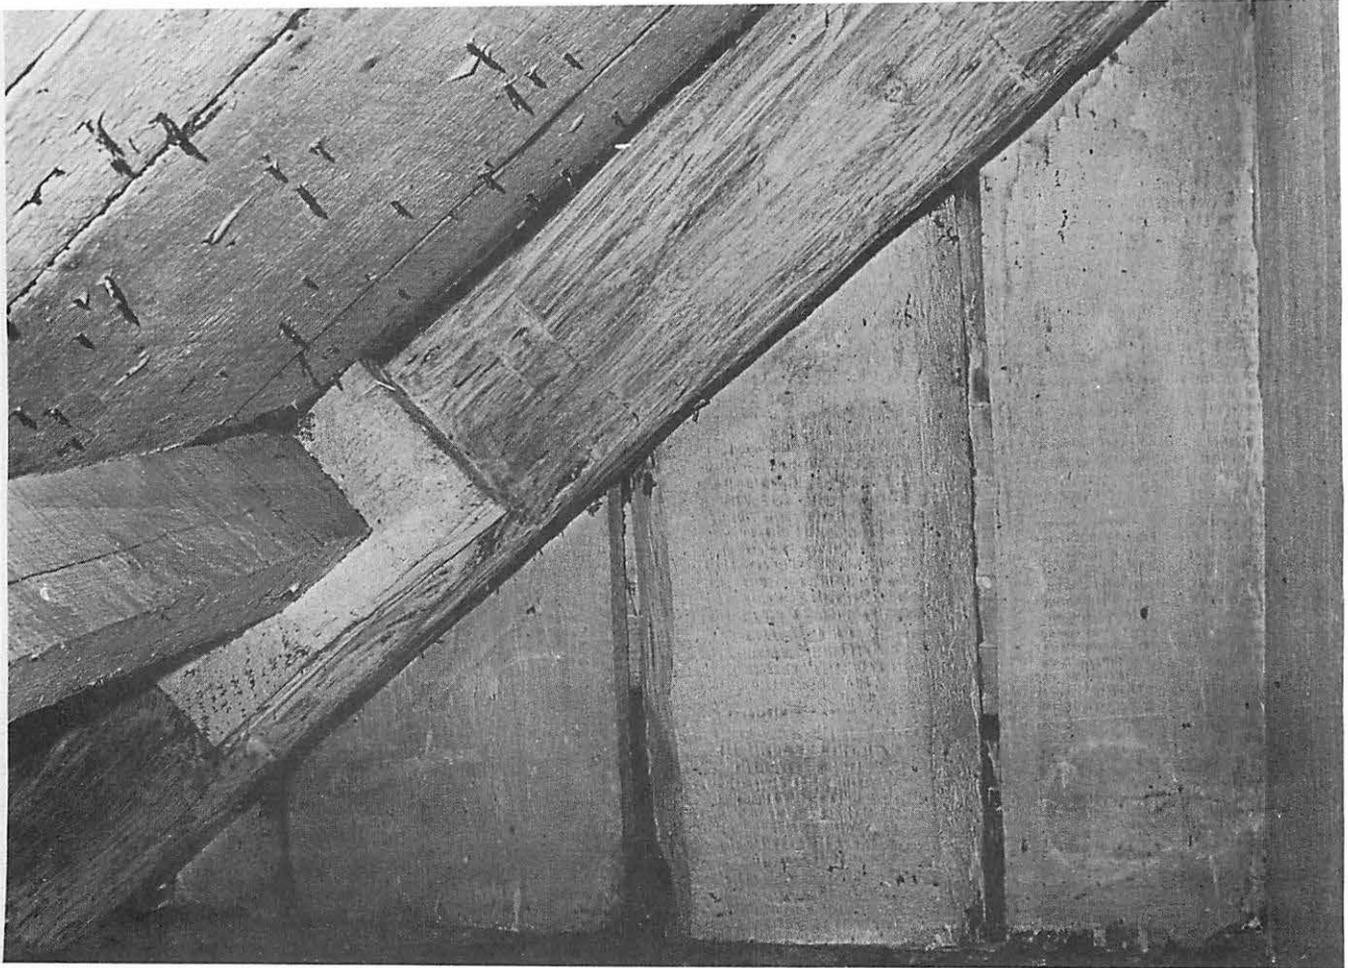
Bedroom 2 Closet. The inside of the original 1767 gable wall shows no sign of birch bark or other draught-proofing materials behind the clapboards. The vertical boards clearly show the saw marks from the water powered saw mill, whereas the rafter shows the less regular surface of the adze or broad axe. The purlin on the left is recent, from 1935 or from 1949.

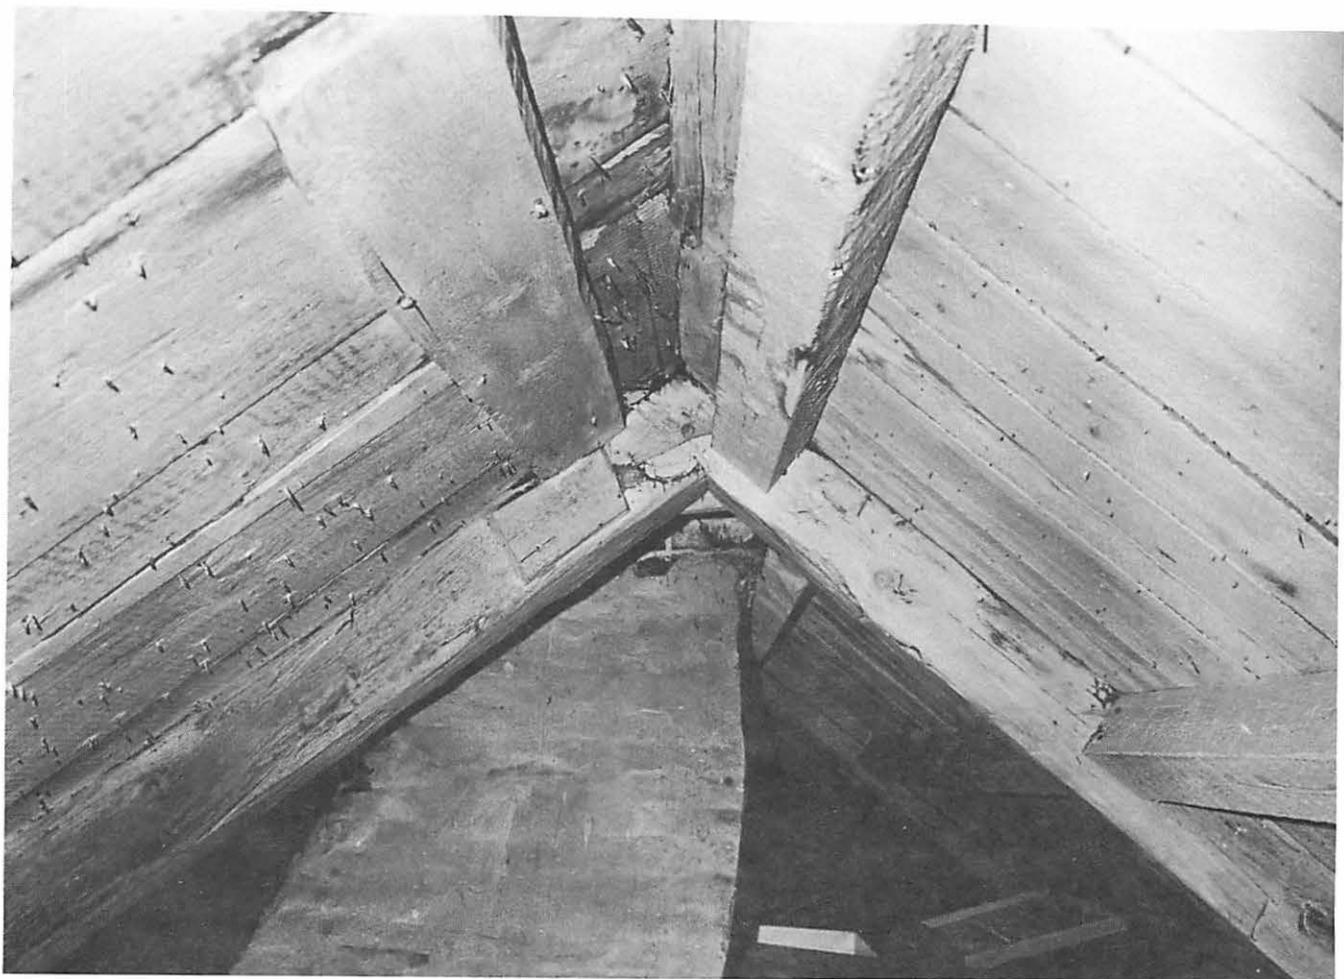
The Attic. At the top centre can be seen the position of the chimney up until its removal in 1781, when it was relocated beyond the original end frame in the new extension. Because the planking on the roof slope to the right was replaced in 1935 the visible clues occur only on the left-hand (north) roofslope.

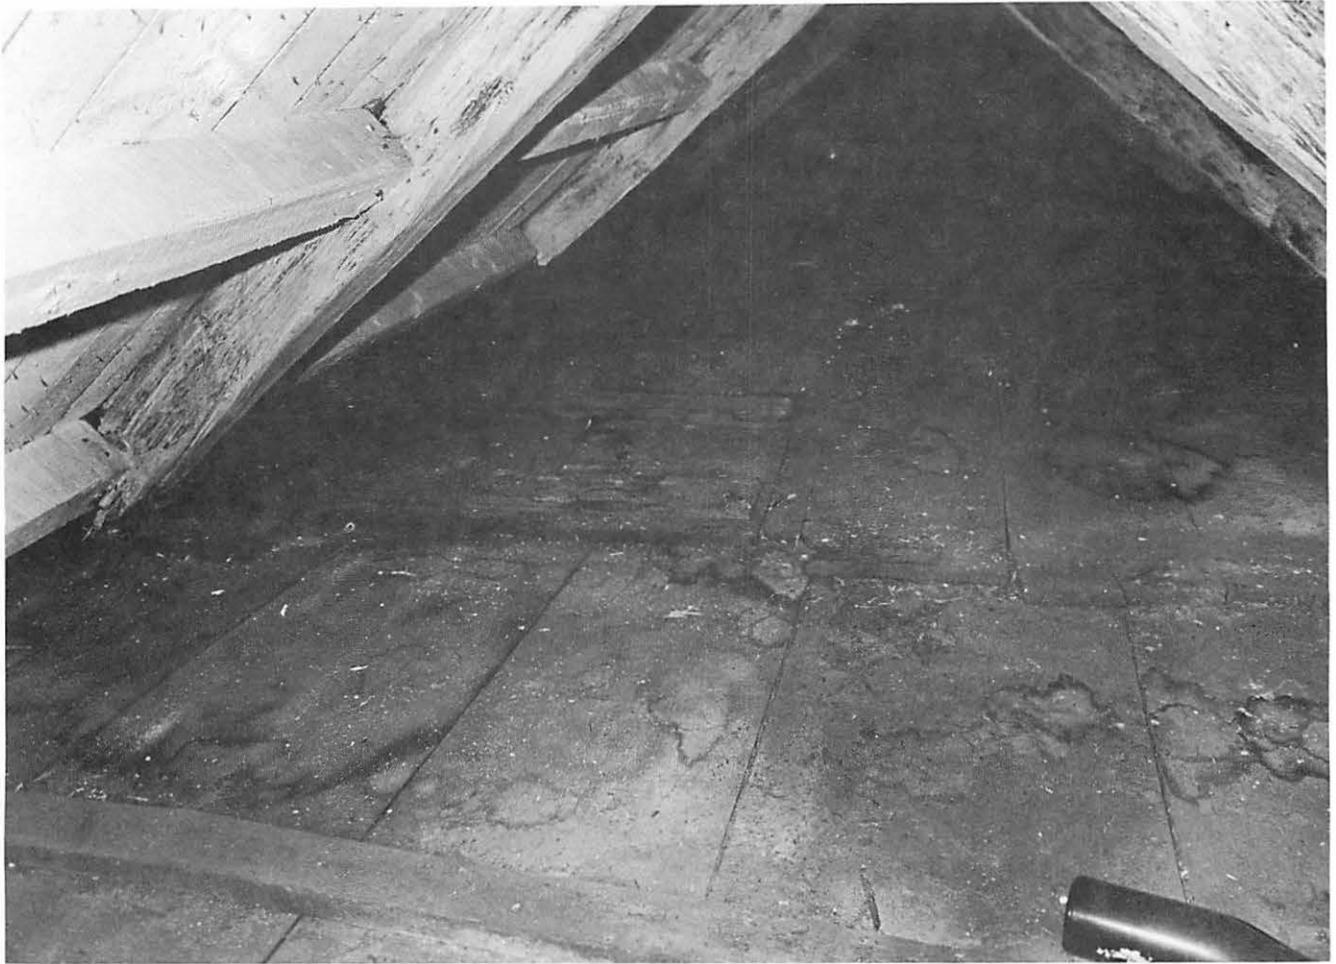
The Attic. At the middle-left can be seen the top of the access hatch which has been plastered over at some time on the ceiling below. The purlins and boarding on the left-hand roofslope date from 1935.
