## Technical Notes

# Debris Flows of the Tunkinsky Goltsy Mountains (Tunkinsky District, Republic of Buryatia in Eastern Siberia)

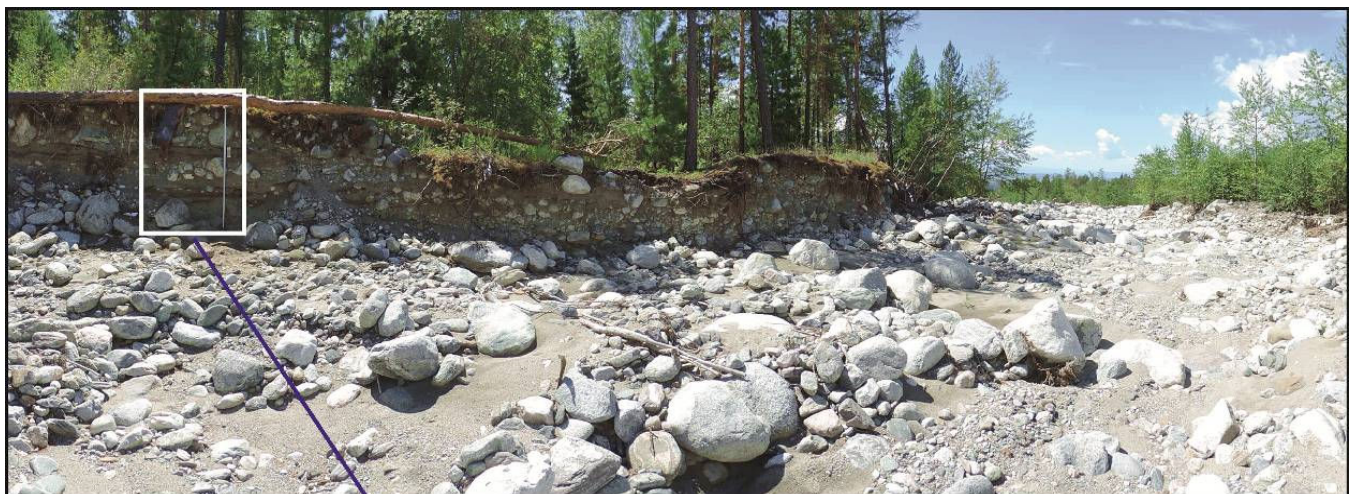
Figure 2. Soil-lithological stratum represented by a number of buried immature soils covered with debris flood deposits. Left bank of the river Malyj Kharimta (point 853). In boxes: radiocarbon / calendar (cal BP) age of the sample and its number

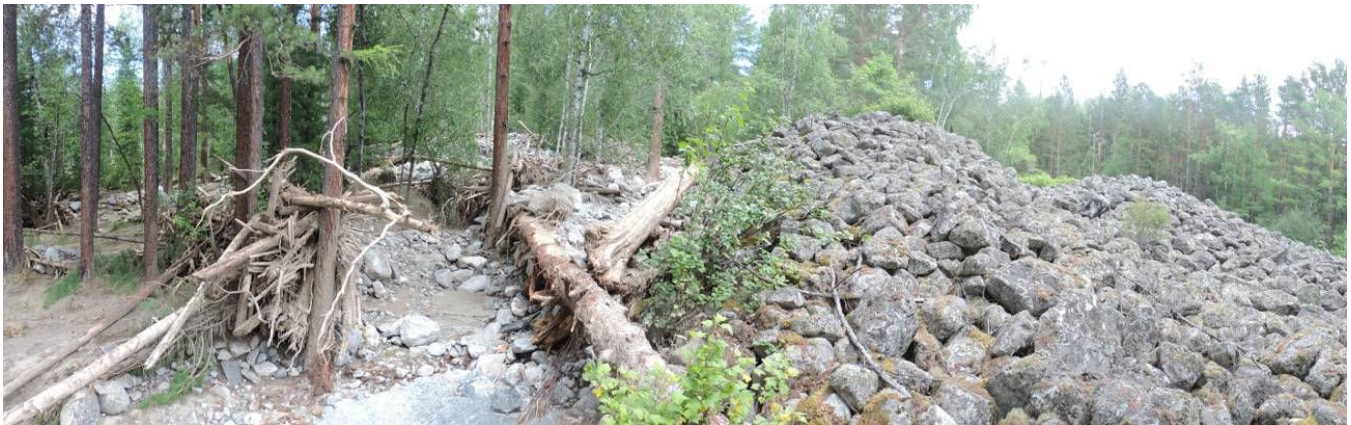
Figure 4. New debris flow gully (on the left in the photo) and ancient debris flow deposits (on the right in the photo) at debris flow fan of the river Pervaja Shikhtolayka (point 769 – 51°55'03.5", 102°27'45.0")

In some places at fans, forming a piedmont sloping plain, traces of ancient as well as of modern debris flows are left as frontal lobes of slightly rounded material and fresh erosional gullies (Figs. 4 & 1).

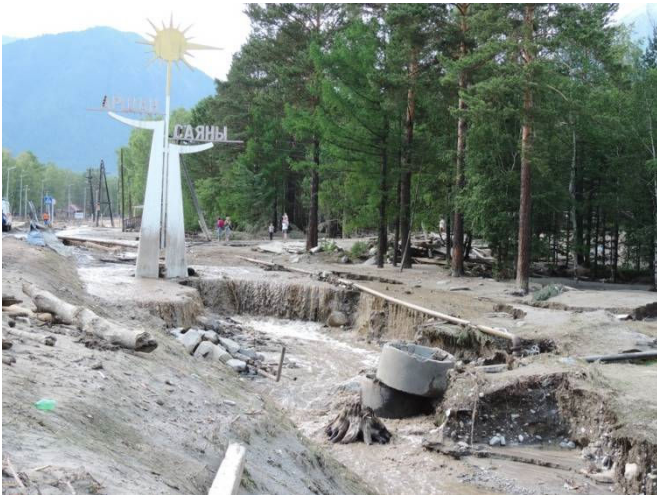
**Figure 6.** Ravine formed by water flow along the Traktovaya street near the “Sayany” resort. Picture of June 28, 2014. Local time 18:30 (point 790 – 51°54'03.5", 102°26'43.3")

loamy material went to the Traktovaya street near the bus terminal of the village of Arshan, destroyed sidewalks and lawns on both sides of the main street, in some places eroding loose gravel-pebble-sand deposits at a depth of up to 1.5 m.

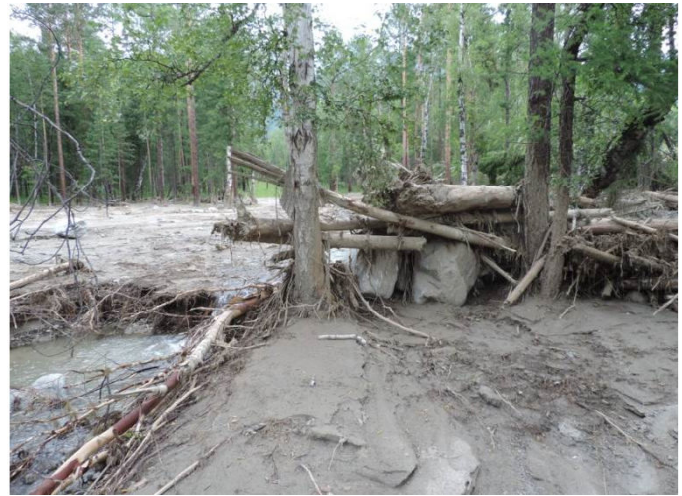
**Figure 7.** Obstruction of wood and stone material in the form of a “fence” near the medical rehabilitation center “Sagan Dali” (point 740 – 51°54'29.0", 102°26'45.2")

boulder material accumulated in the form of debris flow levees. Perpendicular to the debris flows movement among the trees there appeared numerous obstructions of wood and stone material up to two meters in height, resembling a fence (Figs. 7 & 1). In transit zone sporadic shifts of slightly rounded boulders of 2 to 3 m were recorded.

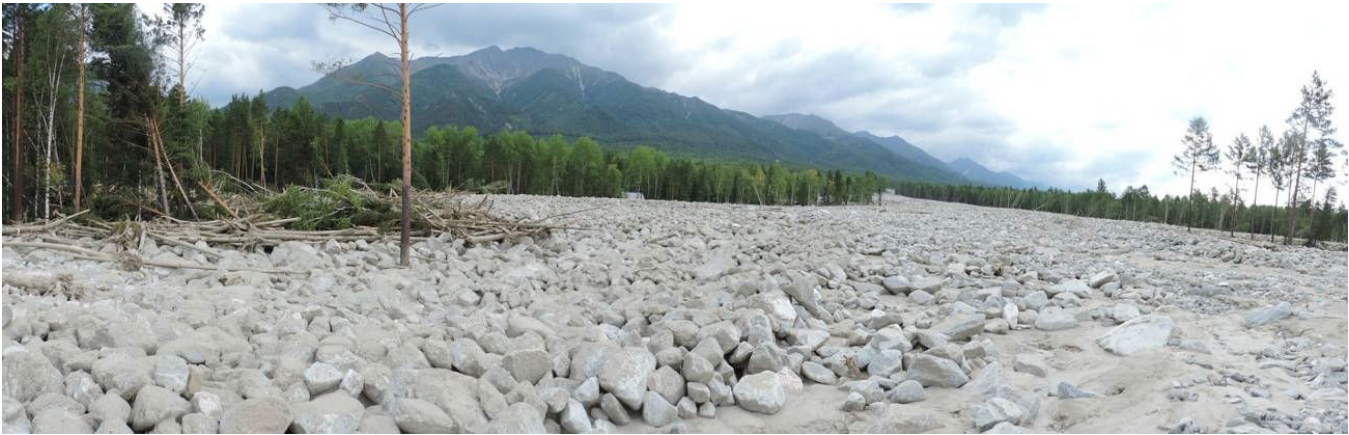
**Figure 8.** Front part of debris flow descended along the river Vtoraja Shikhtolaika. Picture of July 9, 2014 (point 741 – 51°54'32.4", 102°26'53.2")

In the upper part of accumulation zone mainly tractional loads were deposited. Along the valley of the river Vtoraja Shikhtolaika their thickness was 3-3.5 m. Width of the debris flow front part in this zone was 325 m (Figs. 8 & 1). Moving

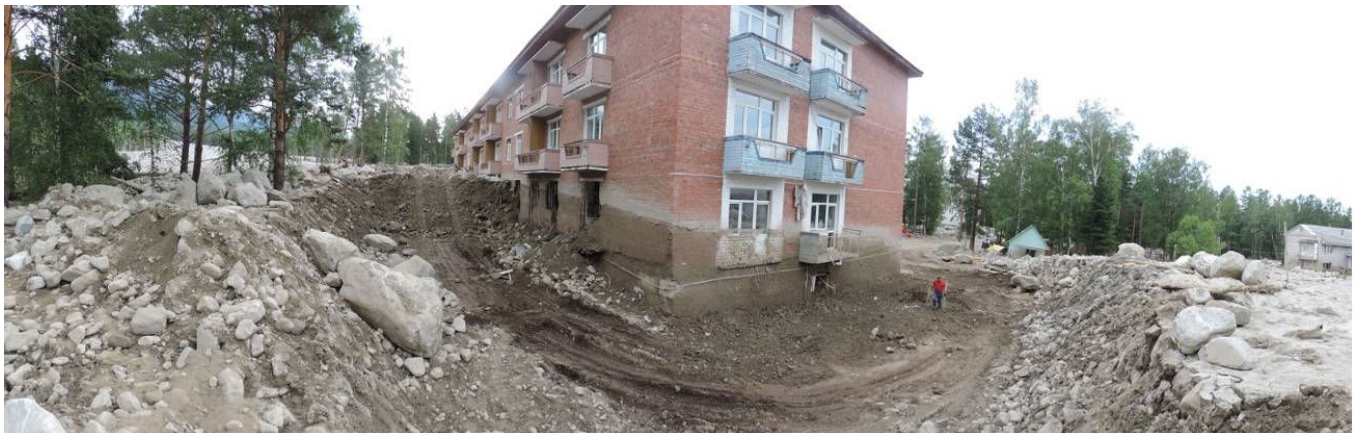
Figure 9. Building of medical rehabilitation center “Sagaan Dali” obstructed with debris flow deposits descended along the river Vtoraja Shikhtolaika. Picture of July 9, 2014 (point 740 – 51°54'29.0", 102°26'45.2")

along the perimeter of fan, boulder material destroyed wooden houses on its way. In the vicinity of the medical rehabilitation center “Sagaan Dali” boulder deposits reached the second floor (Figs. 9 & 1).

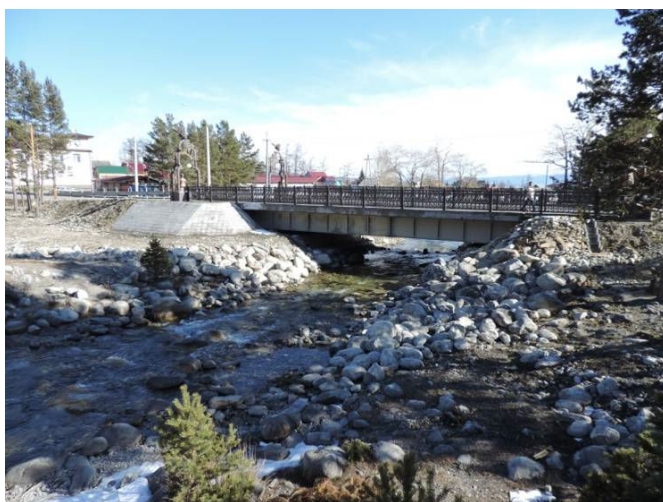
Figure 11. Bridge over the river Kyngarga on March 26, 2014

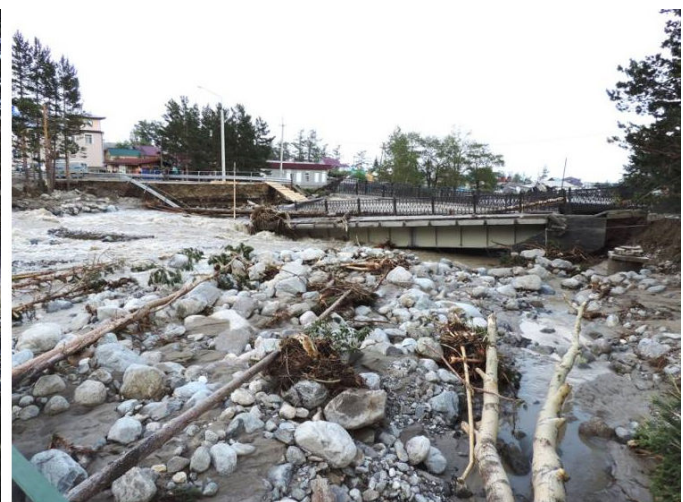
Figure 12. Bridge over the river Kyngarga on June 28, 2014, after the passage of debris flood along the river. Local time 19:18. Photo from the right bank of the river (point 674 – 51°54'51.7", 102°25'36.4")

After the destruction of bridge due to debris flood in 2014, in order to resume the passage of water, three tubes were put and a false fill was made. Then, in autumn of 2014, a wooden bridge on metal bearing structures was mounted below the embankment. On June 14, 2015 after a short rainfall there formed a flood in the river. Pipe culverts got blocked with stone material and water went out of the river to the left bank of the village of Arshan. The consequences were eliminated in quite a brief period by constructing a temporary dam and a channel was made by removing one of the pipes.

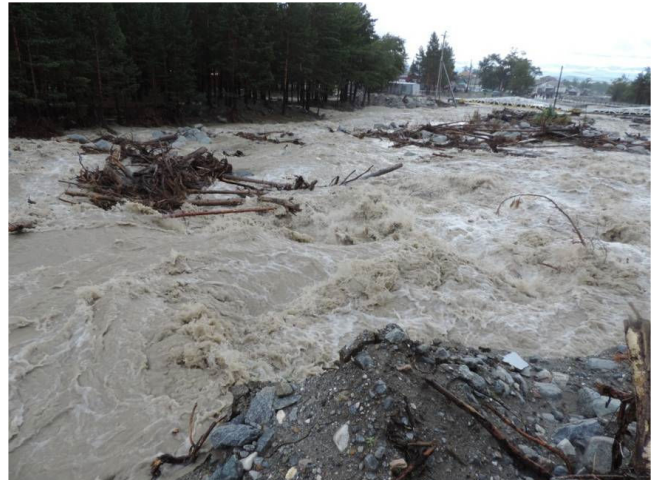
Figure 13. Debris flood in the river Kyngarga at the peak maximum. Local time 11:25, July, 14, 2015 (point 965 – 51°55'00.0", 102°25'33.9")

At the maximum of debris flood passage on the river Kyngarga there was mainly bottom erosion, as for the bank erosion – it was not large and the movement began to involve small-diameter pine. Water flow rate approximately did not exceed 4 m/s.
