Study of Flash Flood in the Rishiganga and Dhauliganga Catchment in Chamoli District of Uttarakhand, India

M.S.Rawat and R. Dobhal
Uttarakhand State Council for Science & Technology
Vigyan Dham, Jhajra, Dehradun

Abstract: The present study is an attempt to investigate a flash flood that occurred on the morning of 7th February 2021 in the Rishiganga and Dhauliganga Catchments in Chamoli District of Uttarakhand. A catastrophic flood was triggered due to a massive rock-cum-snow avalanche caused by Antecedent Snow falls in the region. A huge flash flood was generated as a tremendous quantity of rockslide, comprising deposited ice and snowmelt, rolled down the Ronthi Glacier and flowed downstream into the glacier valley. This massive flash flood hit the NTPC's Tapovan-Vishnugad hydel project and the Rishiganga Hydel Project, bridges, roads, and communities in and around Raini, Tapovan and Joshimath regions in the Chamoli district of Uttarakhand. The mud and slush-inducing elements resulted in the development of a dammed lake, which momentarily blocked one of the Rishiganga's tributaries. Temporal satellite image has been used to access the information of disaster damage assessment in

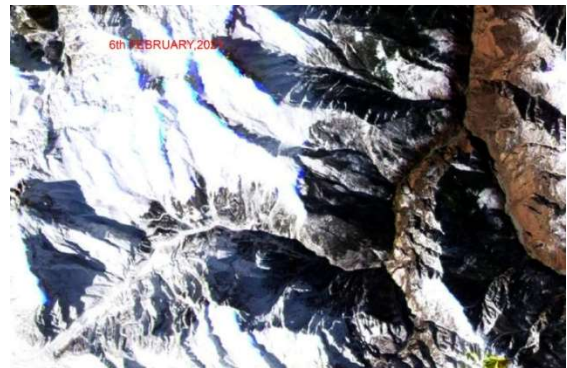
Figure 2. PlanetScope imagery of 6th February, 2021, showing pre-disaster image.

There were no major earthquakes in the area according to data from the National Centre for Seismology, Union Ministry of Earth Sciences. The third reason is that the thawing and re-freezing of ice affects the properties of the rock and soil in the area with glaciers. Pre-satellite image on 6th February, 2021 showing intact condition of the snow covered area in Fig.2.

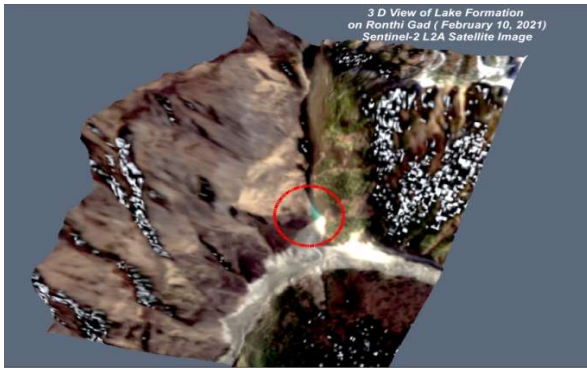
Figure 5(b). Satellite image showing Lake formed after Flash flood in the Rishiganga River.

High-resolution satellite images has identified the exact spot where a "dangerous" lake was formed by the debris of the avalanche Fig.5b that left dozens dead and 200 missing on 7th February 2021.

The total area of the lake is covered 0.44 km² in the High-resolution satellite image which still is a threat to the downstream areas.

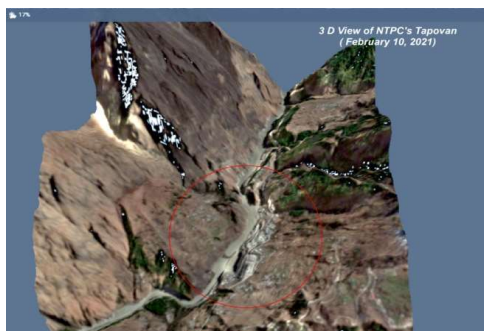
Figure 6(b). Satellite image showing post disaster image on 15th February, 2021 image.

Post-satellite image clearly showing destructions NTPC Power project at Tapovan in the Fig.6b in Gray colour. The following images show the damages. A field survey was conducted to know the actual condition after the disaster in the Rishiganga and Dhauliganga valley (Photo.1).

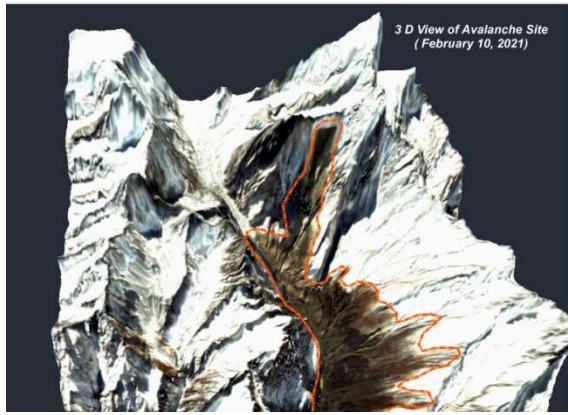
Figure 8. Avalanche site Post-satellite image on 10 February, 2021.

A pre-and post-change analysis from the satellite imagery has shown that the large rockslide incurred along the western slope of the Trishul glacier.

The havoc resulted in the formation of ice and rock-laden unstable the area of the upslope. On the 7th February 2021 this block of snow, ice and debris collapsed, due to the melting of snow and consequent percolation of meltwater into the cracks/joints resulting from the landslide/snow avalanche.

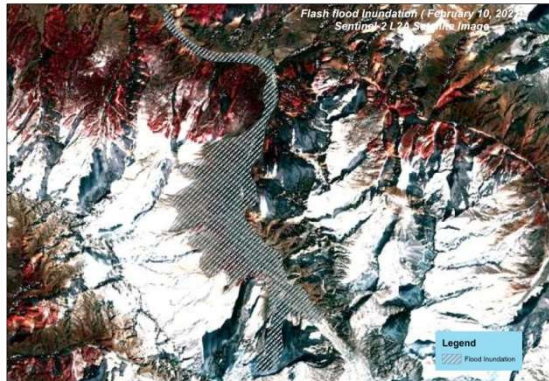
Figure 9. Satellite image showing Flash flood Inundation areas.

The Rishiganga valley and Dhauliganga valley received a large volume of flash flood in the downstream areas. A total area was covered of 18.68sq.km upto Joshimath Fig.9.

The maximum simulated water depth varied from 24-15 m from Rishiganga to Joshimath and 1-2m water depth was observed from Nandprayag to Karnprayag.

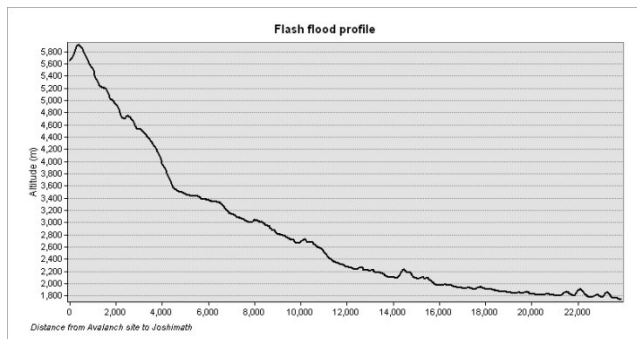
Figure 10. Elevation profile for the stretch between ridge top to Tapovan.

Fig.10 showing the elevation profile drawn from the ridge top of the Raunthi glacier area to Tapovan, traversing a distance of 22 km.

The avalanche travelled a distance of 1.85 km through bedrock before striking the valley floor 3800 m a.m.s.l. The Ice/snow/rock avalanche converted into a debris flow during its transport through the valley.

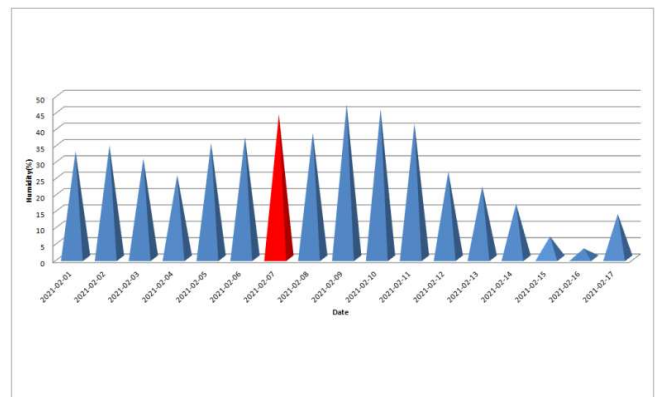
Figure 14. Humidity (%) of the Disaster affected areas.

Humidity in the disaster-affected areas which is quite high on the Disaster morning Fig.14.
