Evaluation of Liquefaction in Ercis Plain during Van Earthquake

Abstract: The destructive Van Earthquake that struck eastern Turkey on 23 October 2011 caused significant damages and casualties in the Southeastern Turkey City of Van. This study focuses on the liquefaction occurrences in Ercis Plain, where Irsat and Zilan streams are discharged to Lake Van. The liquefaction potential in this area was studied using various analytical methods. Assessment of liquefaction triggering and estimation of seismic induced settlement and lateral spreading were performed. The results of site specific ground response analyses showed that the ground motions were amplified significantly during the earthquake, which resulted in larger values of Cyclic Stress Ratio (CSR) relative to those estimated using simplified methods. A comparison of analytical results with post liquefaction observations indicates that a proper evaluation of CSR values is imperative for a realistic estimation of liquefaction triggering and post liquefaction deformations.

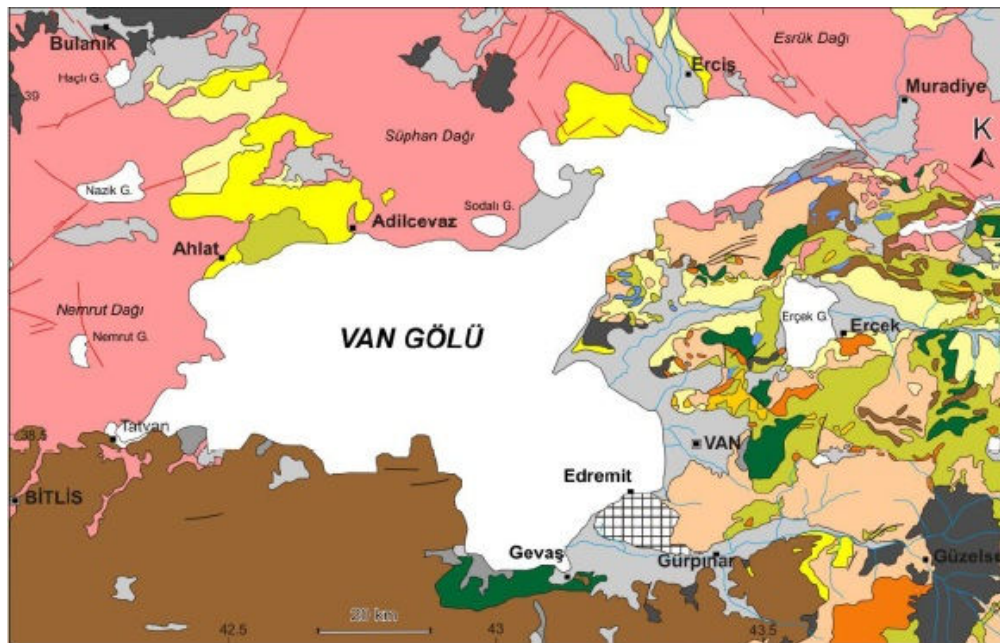
Fig. 4 The geologic map of Van area (after MTA 2002)

the rock masses and alluvial sedimentations formed during Paleozoic Era. Metamorphic rocks belonging to the Bitlis Massif can be observed south of the basin. The volcanic rocks that are produced by Nemrut and Suphan volcanoes are encountered to the west and east. East of the basin comprises the volcanic rocks and ophiolite compositions belonging to Yuksekova Complex. Figure 4 depicts the geologic map of the general area around Lake Van.

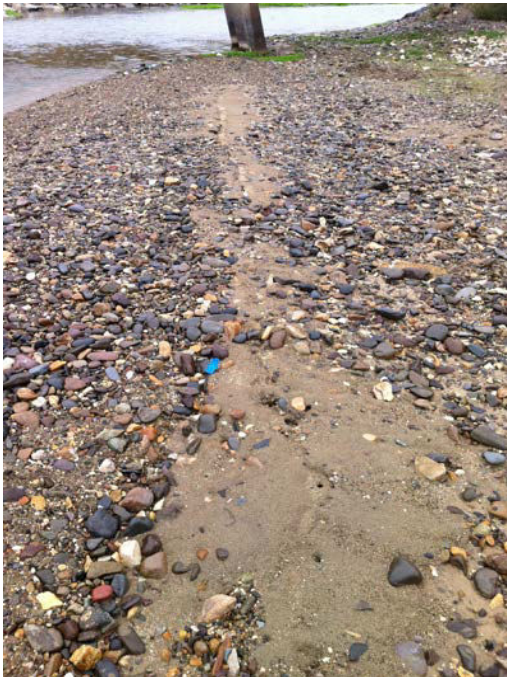
Fig. 12 Sand boiling in Zilan River (after Cetin et al. 2011)

Post earthquake field observations indicated that pockets of the area investigated have experienced liquefaction. Despite the difficulty of quantifying the liquefaction induced ground movement (the area was a constructed zone), signs of lateral soil movement as well as foundation settlements in some buildings were observed. Since the liquefaction assessment presented in this study was based on an average of SPT profiles that were considered to be representative of the area, it is expected that some locations with higher SPT N values did not experience liquefaction. This explains the localized nature of observed liquefaction. Namely, only the locations with low SPT N values were thought to have liquefied during the earthquake. Figure 12 shows the sand boiling that occurred near Zilan River.
