**Curatorial Report Number 74**

Archaeological Investigations on the Uniacke Estate, Hants County, Nova Scotia, 1992 Museum Services Division Nova Scotia Museum 1747 Summer Street Halifax, Nova Scotia, Canada B3H 3A6

By Laird Niven July,1993

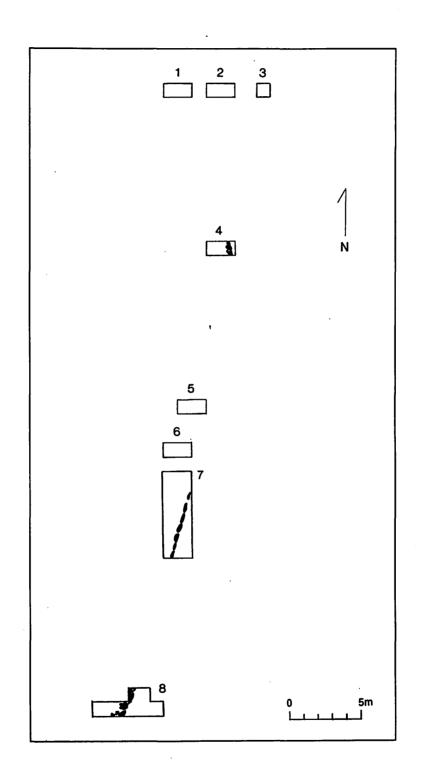
10. Haha wall excavation units, 1992. Scale 1:200 (See text pp.5, 6, 7, 8, 9) 1. e71.5n3-e73.5n2 2. e74.5n3-e76.5n2 3. e78n3-e79n2

4. e74.5s8-e76.5s9 7. e71.5s24-e72.5s30

8. e66.5s40-e71.5s41

The crew first investigated the area believed to contain the haha wall. A haha is a retaining wall, built into a ditch to separate the lawn/garden area from the pasture without obstructing the view<sup>5</sup> (Illus. 9). It was a common feature of English estates in the 18th century, and the Uniacke Estate example would have been elemental in the estate concept. The purpose of the excavation was to confirm the location of the wall, to establish construction and terminal dates, and to evaluate the condition of the wall. These aims were partially fulfilled; the wall was found well-preserved, but no physical evidence was found to support a construction date. The excavations totalled 27.5 m<sup>2</sup> on the east half of the haha wall (Illus. 10).

The artifacts from E74.5S8-E76.5S9 (Illus. 10: #4) were found in context within rock fill on the east side of the wall, at a depth of at least 41cm, and were deposited when the haha was filled. They include a large fragment of a "Maritime-ware" bowl or pan, which has a hard red body, a white slip, and a clear lead glaze that is flaking. It is not certain if this is a local product or one imported from Britain. The second important artifact is the finish/body of a light blue/green glass bottle, made in a 2- or 3-piece vertical body mould. It probably served a medicinal function. The corner of a faint body panel is visible on one side and most likely held a label. This type of mould was

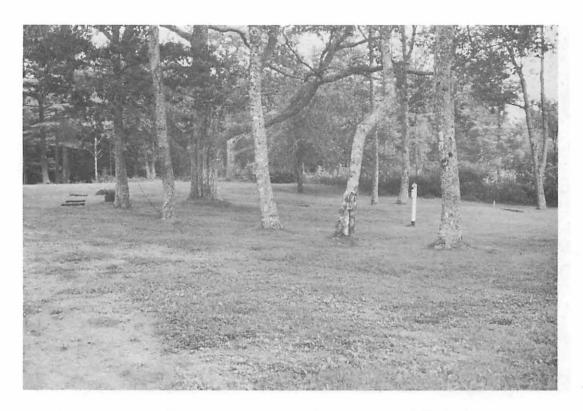
13. The haha wall excavation units on the east lawn, 1992, looking east. Refer to Illus. 9, from left to right, units #1, 2, 3, 4, and 5. Also note the haha wall sign on the right of the photo. (See text p.7)

- 1. This pit was located on the high ground east of the house, on the lawn, and was placed to look for the northeast extremity of the haha (Illus. 13, 17). The soil below the sod was a light brown loamy sand on top of stone fill (c.20-35cm), excavated to a maximum depth of 29cm. Few artifacts were recovered. No evidence of the wall was found.

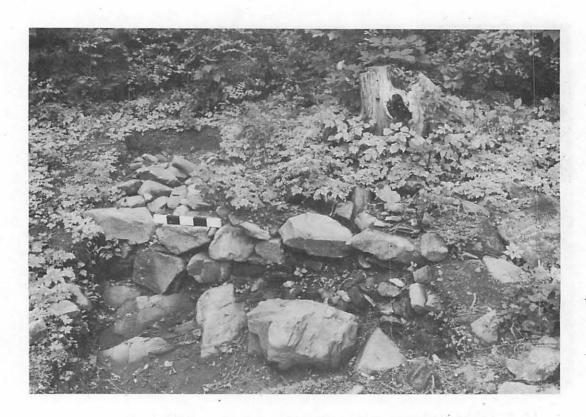
15. Haha wall, unit #8, looking west, wall face and grade fill. (See text pp.6, 8)

A curvilinear mound and depression on the east lawn were assumed to be a clue to the wall's location. The haha was assumed to be a symmetrical feature, with its centre corresponding to the centre front of the house, and its dimensions easily extrapolated to the west side (Illus. 10: 13, 14). Eight excavation units were placed at the centre of the wall and on the east lawn. The wall was found in 3 of the 8 units (Illus. 10: #4, 7, 8). The east central portion of the wall was approximately 1 meter high with a 1.5 meter band of levelling fill on the north (house) side (Illus. 15). No evidence was found

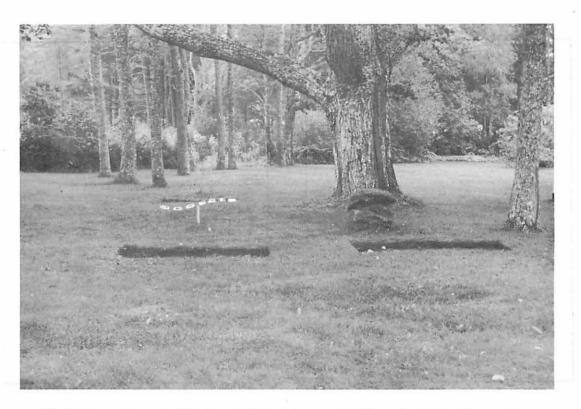
17. Haha wall, units #1, 2, and 4, looking south. Note the slight depression along the line of the posts indicating the exterior of the haha under the ground. (See text p.7)

- 7. This unit is located east of #6, on the east edge of the lawn (Illus. 17). This area was heavily overgrown with brush. Tree roots from a stump in the middle of the area were the cause of some disturbance. The northwest corner of the unit, below the root layer, contained the light brown loamy sand. The grade fill was encountered below this at a depth of c.20cm. The face of the wall was uncovered running from 2 meters south of the northwest corner to the centre of the south wall.

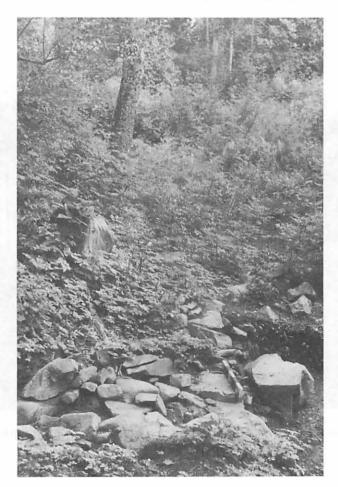
18. Haha wall, unit #8, looking northwest.
Note the possible stile rock at the bottom right.
(See text p.8)

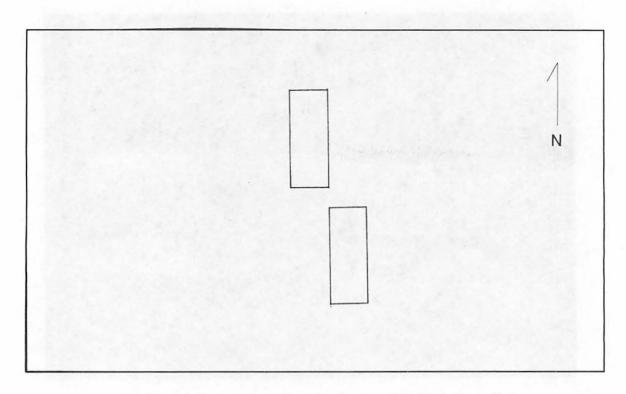
19. Outbuilding excavation units. Scale 1:200 (See text p.12 )

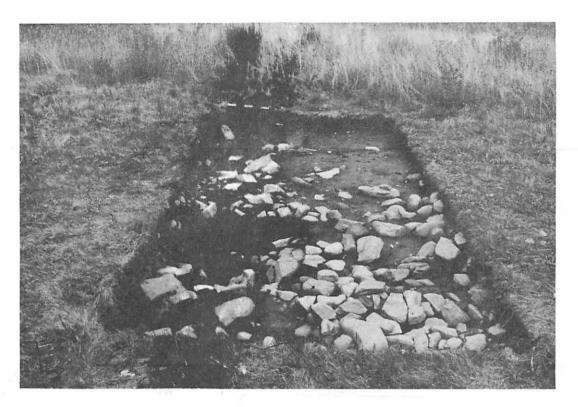
21. Outbuilding excavation unit, looking north. (See text p.12)

The 1992 tests were situated in an area roughly calculated to bisect both the fence and the building. This calculation was arrived at using the known dimensions of the existing barn and carriage house in the context of the Woolford watercolour. In this way the location of missing features could be estimated on modern maps. The area is located just west of a low, wet area and is north of the carriage house (Illus. 19, 20). A total area of  $20m^2$  was excavated. The soil profile in this area is consistent with documentation that Uniacke filled in low areas of his estate: dense sod (0 to 7cm); over wet, brown sand (7 to 60cm); over what is interpreted as fill consisting of field stones roughly 10-40 cm in diameter (Illus. 21).

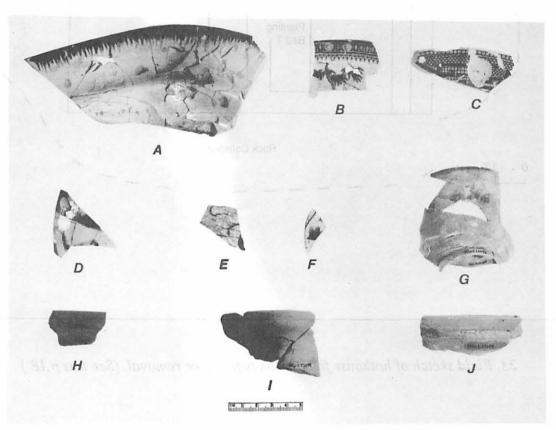
22. Outbuilding artifacts. (See text pp. 13-14)

A. Shell-edge pearlware
(BfCx:2:23250)
B,C. Transfer-printed pearlware
(23263, 23249)
D. Slip marbled and turned refined earthenware
(23264)

E, F. Polychrome painted pearlware. (23260, 23326)
G. Tea bowl, refined earthenware. (23261)
H, I, J. Flower pot rims. (23243, 23244, 23254)

burned refined earthenware tea bowl (Illus. 22: G). It is decorated in a hand-painted, underglaze blue, floral pattern, both inside and out, with a horizontal underglaze blue stripe running around both sides of the rim.

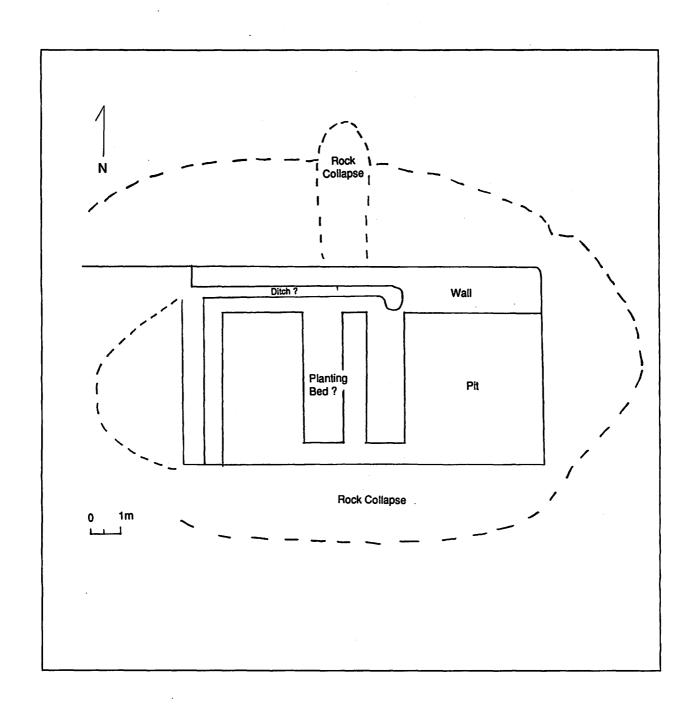
23. Field sketch of hothouse foundation before tree removal. (See text p.18)

The hothouse site is located approximately 160 meters north of the main house, halfway up a moderate slope. In the spring of 1992, while the site was covered with trees, it was visible as a small dry-stone foundation measuring 12 by 6m (Illus. 23). The foundation was 60cm high and 40 cm thick, with two 'planting beds' in the centre and a large deep unit at the east end. By the end of the summer the foundation was revealed to be at least 16.5 by 10.5 meters and comprised of two distinct but connected areas interpreted as a hothouse portion containing the plants and a shed/utility area. A total area of 48m<sup>2</sup> was excavated on the site and over twenty thousand artifacts were uncovered (Illus. 24).

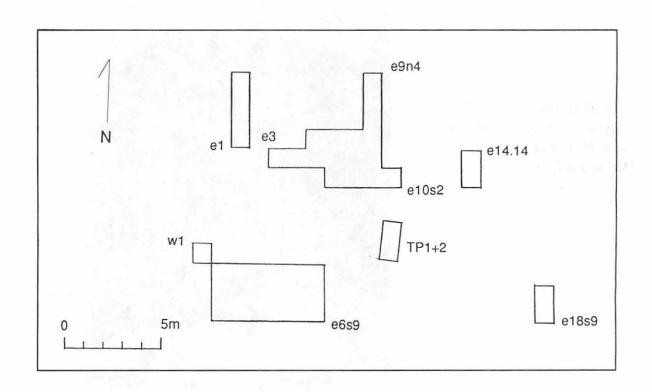
24. Hothouse excavation units, 1992. (See text p.18)

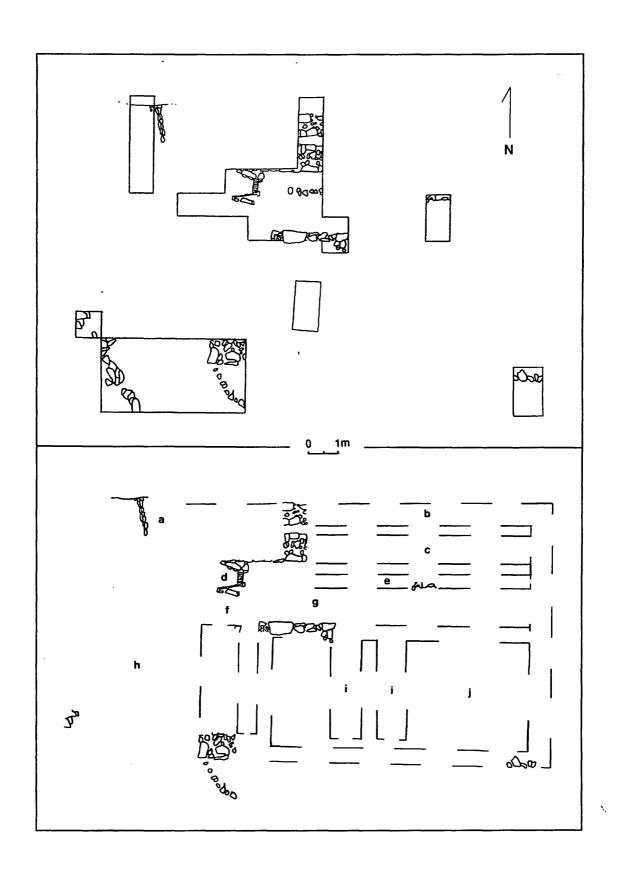
28A. The hothouse foundation with the wall lines extended. B. The hothouse walls. (See text p.21)

a. northwest corner

j. pit area

c. interior north wall f. entrance to hothouse section i. piers for sub-floor

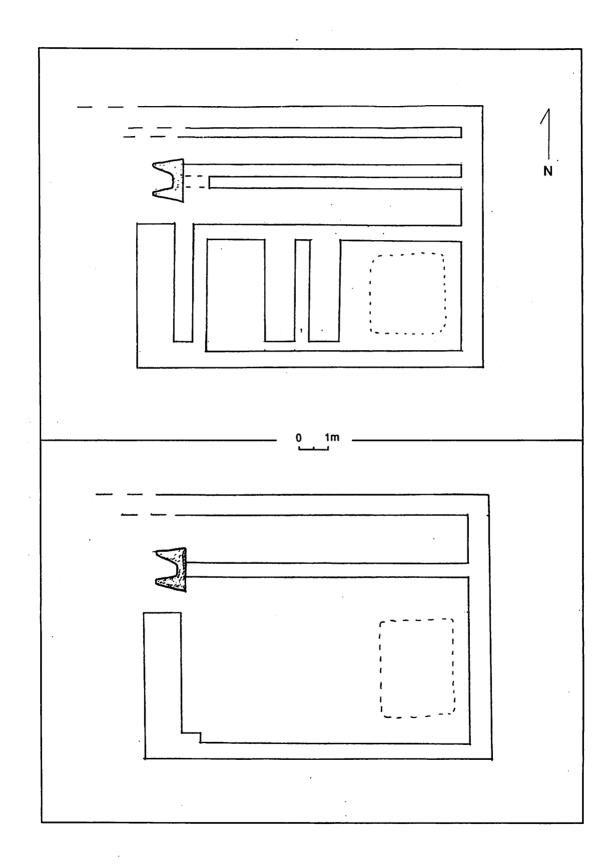
29 A.The hothouse walls B. Conjectural floor plan of the hothouse (See text p.21, 22)

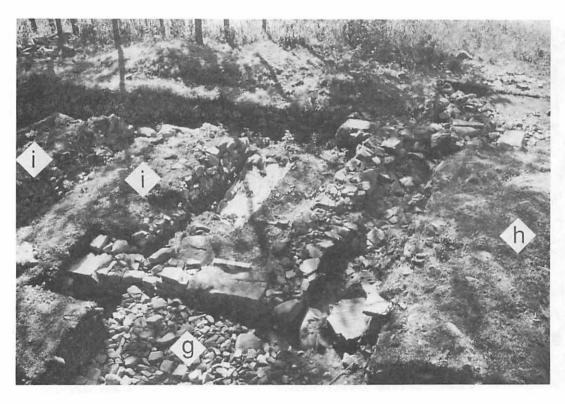
31. Hothouse, looking southeast. (See text p.21)

Prior to excavation, the exposed foundation was thought to be the complete hothouse structure; however, as the excavation progressed and historical sources were consulted, it was increasingly clear that the building was much larger than anticipated. The excavations also showed the hothouse to consist of two distinct areas under a single roof: a shed/utility area along the west and north; and a hothouse area along the southeast (Illus. 28: A, B; Illus. 29: A, B). The southwest corner of the foundation was uncovered, but the search for the northwest corner proved futile (Illus. 30). What became clear was that the northwest corner ran at least 3m further west than the southwest corner. This overlap likely delineates the shed/utility area (Illus. 31).

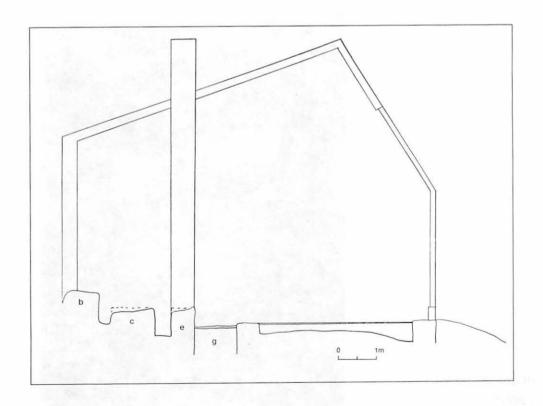
35. Conjectural drawing of an unequal span-roofed building on the hothouse foundation, based on Miller (1807). (See text p.23)

The hothouse is drawn in cross-section in Illus. 35, running north-south from e9n4 to e9n10, with an uneven span-roofed structure on the foundation. This is simply intended to illustrate how the hothouse may have looked based on the appearance of the Québec 1815 greenhouse.

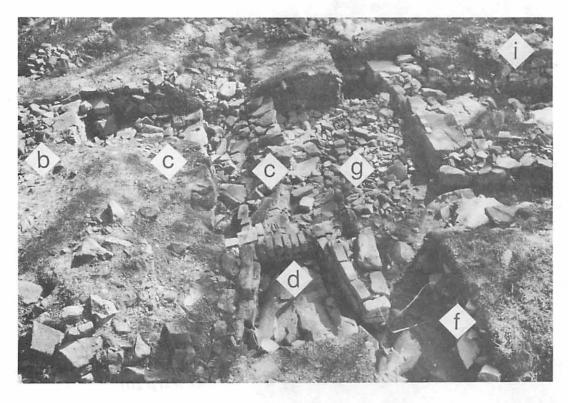
39. Hothouse, looking east. (See text p. 23)

The most important clue supporting this as the site of the 1830 hothouse is the somewhat complicated foundation. The hothouse foundation is an example of the exploitation of an abundant local resource – field stones. It was built on bedrock which slopes gently from the northwest to the southeast. The exterior walls vary in height from approximately 20cm to over 150cm and are 90cm thick. The exterior walls were bermed with fieldstones, presumably to provide both support and insulation. The east and southeast sides of the foundation had been built up approximately 3-4m to bring it level with the west side (Illus. 34, 36). A test unit in the area of the southeast corner<sup>16</sup> revealed that the wall was built on a layer of cracked quartz on top of bedrock and that a portion of the top of the wall was chinked with mortar, possibly indicating it once lay above the ground and was chinked to protect it from the elements (Illus. 37) (Beaudet, 1991:100). To the north is a wall system consisting of a 90cm exterior wall, a 40cm gap, and a 122cm wall (Illus. 38). This abutts a 90cm stone feature which is 40cm high. A portion of this last feature may be part of the heating/flue system running from the 'fireplace' (Illus. 39).

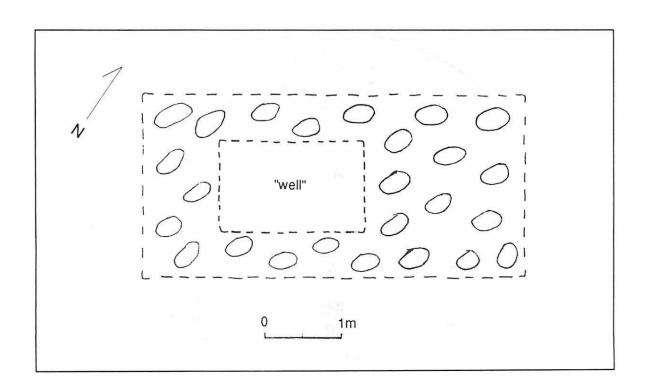
46. Field sketch of the hothouse well. (See text p.29)

There is a small stone feature located c.18m northeast of the hothouse which may be a well contemporary with the hothouse (Illus. 46). The feature is built of dry-laid stone and was filled with the same stone after it was abandoned. A small test excavation on the north side of the 'well' failed to yield any new information about its use. Further excavations inside the feature are necessary to determine its function.

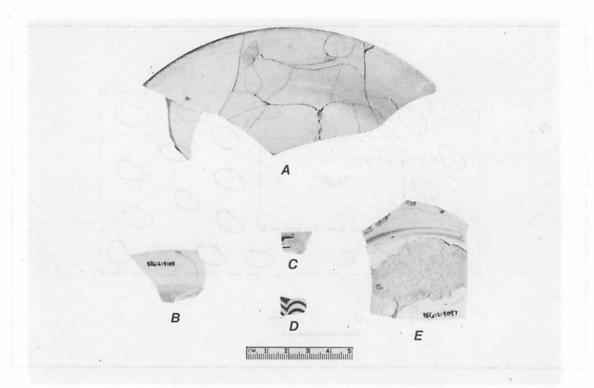
## 48. Hothouse creamware. (See text p.37)

A. plate, plain rim, overglaze brown stripe (BfCx:2:1040) C. plain rim, overglaze brown stripes (1847)E. plate, base fragment

B. plain rim, unid. vessel (4103) D. body sherd, underglaze brown (1848)

The most complete creamware artifact is the plain rim of a plate which would have been 8" (200mm) in diameter and 22mm high (Illus. 48A). It has a flat brim turned up at a 45° angle. The base is flat and has considerable use-wear on it. The rim is encircled by a 3mm wide overglaze brown stripe, 2mm above a 1mm wide overglaze brown stripe. This pattern matches that on a pearlware plate illustrated by Sussman (1977: 108). This type of decoration was popular during the late 18th and early 19th centuries (Ibid: 108). This piece may also have been part of the "com. Brown edge dinner set" listed in the 1830 inventory.

Two interesting creamware sherds were found during the excavation of the southeast corner. The first is a fragment of a plain rim which is decorated with overglaze brown stripes (Illus. 48: C). The second is a body sherd decorated with a curvilinear design in underglaze brown (Illus. 48: D). This decoration dates from the end of the 18th to the early 19th centuries (Ibid).

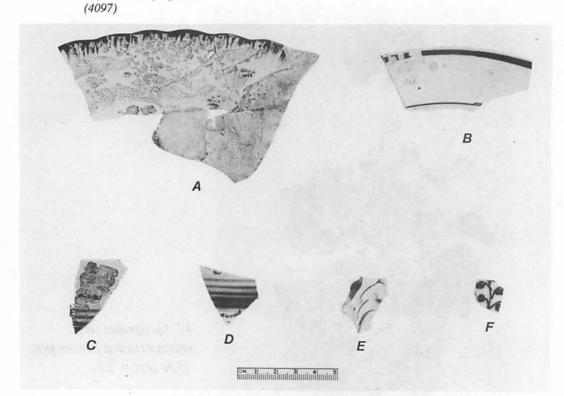
A. plate, blue shell edge (1042)C. rim, underglaze green annular E. body, underglaze polychrome (1960)

49. Hothouse pearlware. (See text pp.38-39) hell edge B. plate, underglaze green/brown stripe (1024)D. body, underglaze green annular (1821)F. body, underglaze blue (1954)

One of the most common pearlware patterns of the late 18th and early 19th centuries is the shell-edged pattern decorated in underglaze blue or, less commonly, green. An example of this pattern was found at the hothouse (Illus. 49: A). It is part of a platter and has a scalloped rim decorated with painted, but not moulded, vertical lines in underglaze blue. The flat brim is 1½" (38mm) wide and upturned. It has a smooth, rounded upper edge and a more sharply defined bottom edge which, according to Sussman, may indicate it was mechanically trimmed, a technique which replaced hand trimming in the 19th century (1977: 110). South dates this type of pearlware to c.1780-c.1830 (1977: 212).

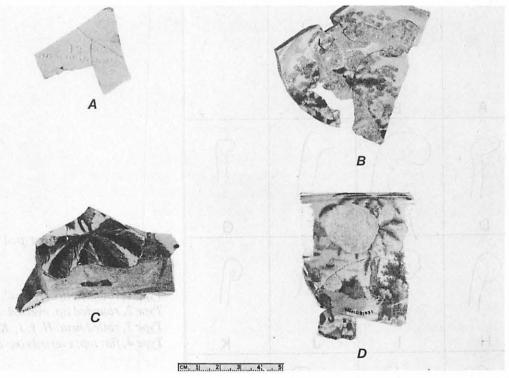
## 51. Hothouse Herculaneum pearlware. (See text pp.40-41)

A. base sherd, impressed mark (1034)

C. base frag., desert scene (1037)

B. base frag., unid. pattern (1033) D. body frag., pattern similar to C (1031)

Two pearlware artifacts have been associated with a pattern used by the Herculaneum factory. One is the partial foot/base of a bowl with a 7"(179mm) footring (Illus. 51: C). The remaining portion of the pattern is palm leaves which correspond almost exactly with those on an East Indian-style pattern shown in Smith (Ibid: Pl.158). The pattern shows three people on an elephant approaching what may be temple. The pattern is found on a meat dish, a plate, a frog mug, and a bed pan, all dated to c.1825 (Ibid). The pattern of the second pearlware artifact is of a less intense blue than the first and is not as well defined. Although not exactly the same as the pattern described above,

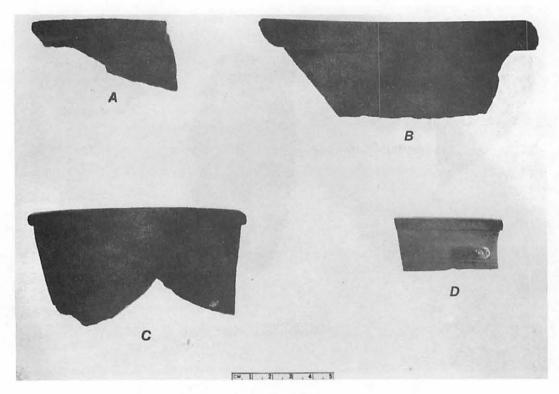
56. Hothouse flower pot rims Type 2. (See text pp. 44-45)

A. Type 2A B. Type 2B C. Type 2C D. Type 2D
(22248) (1006) (1011) (1016)

Type 2B rims are much more robust than Type 2A (13mm vs 9mm thick) and everted at least 90° (Illus. 53: E; Illus. 56: B). The lip was thickened by pulling up a 15mm wide band of clay from the exterior, creating a broad groove below the lip. This rim style and ceramic body are similar to those found on artifacts made of 'Maritime' ware, which would have been covered in a white slip and a clear lead glaze. Duguay refers to this ceramic body and ascribes it to the northeast of England or New England

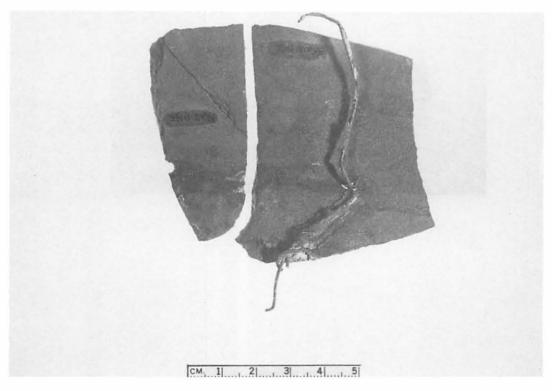
59. Hothouse, mended flower pot fragment. (See text p.pp.46-47 ) (1132)

Evidence for the mending of flower pots was found in the form of two body pieces. The first is a large body sherd with a 6mm hole drilled in it<sup>29</sup>. There is a large break

above the hole which contains a 50mm strip of glue residue. The second mended piece is actually two sherds, almost certainly broken before 1830, each with a 3mm drill hole, which were glued together and secured with copper wire anchored through the drill holes (Illus. 59). This piece is likely from the same vessel as the first, indicating the mending of multiple breaks.

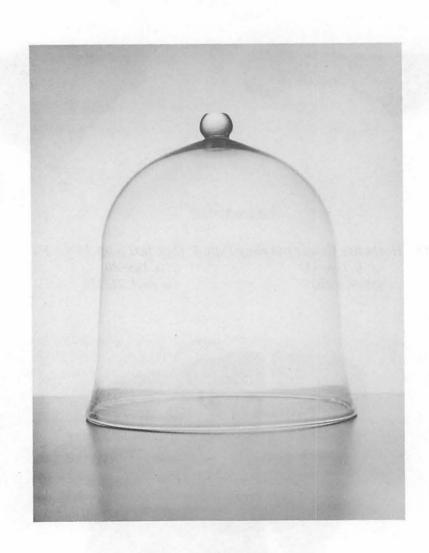
60. Bell glass from the Nova Scotia Museum, Acc. # Z3813 (See text p.47-48).

A second distinctively horticultural artifact found during the excavations was the bell glass. These were large bell-shaped glass covers to be put over small, delicate plants to protect them and accelerate their growth. The bell glasses would have been used both directly on the ground in the garden or hot-bed, or set on the rims of Type 4 flower pots.
