## Geophysical Investigation and Management Plan of a Shallow Landslide along the NH-44 in Atharamura Hill, Tripura, India

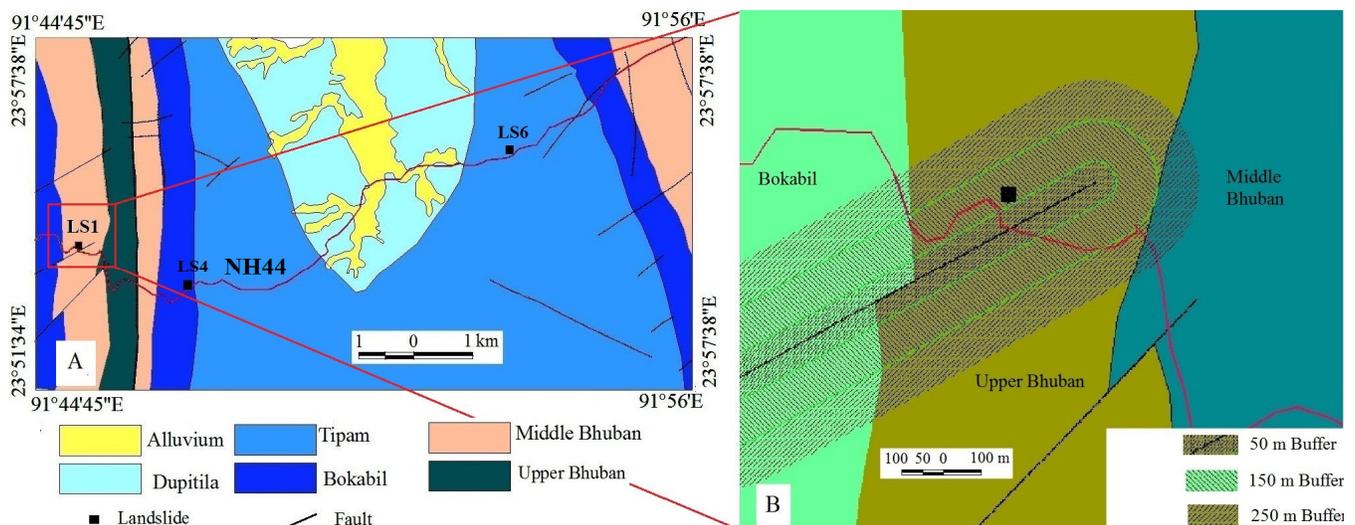
Figure 2. (A) Geology of the area. (B) Fault buffer with the landslide location (Source: Geological map of ONGC and GSI)

materials with occasional intercalation of moderate to poorly sorted silt or clay layers. The whole slope is composed of highly weathered and fragile shale and mudstone. They are relatively weak in resistance and favour the development of landslides. In some parts of the slope, coarse grained sand with mud balls (Plate 1A) was also found. The whole landslide scar is mainly composed of huge thickness of laminated siltstone, shale with narrow bands of sandstone; occasionally lenticular structure of medium to coarse sandstone with mudstone (Plate 1B). The present study area is characterized by the presence of large number of strike-slip fault. Most of the fault lines are in SW – NE direction. The altitude of the slide varies from 166 m - 191 m asl with a convex slope ranging from 15° to 75°. Dip of the rock strata ranges between 40° to 45° in SSW direction. The alignment of the bedding indicates two major directions from which deposition started, i.e., northwest to southeast, and north to southeast trends. The present landslide is located within 150 m buffer zone of fault line (Figure 2B).

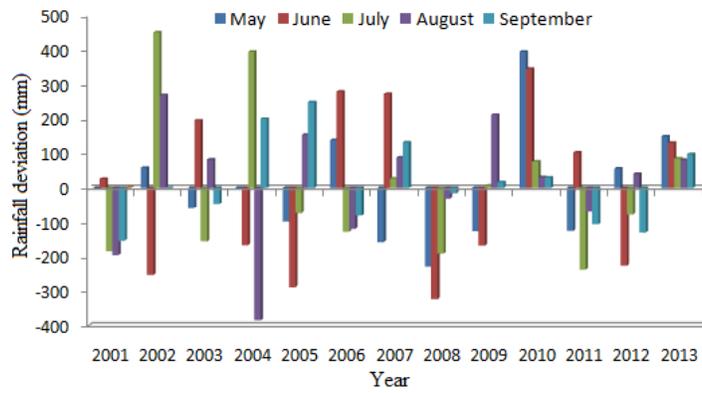
Figure 6. Rainfall variation in the month of May, June, July, August, and September from the year of 2001 to 2013 at Ambassa rain-gauge station  
Source: Agricultural Department, Govt. of Tripura

445.8 mm cumulative rainfall has been recorded, which is accounted 84.78% of the total rainfall of this month. The average annual rainfall is very high in the study area. The area receives rainfall from monsoon. Generally in the month of June, July and August, the amount of average rainfall and number of rainy days are very high. The highest rainfall is recorded as 900.3 mm in the month of June in the year of 2010. The amount of monthly rainfall varies in great extent. During the years of 2001 - 2013, the average amount of rainfall for the months of May, June, July, August and September were 412.85 mm, 555.03 mm, 414.09 mm, 399.7 mm and 27.7 mm, respectively. In the months of May and June 2010, it is observed that 809.1 and 900.3 mm rainfall exceeded the average rainfall. In the month of

June, the amount of rainfall was higher than the normal rainfall in the year of 2001, 2003, 2006, 2007, 2010, 2011 and 2013. The maximum deviation of rainfall is observed in July, 2002 and the amount is 429.31 mm (Figure 7). This excessive rainwater acts as an agent to initiate and accelerate the movement of slope materials. The loose soil allows the rainwater to percolate downward and thereby, subsurface layers get wet and slippery and as a result the slope materials start to move downward. It is observed that the slope is composed of highly fragile rocks and coarse textured soil that allows rain water to percolate downward. This increases the pore water pressure and changes the consistency and shear resistance of the slope material.

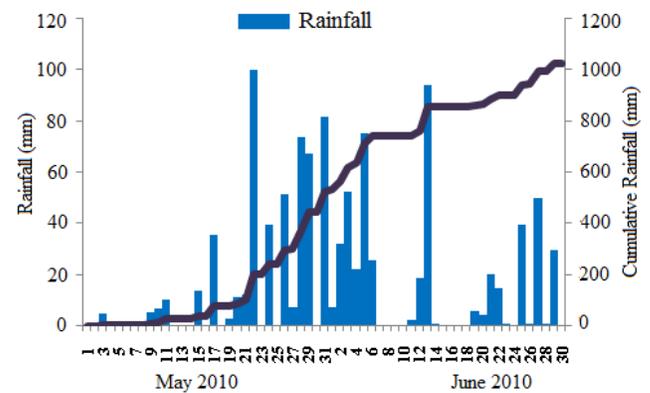
Figure 7. Daily and cumulative rainfall distribution in the month of May and June, 2010

Intense rainfall lasting for a few hours leads to saturation of porous soil and causes a decrease in shear strength of the slope forming materials. In case of the present landslide, the closest rain gauge station (Ambassa) is located about 10 km east from the landslide location. According to the local respondents, in 2010 this landslide was reactivated after a cumulative rainfall 215.4 of mm from 1<sup>st</sup> - 6<sup>th</sup> June, 2010. This amount of rainfall accounted 46.05% of the total rainfall of this month. High amount of rainfall is also recorded in the month of May, 2010. It is 525 mm, which is 66% higher than the annual average rainfall 325 mm of this month (Figure 6). Before that, from 20<sup>th</sup> - 31<sup>st</sup> March, 2010, within ten days,
